Fire Risk Assessment

1-93 Laburnum House - Dagenham - 900042519

28 Mar 2024

SECTION 1: MANAGEMENT OVERVIEW - RISK ASSESSMENT

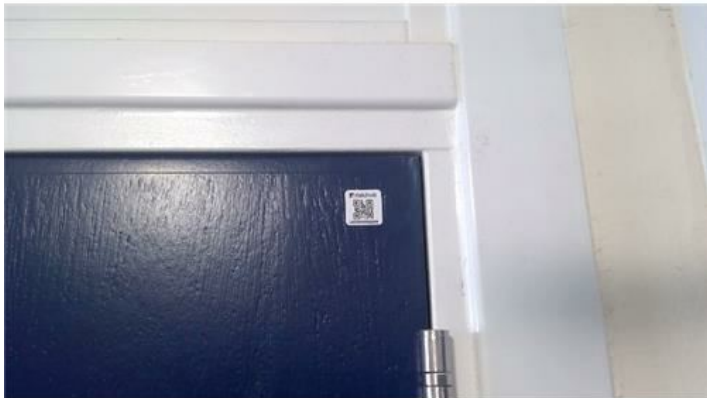
2024328105022.jpg

Ref	Sub Section	Question	Non-conformity	Recommendation	Location	Who is responsible	By When
13108043	10.0.NR-54-212-3	Are management and employees fully aware of the fire safety features provided and their purpose?	The fire doors displayed 'riskhub' QR stickers which indicate that the doors were subject to recent inspection however there was no evidence of the standard or frequency of the inspection.	Fire doors should be maintained periodically in accordance with the Fire Safety (England) Regulations 2022.		Statutory requirement of the Client	18/05/2024

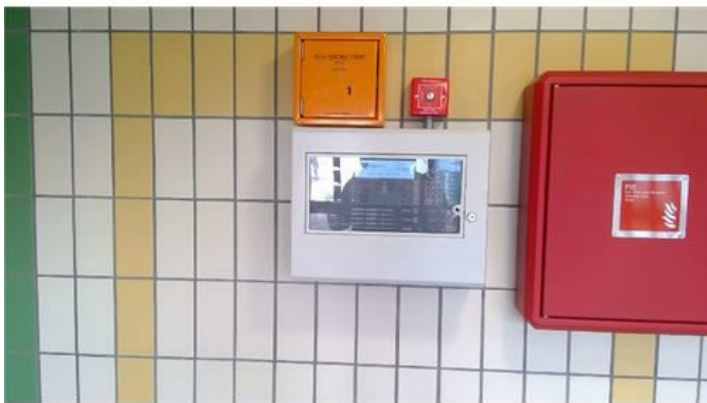
2024328103157.jpg

Ref	Sub Section	Question	Non-conformity	Recommendation	Location	Who is responsible	By When
13108031	7.0.M	Is there an adequate method for raising the alarm and detecting a fire present in the premises?	The fire alarm zones have not been adequately identified.	On or adjacent to indicating equipment, there should be a diagrammatic representation of the building, showing at least the building entrances, the main circulation areas and the division into zones.	Adjacent to the fire panel	Statutory requirement of the Client	18/05/2024

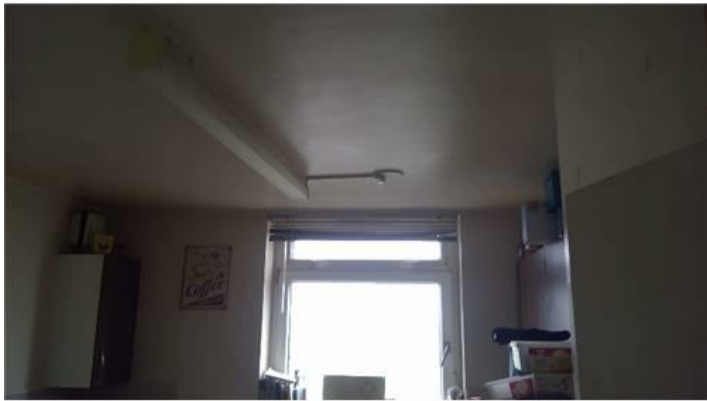
202432813054.jpg

Ref	Sub Section	Question	Non-conformity	Recommendation	Location	Who is responsible	By When
13108032	7.0.O	Is there an adequate method for raising the alarm and detecting a fire present in the premises?	The automatic heat detection was found to have been removed	The automatic heat detectors must not be removed and replaced as soon as possible	Flat 82 kitchen	Statutory requirement of the Client	18/05/2024

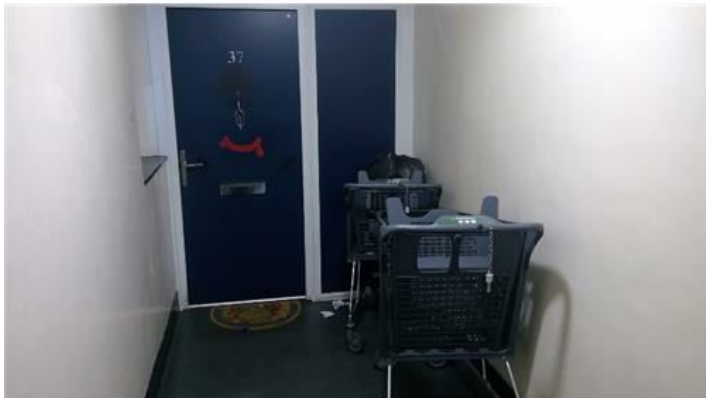
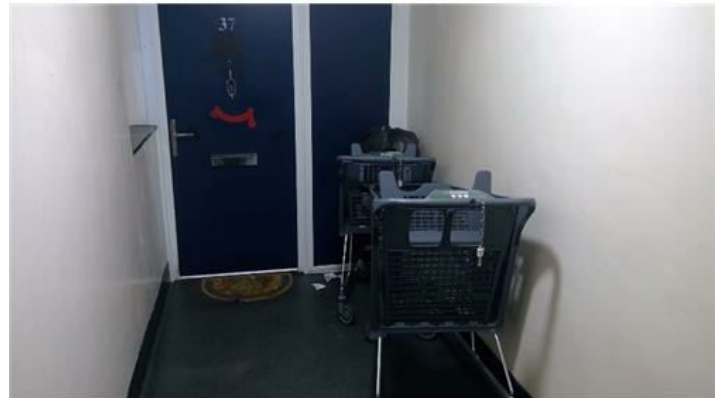
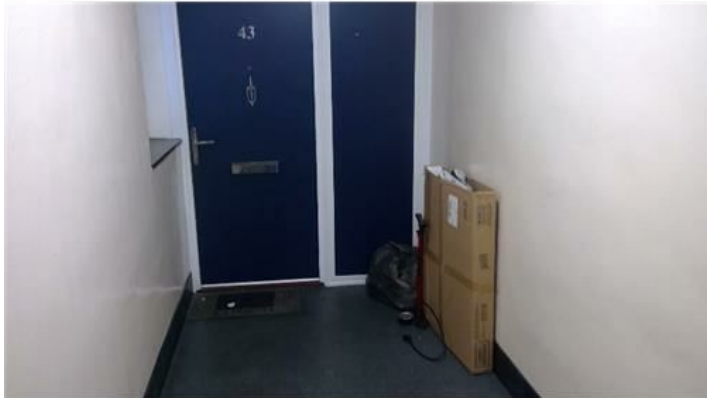
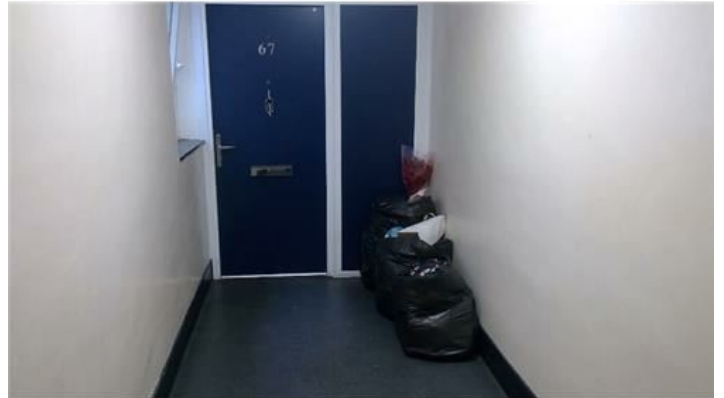
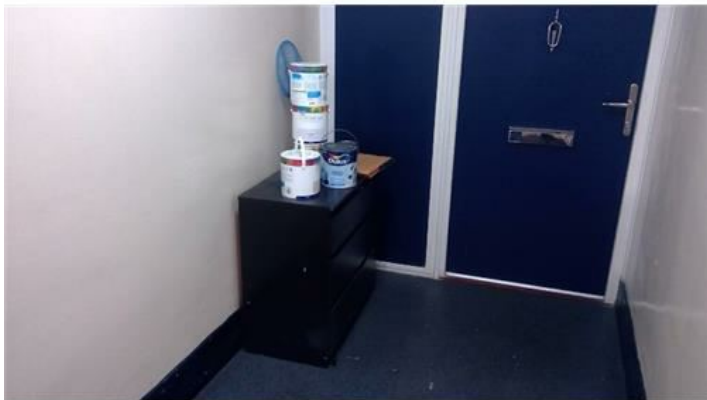
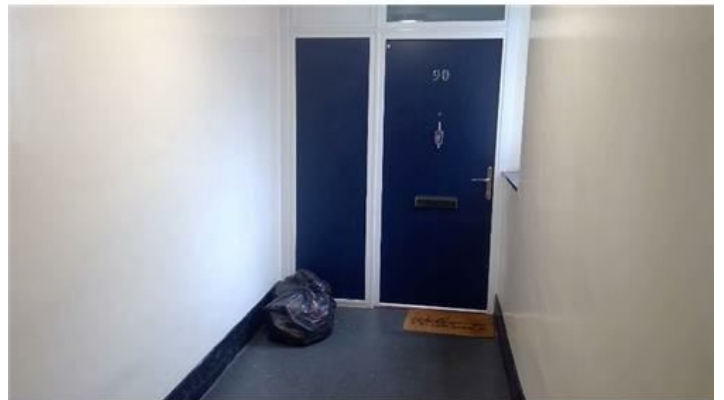
Ref	Sub Section	Question	Non-conformity	Recommendation	Location	Who is responsible	By When
13108027	A	Are house keeping arrangements satisfactory?	Combustible materials are located/stored in the escape routes.	Items that are a source of fuel or are combustible and likely to increase the fire loading or spread of fire, should not be located on any corridor, stairway or circulation space that will be used as an escape route. Therefore, the combustible materials stored in the escape routes must be removed.	Outside flats 37, 43, 67, 88 & 90	Statutory requirement of the Client	18/05/2024

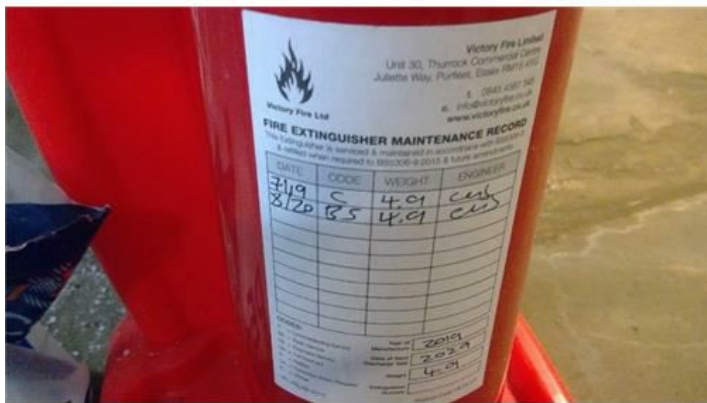
202432810950.jpg

Ref	Sub Section	Question	Non-conformity	Recommendation	Location	Who is responsible	By When
13108028	B	Are there sufficient quantities of portable fire-fighting equipment provided, correctly sited and adequately maintained?	The portable fire-fighting equipment is not being periodically maintained.	The equipment is to be periodically maintained by a competent person to BS 5306-3 and records maintained.	Sprinkler pump room.	Statutory requirement of the Client	18/05/2024

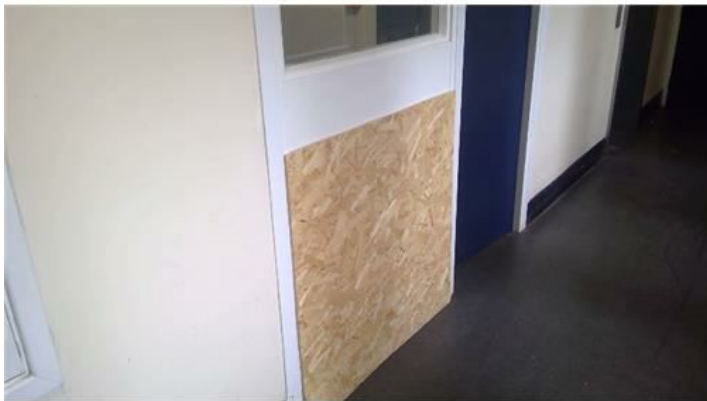
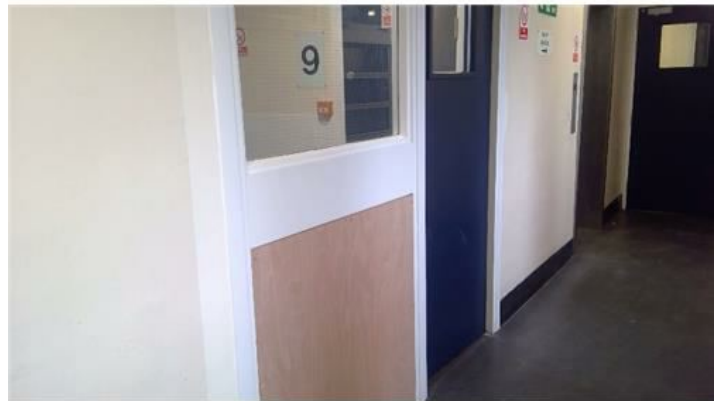
Ref	Sub Section	Question	Non-conformity	Recommendation	Location	Who is responsible	By When
13108025	C	Are the fire resisting partitions present installed and maintained to the appropriate standards?	The fire resisting wire reinforced partition appears to have been damaged and has a temporary repair.	Replace or repair the existing partition with approved materials which will provide the required level of fire resistance.	Floors 5, 9	Statutory requirement of the Client	18/05/2024

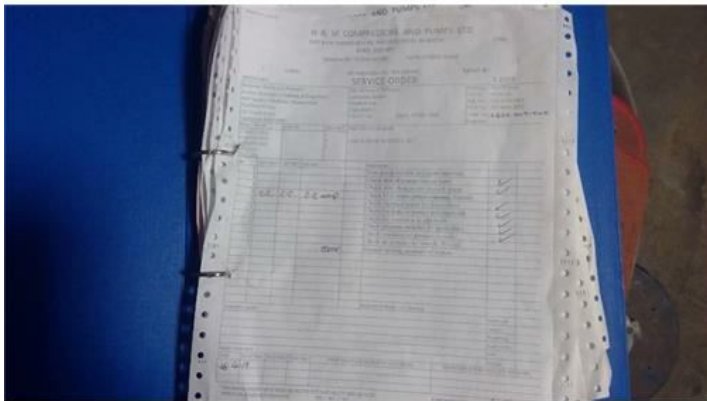
20243281088.jpg

Ref	Sub Section	Question	Non-conformity	Recommendation	Location	Who is responsible	By When
13108029	F	Are the fixed fire-fighting installations correctly installed, adequately maintained and appropriate for the risk?	There was no evidence of current servicing of the sprinkler system. The last service order is dated 26/04/2019.	Ensure the system is tested and maintained in accordance with manufacturers' instructions and/or current British Standard.		Statutory requirement of the Client	18/05/2024

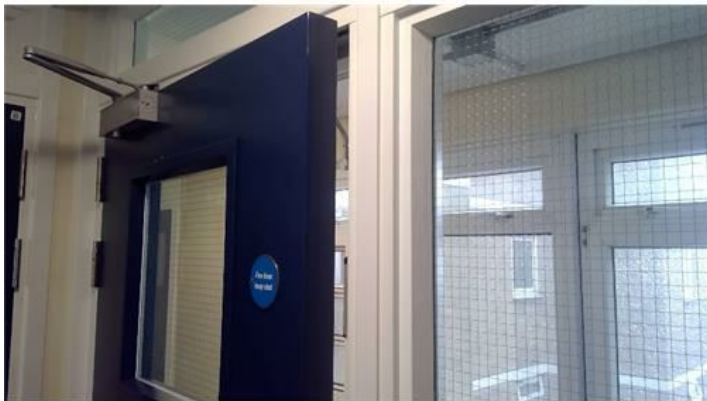
2024328125632.jpg

Ref	Sub Section	Question	Non-conformity	Recommendation	Location	Who is responsible	By When
13108023	J	Do the fire resisting door sets meet the appropriate standard?	Ineffective self closing devices. The through draught from the open windows either side of the stair core FD60S door is preventing complete closure.	Repair or replace the self-closing device/s to ensure fire door/s close fully into their frame/s against the door stops.	All stair core doors.	Statutory requirement of the Client	18/05/2024

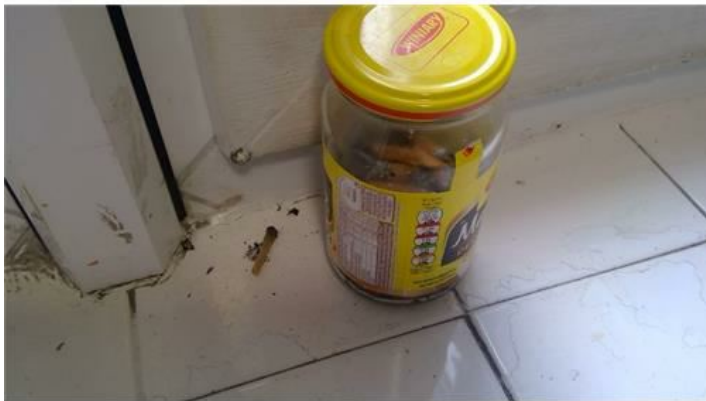
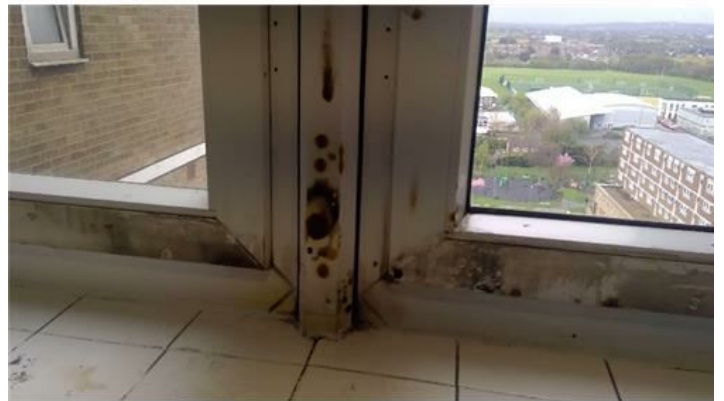
Ref	Sub Section	Question	Non-conformity	Recommendation	Location	Who is responsible	By When
13108004	NR-46-179-4	Are potential sources of ignition adequately controlled?	Evidence of smoking was found on stair core 11 & 13.	The client should remind tenants of the no smoking policy.	Stair core 11.	Statutory requirement of the Client	18/05/2024

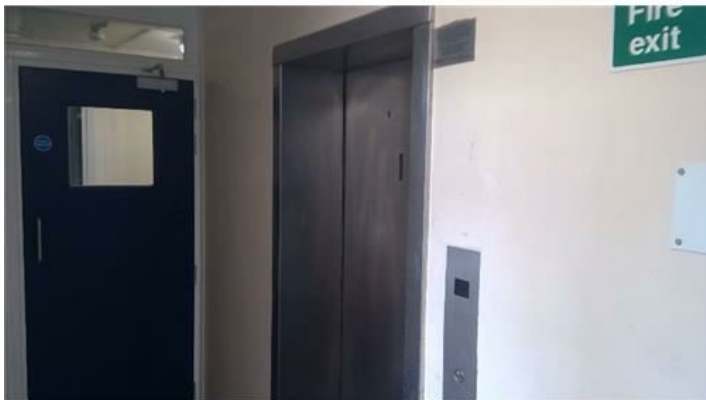
2024328114145.jpg

Ref	Sub Section	Question	Non-conformity	Recommendation	Location	Who is responsible	By When
13108049	A	Are there adequate and suitable fire safety signs and notices displayed in the appropriate places throughout the premises?	There are no signs provided to discourage people from using the lifts in an emergency.	Install "Do not use lift in the event of Fire" signs that comply with BS 5499-5.	Floors 1, 2, 4, 5, 6, 8, 10,	Statutory requirement of the Client	17/07/2024
