Fire Risk Assessment

1-96 Highview House - Romford - 900045630

20 Mar 2024

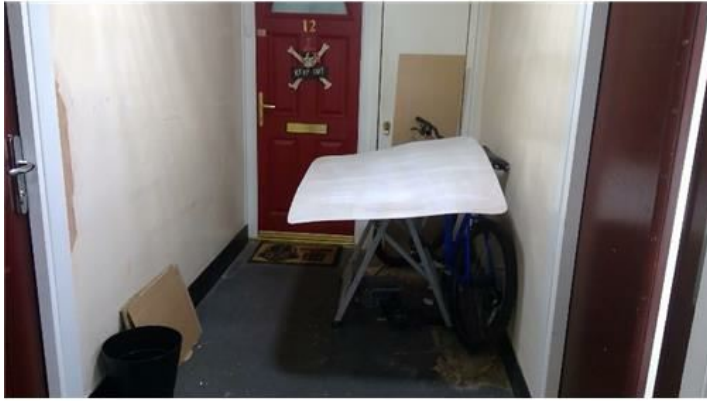
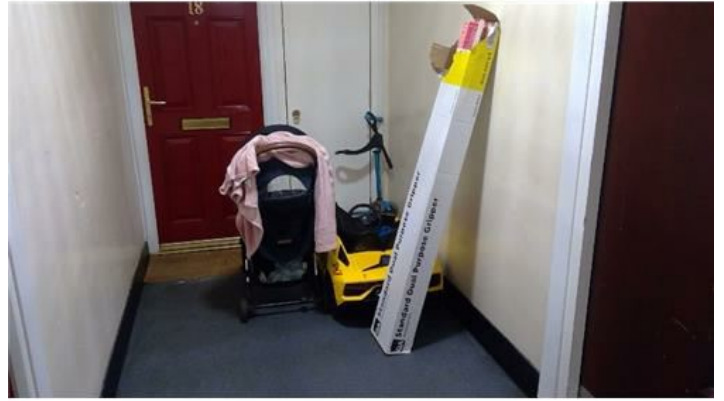
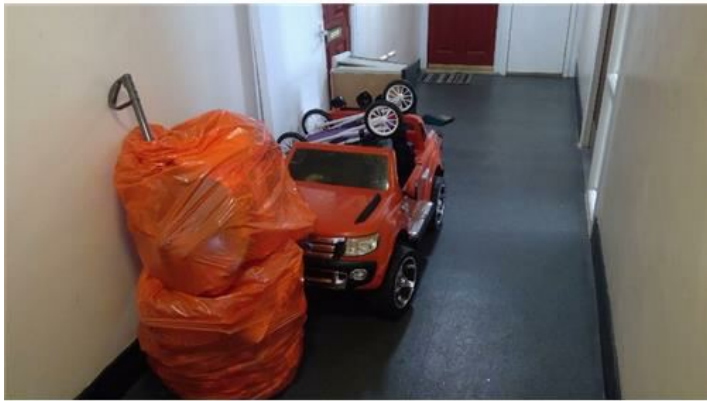
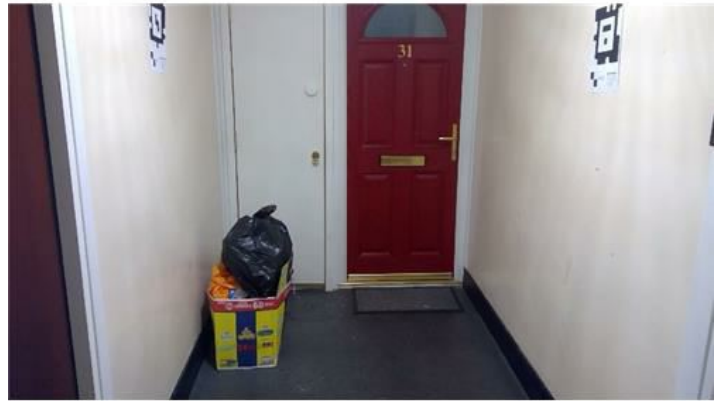
Ref	Sub Section	Question	Non-conformity	Recommendation	Location	Who is responsible	By When
13100914	A	Are house keeping arrangements satisfactory?	Combustible materials are located/stored in the escape routes.	Items that are a source of fuel or are combustible and likely to increase the fire loading or spread of fire, should not be located on any corridor, stairway or circulation space that will be used as an escape route. Therefore, the combustible materials stored in the escape routes must be removed.	Please See Plan	Statutory requirement of the Client	06/05/2024

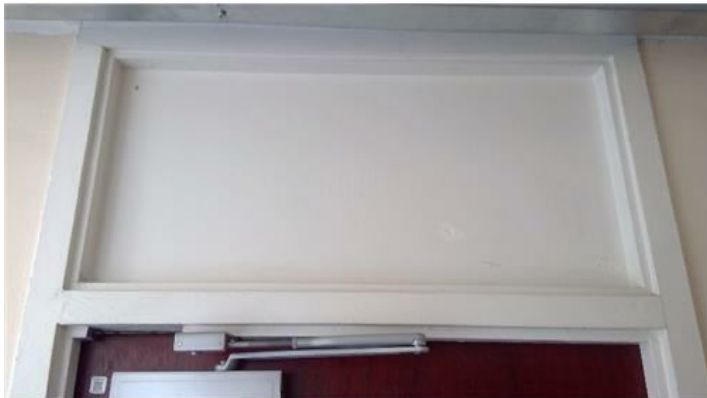
2024320132130.jpg

Ref	Sub Section	Question	Non-conformity	Recommendation	Location	Who is responsible	By When
13100896	A	Are the fire resisting and separating walls and floors in good condition?	The assessor was unable to ascertain that the timber panel installed over the refuse Shute door are to the required and approved levels of fire resistance.	A further investigation will be required by a competent person to ascertain the integrity of the materials used and that they will provide the equivalent level of fire resistance as the fire door.	Please See Plan	Statutory requirement of the Client	06/05/2024

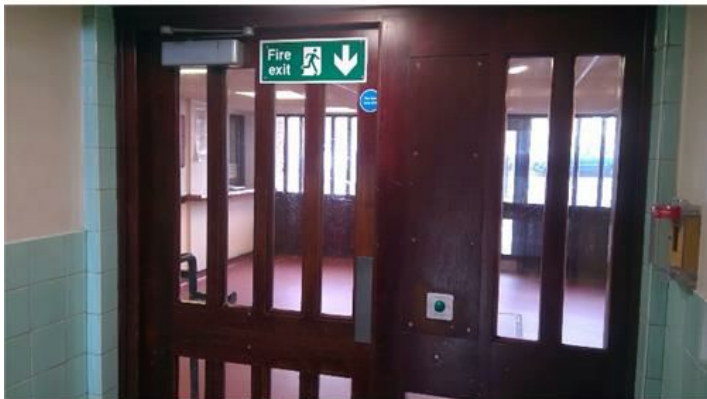
2024320113632.jpg

Ref	Sub Section	Question	Non-conformity	Recommendation	Location	Who is responsible	By When
13100913	D	Are the doors required to form part of the escape route in an emergency?	At the time of the fire risk assessment it was not possible to ascertain whether the electronically locked doors release on the activation of the fire alarm and/or mains failure.	It must be ensured that all electronically powered locks return to the unlocked position upon activation of the fire alarm system, on loss of power or system error and upon activation of a manual release unit (Type A).	Please See Plan	Statutory requirement of the Client	06/05/2024

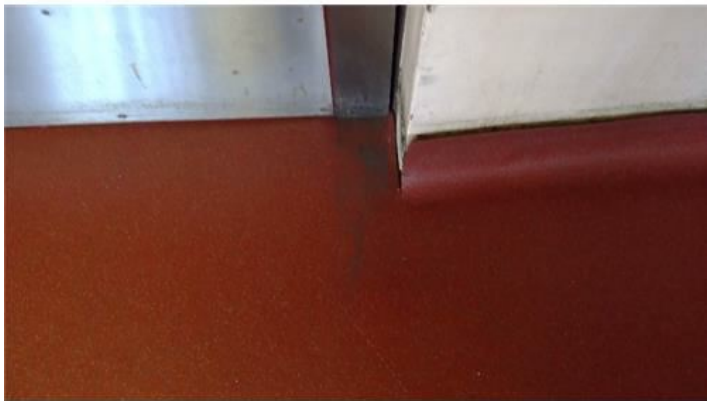
2024320102852.jpg

Ref	Sub Section	Question	Non-conformity	Recommendation	Location	Who is responsible	By When
13100907	H	Do the fire resisting door sets meet the appropriate standard?	Fire door is dragging on the floor surface and are not closing completely against the door stops.	All fire doors and associated self-closing devices should be maintained to ensure they close fully into their frames.	Please See Plan	Statutory requirement of the Client	06/05/2024

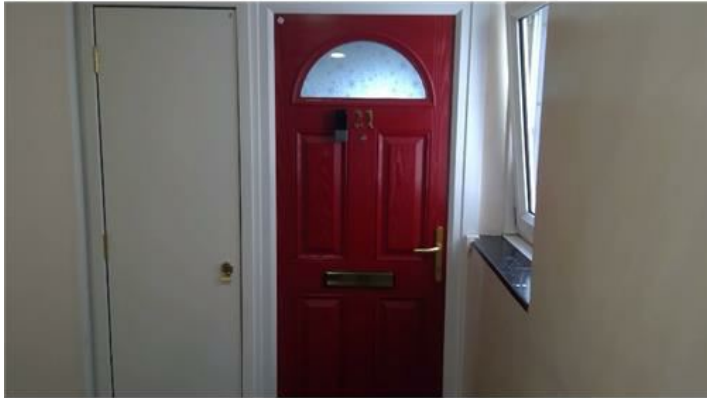
2024320123946.jpg

Ref	Sub Section	Question	Non-conformity	Recommendation	Location	Who is responsible	By When
13100909	K	Do the fire resisting door sets meet the appropriate standard?	The fire door/s require/s a self-closing device. The concealed self-closing device has been removed.	The fire doors indicated on the plan must be fitted with a suitable positive action self-closing device (BS EN 1154).	Please See Plan/ flat 21.	Statutory requirement of the Client	06/05/2024

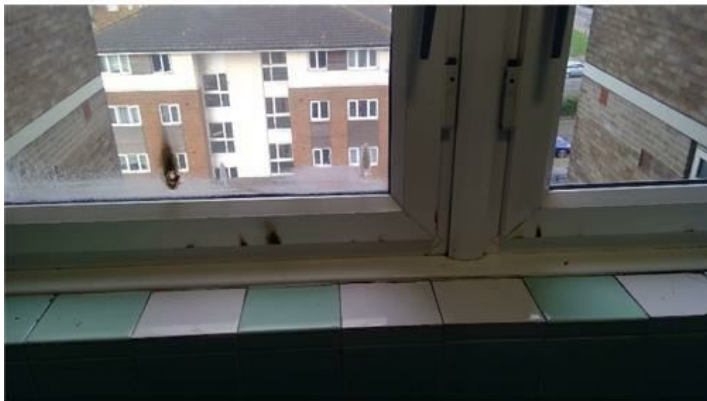
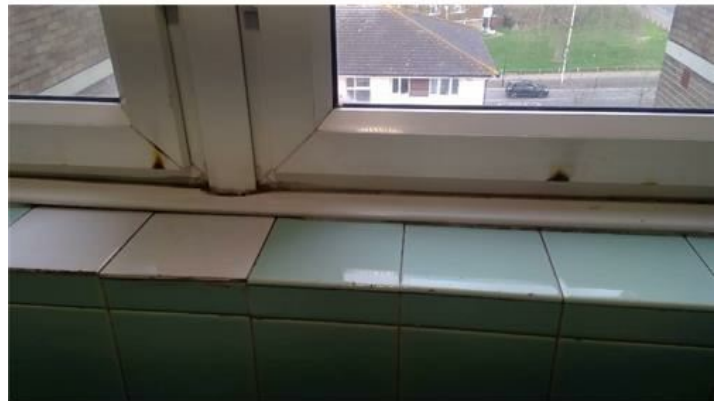
04 - Miscellaneous	Are potential sources of ignition adequately controlled?	Signs of fire damage to windows and frame.	NR-45-179-5	Non-Compliant

Ref	Sub Section	Question	Non-conformity	Recommendation	Location	Who is responsible	By When
13100894	NR-46-179-5	Are potential sources of ignition adequately controlled?	Signs of fire damage to windows and frame.	The situation should be monitored and steps taken to reduce the risk.	Please See Plan	Statutory requirement of the Client	06/05/2024

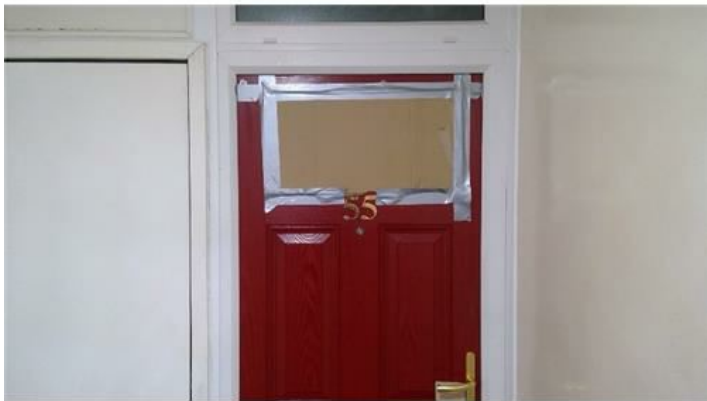
2024320133234.jpg

11 - Fire-resisting doors	Do the fire resisting door sets meet the appropriate standard?	The existing fire doors are damaged compromising the fire resistance provided by the door sets.	V	Non_Compliant
11 - Fire-resisting doors	Do the fire resisting door sets meet the appropriate standard?	The standard of the single full length hinge provision on the sub-compartment doors could not be determined.	5.0.A	Non_Compliant
12 - Fire-resisting partitions	Are the fire resisting partitions present installed and maintained to the appropriate standards?	The fire resisting partitions within the building are constructed and maintained to an appropriate standard.		Compliant

Ref	Sub Section	Question	Non-conformity	Recommendation	Location	Who is responsible	By When
13100910	V	Do the fire resisting door sets meet the appropriate standard?	The existing fire doors are damaged compromising the fire resistance provided by the door sets.	The damaged fire doors must be repaired or replaced to ensure that the required level of fire resistance is maintained.	Please See Plan	Statutory requirement of the Client	06/05/2024

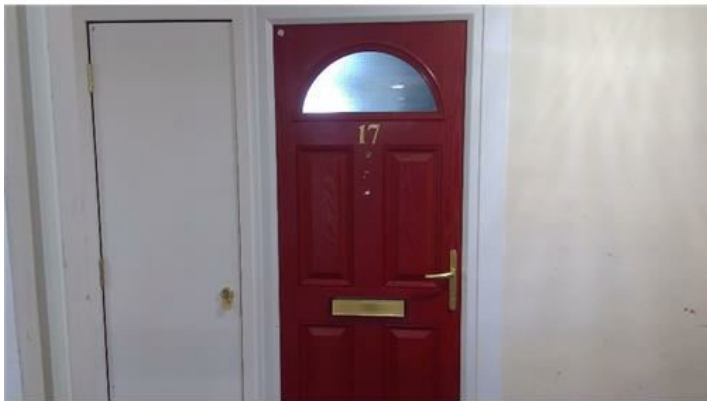
2024320123149.jpg

Ref	Sub Section	Question	Non-conformity	Recommendation	Location	Who is responsible	By When
13100908	5.0.E	Do the fire resisting door sets meet the appropriate standard?	In the absence of documentary evidence it could not be confirmed if the flat entrance doors are of the appropriate FD30S standard. The flat entrance doors appeared a generic door type with wire reinforced glazed pane and concealed door closer. Reinforced wire glazed transom light.	The client should confirm that all flat entrance doors must be provisioned of 3 x fire resistant hinges (BS EN 1935), door handles that comply with BS EN 1906 Annex C, dual intumescent heat strip/cold smoke seals along the door edges and suitable, positive action self-closing devices (BS EN 1154).	All flat entrance doors except flat 11	Statutory requirement of the Client	05/07/2024

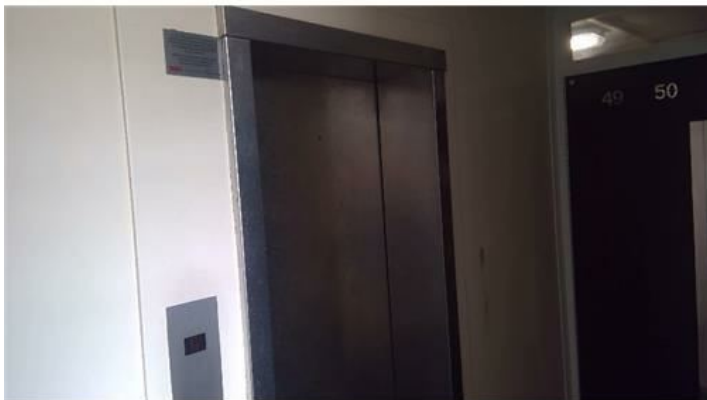
2024320132430.jpg

Ref	Sub Section	Question	Non-conformity	Recommendation	Location	Who is responsible	By When
13100934	A	Are there adequate and suitable fire safety signs and notices displayed in the appropriate places throughout the premises?	There are no signs provided to discourage people from using the lifts in an emergency.	Install "Do not use lift in the event of Fire" signs that comply with BS 5499-5.	Please See Plan	Statutory requirement of the Client	05/07/2024
