Fire Risk Assessment

1-93 Peverel House - Dagenham - 900001545

02 Apr 2024

This Risk Assessment was carried out on 02 Apr 2024 and the assessor has stated that this building cannot be below High risk.

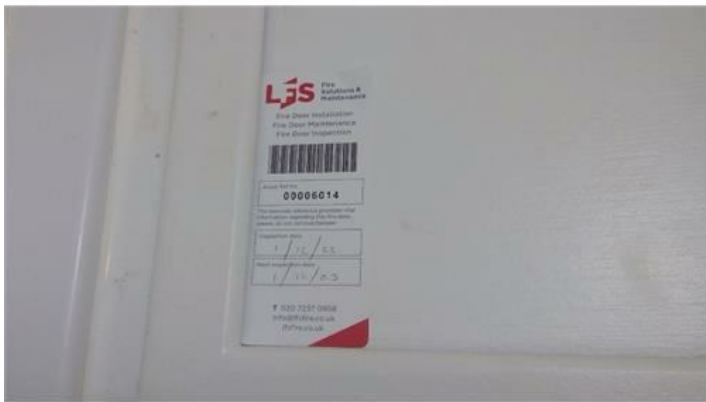
202442113730.jpg

Ref	Sub Section	Question	Non-conformity	Recommendation	Location	Who is responsible	By When
13112470	10.0.NR-54-212-3	Are management and employees fully aware of the fire safety features provided and their purpose?	The fire doors displayed 'riskhub' QR stickers and maintenance labels which indicate that the doors were subject to recent inspection between 01/11/2022-01/12/2022 with a recommended reinspection date 01/11/2023 - 01/12/2023.	Fire doors should be maintained periodically in accordance with the Fire Safety (England) Regulations 2022. In residential buildings with storeys over 11 metres in height, responsible persons are required to undertake annual checks of flat entrance doors and quarterly checks of all fire doors in the common parts.		Statutory requirement of the Client	14/05/2024

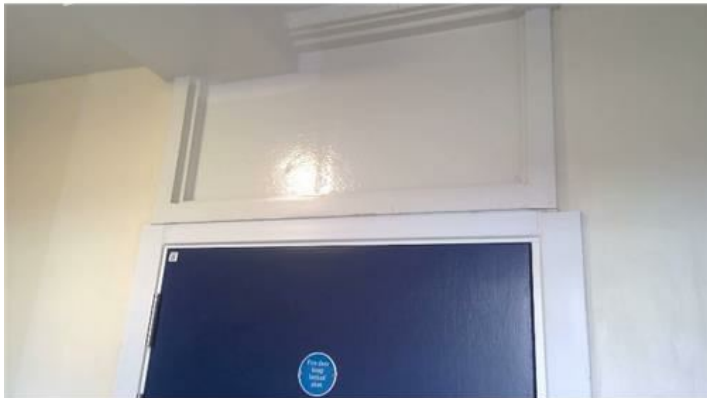
202442122149.jpg

Ref	Sub Section	Question	Non-conformity	Recommendation	Location	Who is responsible	By When
13112433	A	Are the escalators, chutes, ducts and pipes contained within protected shafts?	The timber panel above the service cupboard does not appear to be of the same fire resistance as the fire door.	The services must be enclosed with such materials that afford the appropriate level of fire resistance in accordance with Approved Document B of the Building Regulations.	Please See Plan/ all floors.	Statutory requirement of the Client	14/05/2024

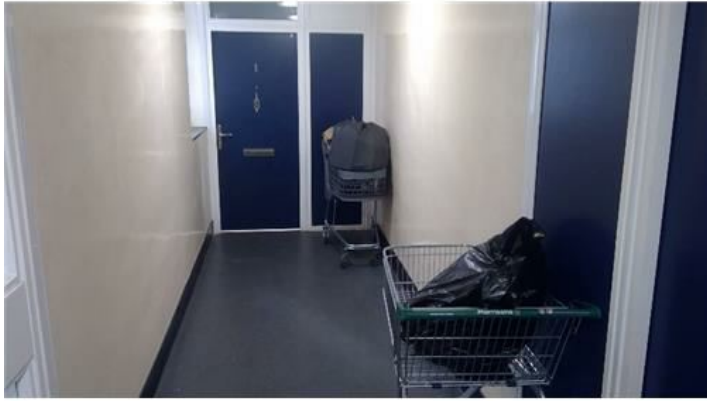
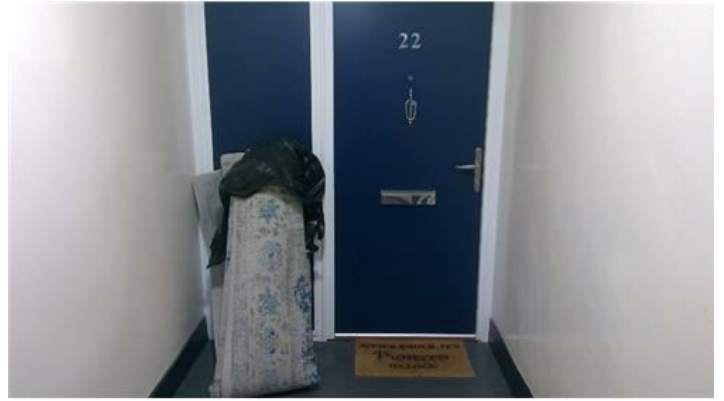
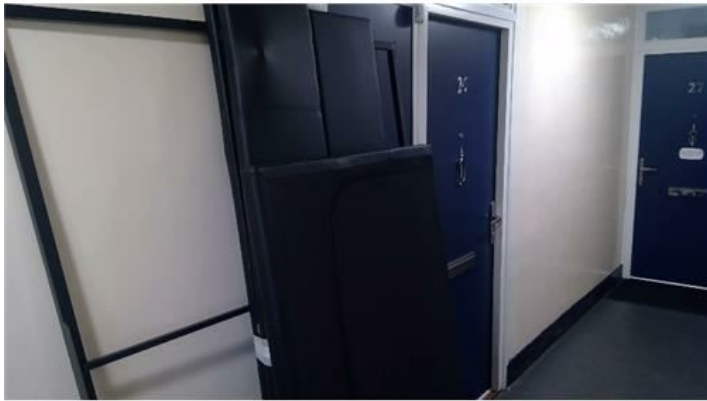
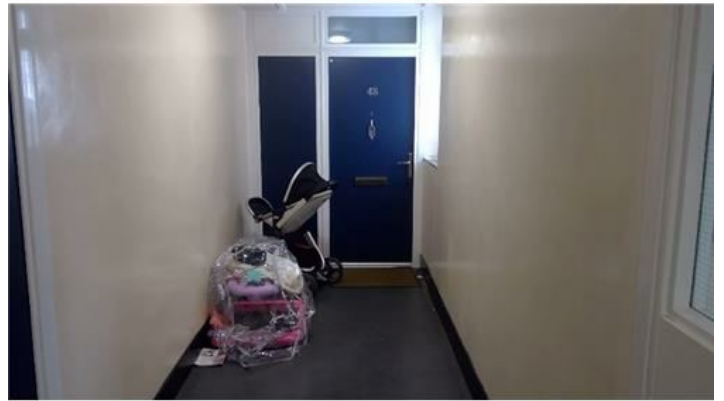
Ref	Sub Section	Question	Non-conformity	Recommendation	Location	Who is responsible	By When
13112453	A	Are house keeping arrangements satisfactory?	Combustible materials are located/stored in the escape routes.	Items that are a source of fuel or are combustible and likely to increase the fire loading or spread of fire, should not be located on any corridor, stairway or circulation space that will be used as an escape route. Therefore, the combustible materials stored in the escape routes must be removed.	Please See Plan	Statutory requirement of the Client	14/05/2024

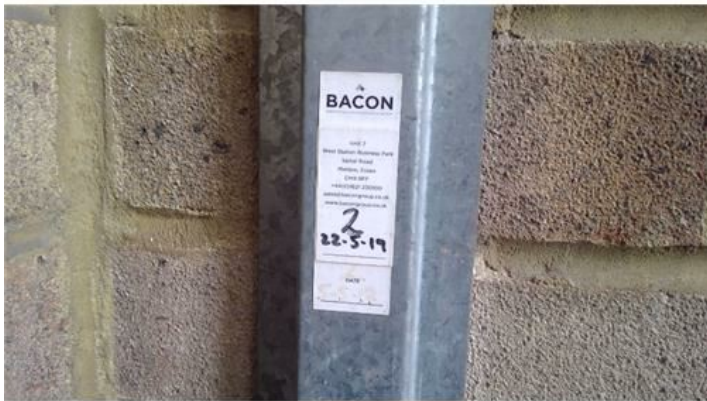
202442102150.jpg

Ref	Sub Section	Question	Non-conformity	Recommendation	Location	Who is responsible	By When
13112428	B	Is lightning protection provided for the building?	A lightning protection system has been installed, there is no evidence of current periodic inspection and maintenance being completed. The service label is dated 22/05/2019.	The lightning protection system is to be inspected and maintained by a competent person in accordance with BS 62305. Records are to be maintained.		Statutory requirement of the Client	14/05/2024

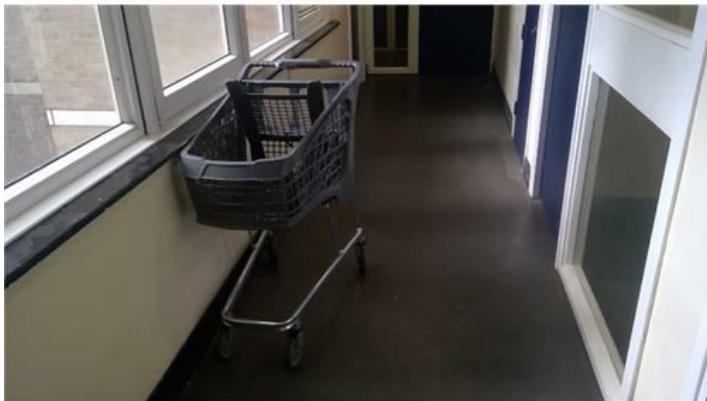
202442114022.jpg

Ref	Sub Section	Question	Non-conformity	Recommendation	Location	Who is responsible	By When
13112454	D	Are house keeping arrangements satisfactory?	The escape route is obstructed.	The items obstructing the escape route must be removed as soon as possible.	Please See Plan	Statutory requirement of the Client	14/05/2024

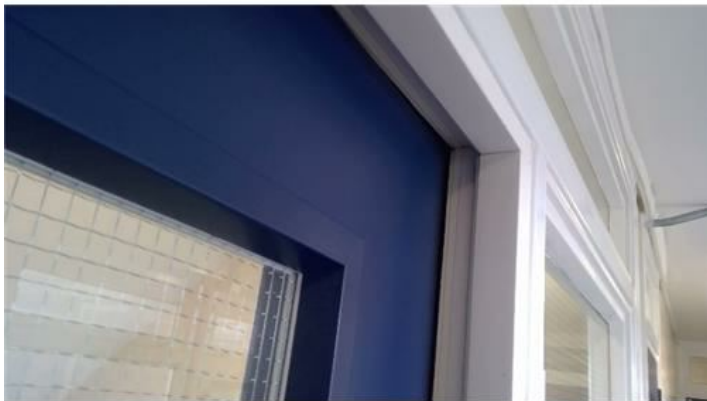
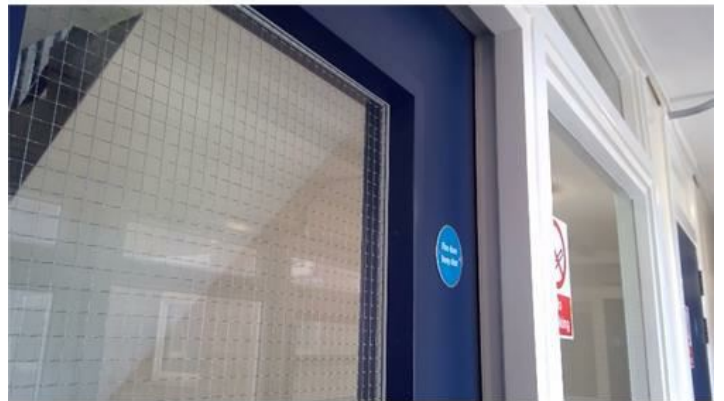
Ref	Sub Section	Question	Non-conformity	Recommendation	Location	Who is responsible	By When
13112448	J	Do the fire resisting door sets meet the appropriate standard?	Ineffective self closing devices.	Repair or replace the self-closing device/s to ensure fire door/s close fully into their frame/s against the door stops.	Please See Plan	Statutory requirement of the Client	14/05/2024

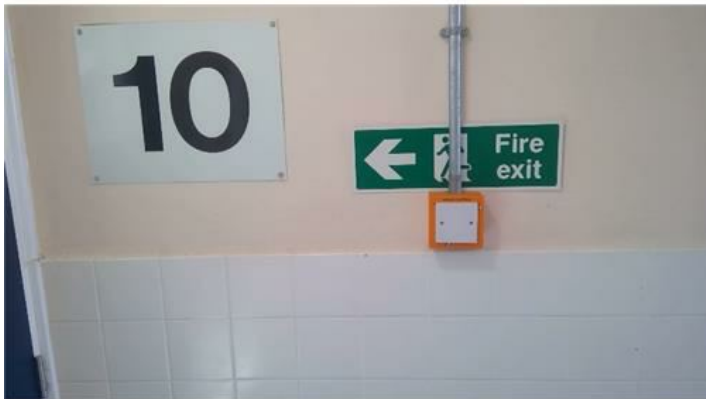
20244213630.jpg

Ref	Sub Section	Question	Non-conformity	Recommendation	Location	Who is responsible	By When
13112478	L	Are there adequate and suitable fire safety signs and notices displayed in the appropriate places throughout the premises?	The escape route signs are not sited correctly, the wayfinding escape sign indicates a route from the stair core into lift lobby 10.	Escape route signs must be sited in accordance with BS 5499-4 and direct persons making their escape to the protected stair core.	Please See Plan	Statutory requirement of the Client	14/05/2024

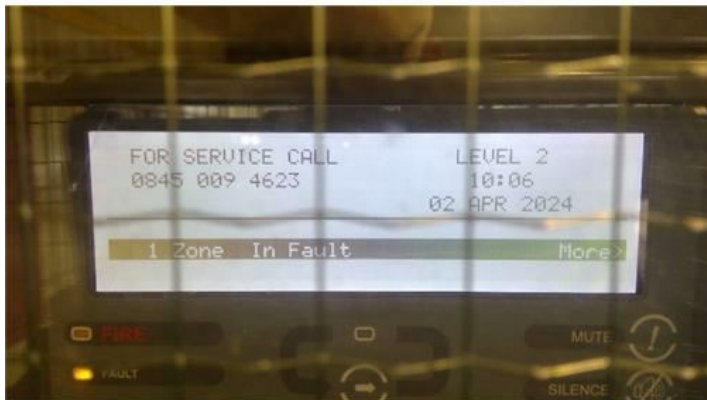
20244210812.jpg

Ref	Sub Section	Question	Non-conformity	Recommendation	Location	Who is responsible	By When
13112459	NR-51-205-1	Is the fire alarm system routinely tested, inspected and maintained in accordance with current guidance?	The fire panel is indicating a fault in zone 1 (stair core).	The fire alarm system must be inspected and maintained by a competent certificated organisation in accordance with BS 5839-1.	Stair core	Statutory requirement of the Client	14/05/2024

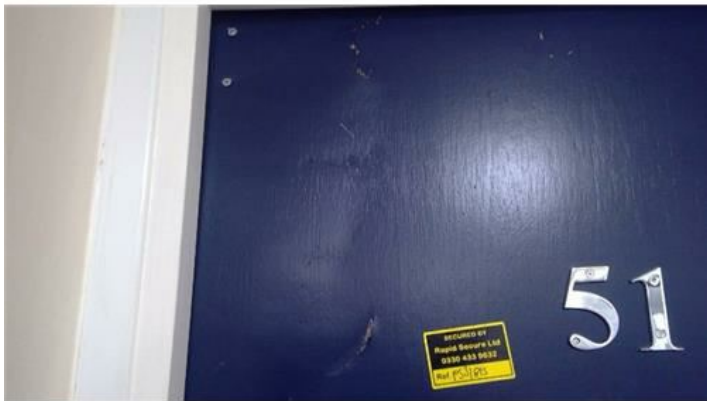
20244212557.jpg

Ref	Sub Section	Question	Non-conformity	Recommendation	Location	Who is responsible	By When
13112450	V	Do the fire resisting door sets meet the appropriate standard?	The existing fire doors are damaged compromising the fire resistance provided by the door sets.	The damaged fire doors must be repaired or replaced to ensure that the required level of fire resistance is maintained.	Please See Plan	Statutory requirement of the Client	14/05/2024

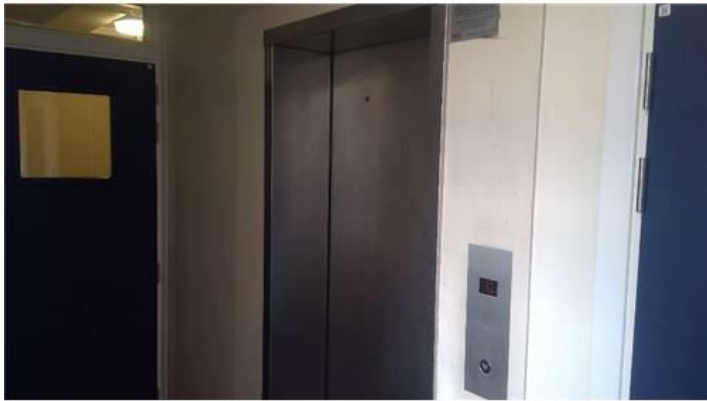
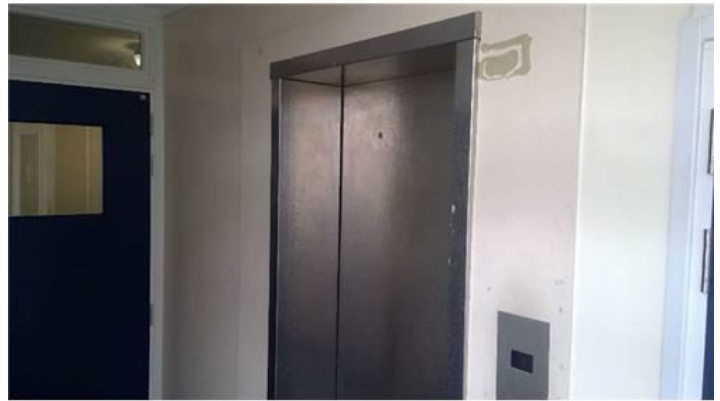
Ref	Sub Section	Question	Non-conformity	Recommendation	Location	Who is responsible	By When
13112476	A	Are there adequate and suitable fire safety signs and notices displayed in the appropriate places throughout the premises?	There are no signs provided to discourage people from using the lifts in an emergency.	Install "Do not use lift in the event of Fire" signs that comply with BS 5499-5.	Please See Plan	Statutory requirement of the Client	13/07/2024

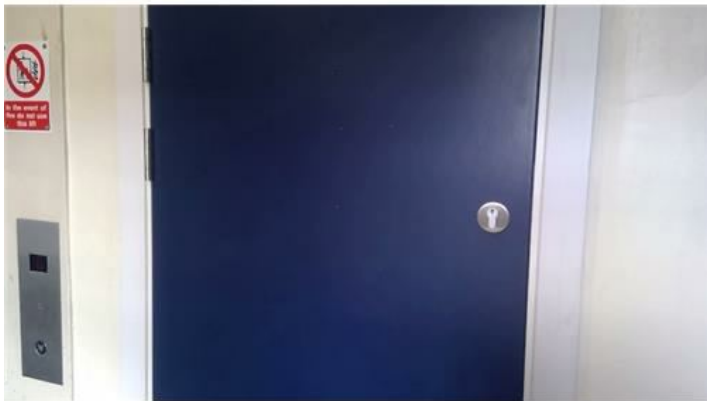
202442123722.jpg

Ref	Sub Section	Question	Non-conformity	Recommendation	Location	Who is responsible	By When
13112477	D	Are there adequate and suitable fire safety signs and notices displayed in the appropriate places throughout the premises?	The fire door/s are not provided with appropriate sign/s.	Fire door/s for cupboards, stores or high hazard areas should be provided with "Fire Door Keep Locked" signs complying with BS 5499-5.	Please See Plan	Statutory requirement of the Client	13/07/2024
