Fire Risk Assessment

1-52 Bartletts House - Dagenham - 900057385

26 Mar 2024

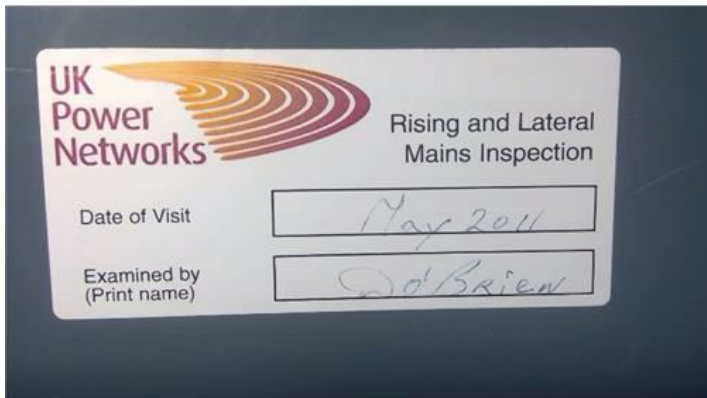
2024326113324.jpg

Ref	Sub Section	Question	Non-conformity	Recommendation	Location	Who is responsible	By When
13108059	2.0.A	Are all electrical installations and appliances correctly installed and maintained?	There was no evidence of periodic inspections of the electrical installations having been carried out within the last 5 years.	If evidence of an inspection is unavailable, a competent electrician is to inspect all electrical installations throughout the premises in accordance with IEE Regulations (BS 7671) and records maintained.		Statutory requirement of the Client	14/05/2024

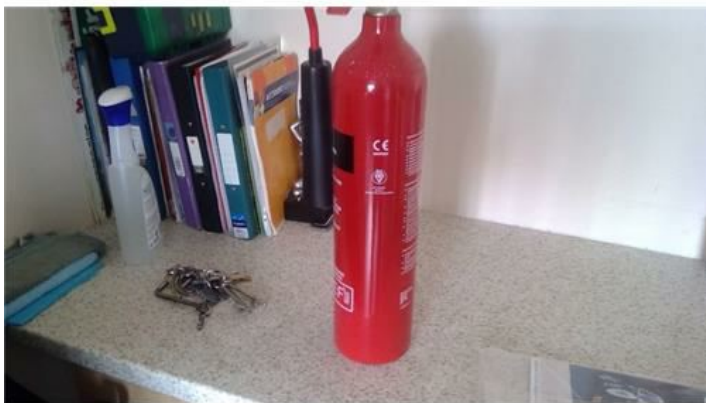
202432611124.jpg

Ref	Sub Section	Question	Non-conformity	Recommendation	Location	Who is responsible	By When
13108091	6.0.B	Are there sufficient quantities of portable fire-fighting equipment provided, correctly sited and adequately maintained?	There is no evidence available to confirm that the portable fire-fighting equipment is being periodically maintained.	The equipment is to be periodically maintained by a competent person to BS 5306-3 and records maintained.	Staff Office	Statutory requirement of the Client	14/05/2024

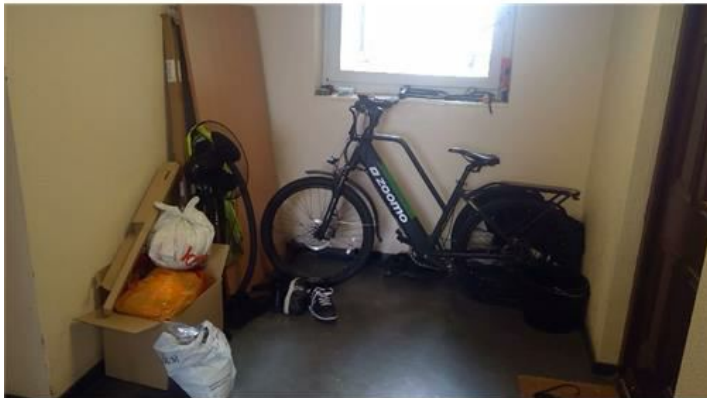
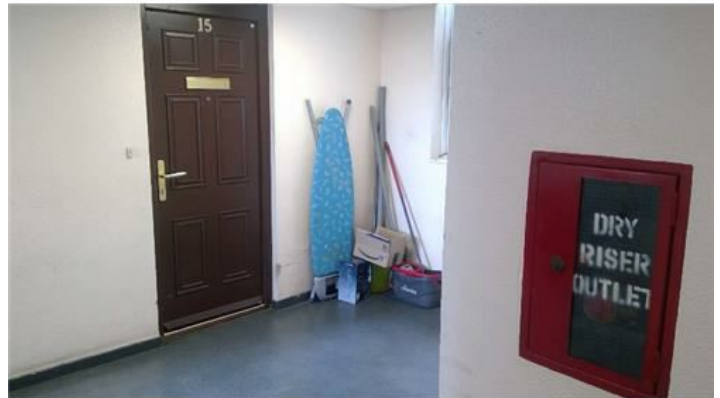
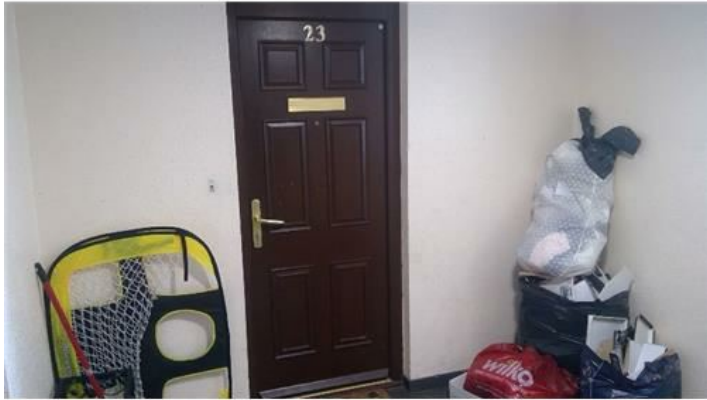
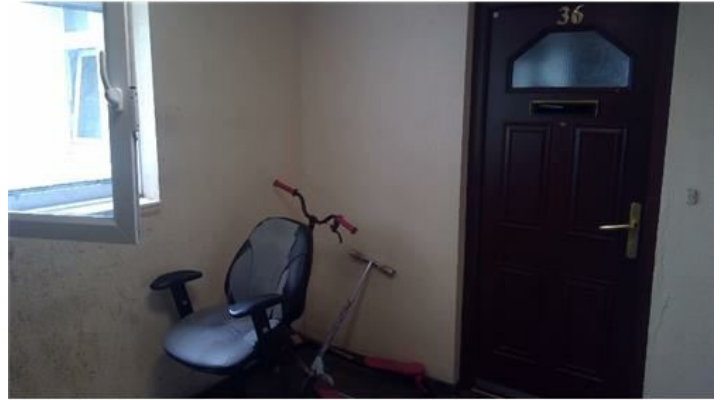
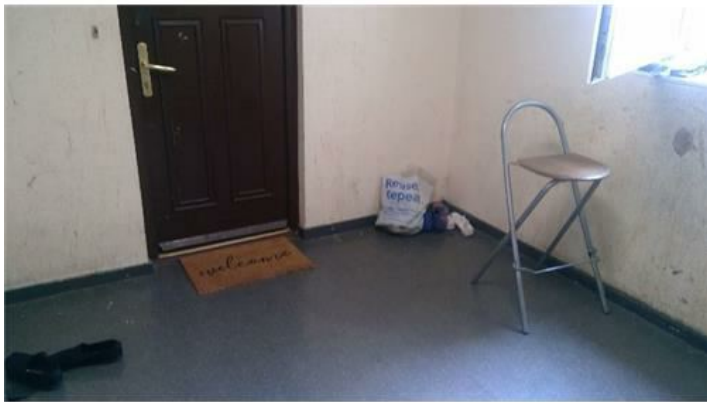
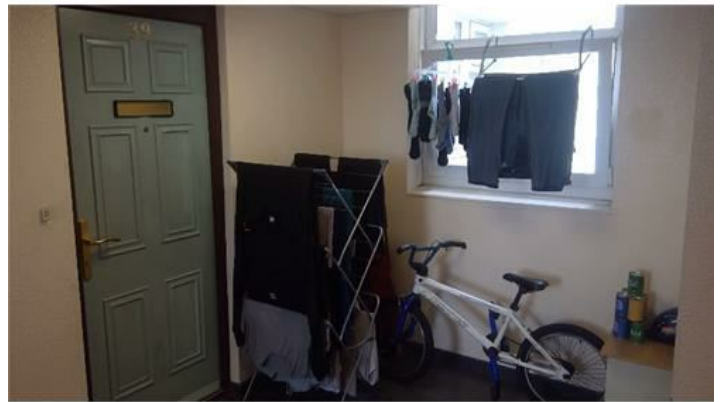
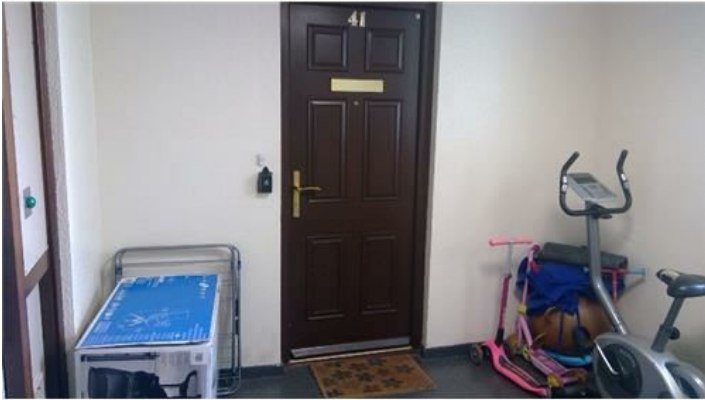
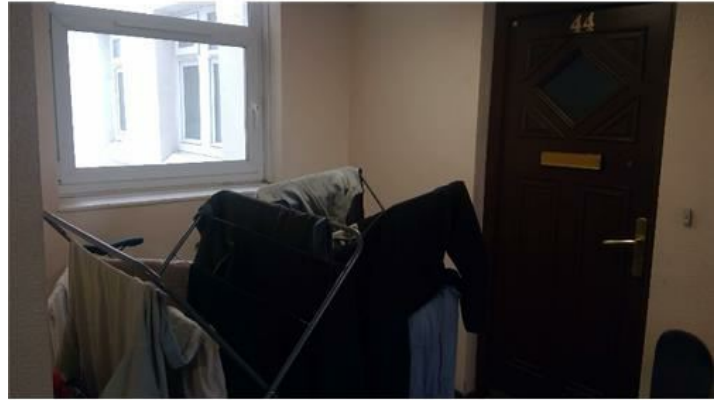
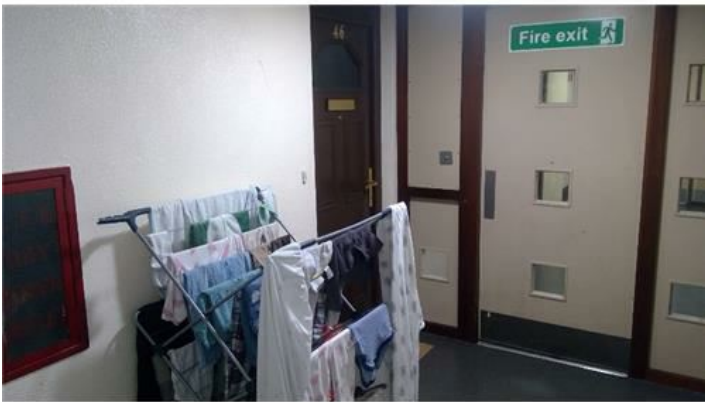
Ref	Sub Section	Question	Non-conformity	Recommendation	Location	Who is responsible	By When
13108089	A	Are house keeping arrangements satisfactory?	Combustible materials are located/stored in the escape routes.	Items that are a source of fuel or are combustible and likely to increase the fire loading or spread of fire, should not be located on any corridor, stairway or circulation space that will be used as an escape route. Therefore, the combustible materials stored in the escape routes must be removed.	Please See Plan	Statutory requirement of the Client	14/05/2024

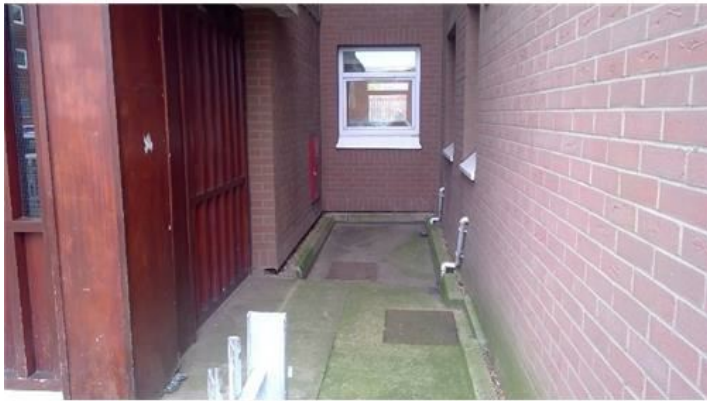
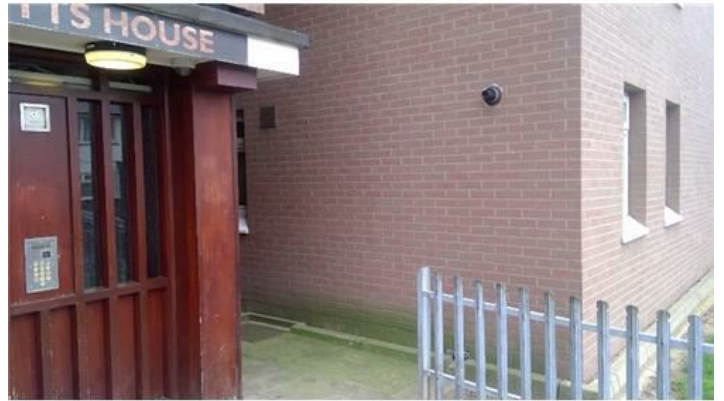
Ref	Sub Section	Question	Non-conformity	Recommendation	Location	Who is responsible	By When
13108103	C	Are rising mains adequately provided to assist firefighting personnel in their firefighting tasks?	Access to the main inlet connection point for the Fire & Rescue Service is obscure.	It is recommended that a directional sign is provided to indicate the location of the dry riser inlet.	Please See Plan	Statutory requirement of the Client	14/05/2024

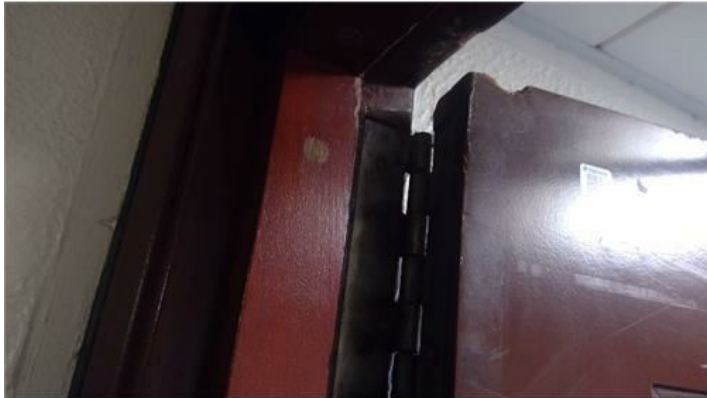
2024326114224.jpg

Ref	Sub Section	Question	Non-conformity	Recommendation	Location	Who is responsible	By When
13108082	D	Do the fire resisting door sets meet the appropriate standard?	The fire door has not been provided with a means to prevent the spread of fire and smoke between compartments.	Dual intumescent heat strips/cold smoke seals are to be installed by a competent person in accordance with the manufacturer's instructions.	Please See Plan	Statutory requirement of the Client	14/05/2024

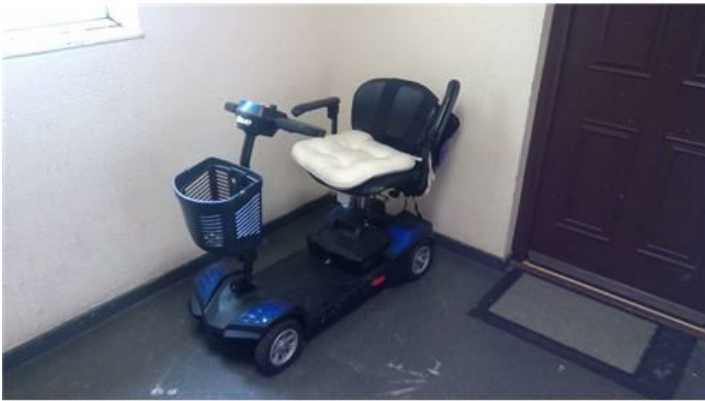
2024326122338.jpg

Ref	Sub Section	Question	Non-conformity	Recommendation	Location	Who is responsible	By When
13108088	E	Are house keeping arrangements satisfactory?	Inappropriate electrical mobility scooter is sited within the escape route.	The electrical mobility must be removed from the escape route and located in an area appropriate for their use.	Please See Plan	Statutory requirement of the Client	14/05/2024

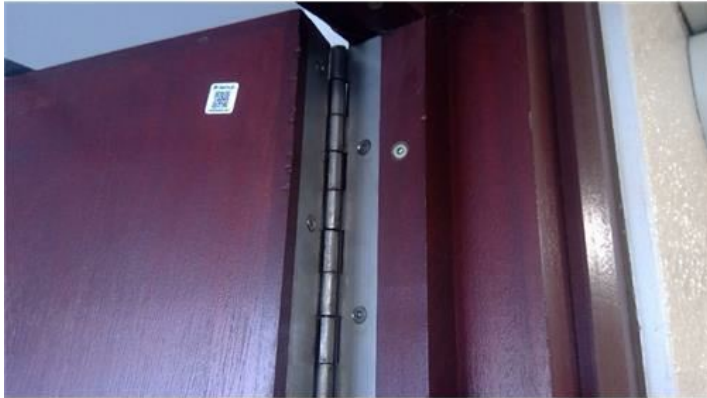
202432611297.jpg

Ref	Sub Section	Question	Non-conformity	Recommendation	Location	Who is responsible	By When
13108081	F	Do the fire resisting door sets meet the appropriate standard?	A number of sub-compartment doors appeared generic in design with intumescent strips and cold smoke seal to the top and leading edge only. Overhead self-closing device and a single full length door hinge.	The existing doors are to be upgraded to include the provision of 3 x fire resistant hinges (BS EN 1935) or confirmation of the standard of the existing full length hinge, door handles that comply with BS EN 1906 Annex C, dual intumescent heat strip/cold smoke seals along the door edges and suitable, positive action self-closing devices (BS EN 1154).	Please See Plan	Statutory requirement of the Client	14/05/2024

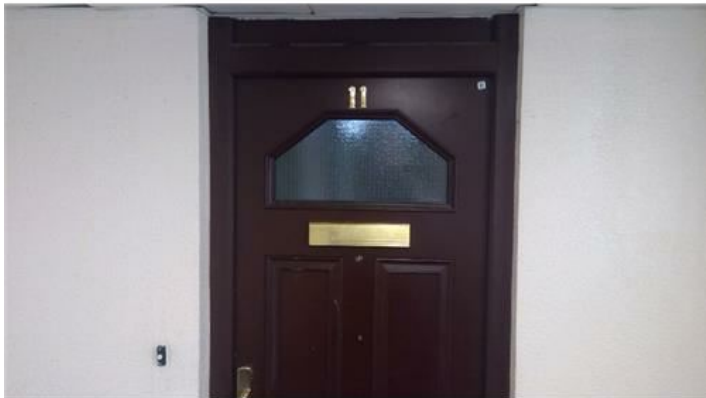
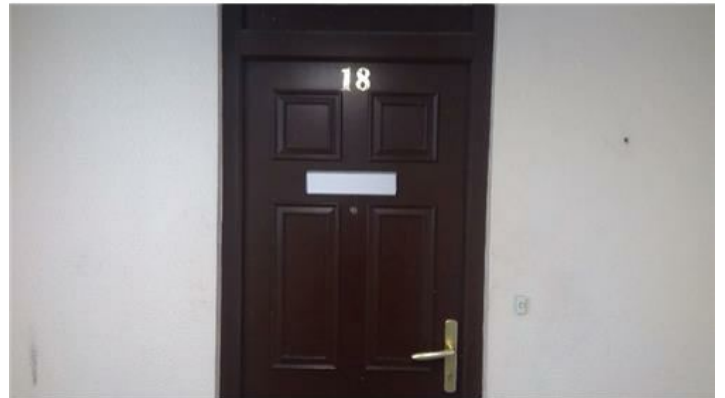
Ref	Sub Section	Question	Non-conformity	Recommendation	Location	Who is responsible	By When
13108083	J	Do the fire resisting door sets meet the appropriate standard?	Ineffective self closing devices.	Repair or replace the self-closing device/s to ensure fire door/s close fully into their frame/s against the door stops.	Please See Plan/ flat 11	Statutory requirement of the Client	14/05/2024

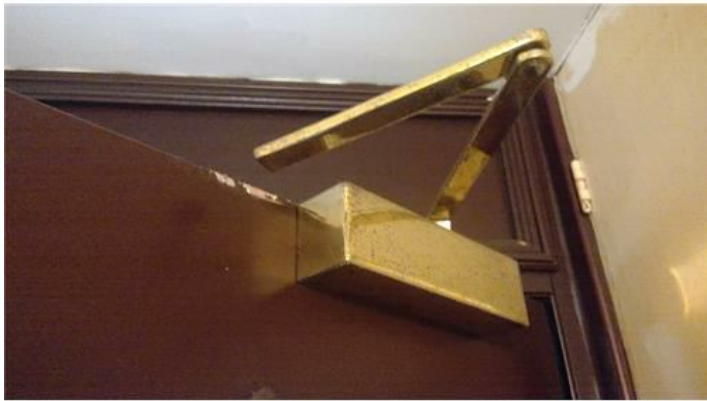
2024326135050.jpg

Ref	Sub Section	Question	Non-conformity	Recommendation	Location	Who is responsible	By When
13108085	K	Do the fire resisting door sets meet the appropriate standard?	The fire door self-closing device has been disconnected	The fire doors indicated on the plan must be fitted with a suitable positive action self-closing device (BS EN 1154).	Please See Plan/flat 44.	Statutory requirement of the Client	14/05/2024

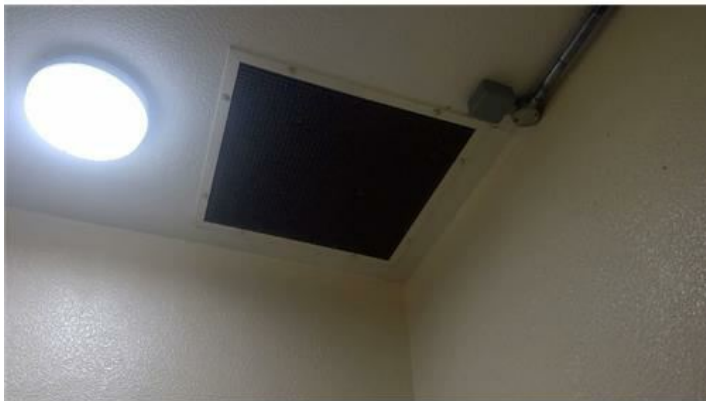
2024326135736.jpg

Ref	Sub Section	Question	Non-conformity	Recommendation	Location	Who is responsible	By When
13108095	NR-51-204-4	Is there an adequate method for raising the alarm and detecting a fire present in the premises?	There is a small grill located in the 8th floor of the protected stair. It could not be determined if this was part of the smoke extraction.	The clients should confirm if the open grill forms part of the smoke extraction system.	Please See Plan	Statutory requirement of the Client	14/05/2024

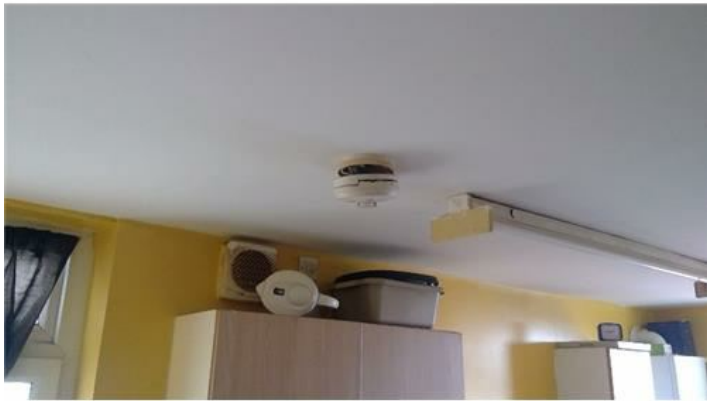
2024326134812.jpg

Ref	Sub Section	Question	Non-conformity	Recommendation	Location	Who is responsible	By When
13108094	O	Is there an adequate method for raising the alarm and detecting a fire present in the premises?	The automatic heat detection was found to be damaged preventing it from operating correctly.	The automatic smokeheat detectors must be replaced	Please See Plan/ kitchen flat 44.	Recommendation to the Client	14/05/2024

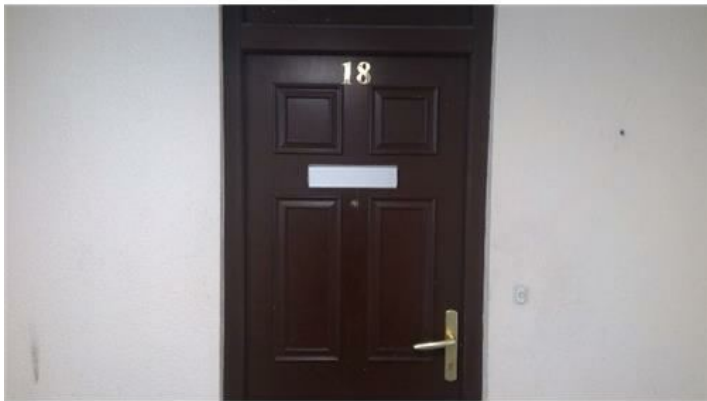
202432612402.jpg

Ref	Sub Section	Question	Non-conformity	Recommendation	Location	Who is responsible	By When
13108084	U	Do the fire resisting door sets meet the appropriate standard?	The intumescent cold smoke seals installed to prevent the spread of smoke and fire between compartments are missing/damaged.	The missing/damaged intumescent cold smoke seals must be replaced to ensure that the spread of smoke and fire is restricted.	Please See Plan	Statutory requirement of the Client	14/05/2024
