Fire Risk Assessment

1-52 Oldmead House - Dagenham - 900057672

12 Feb 2024

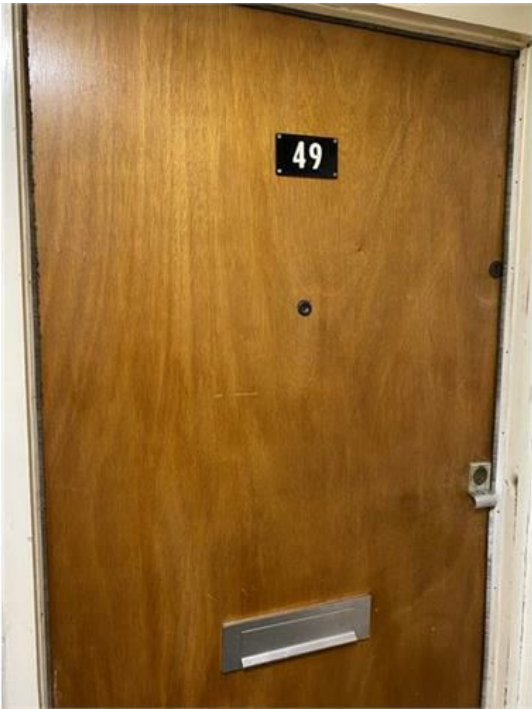
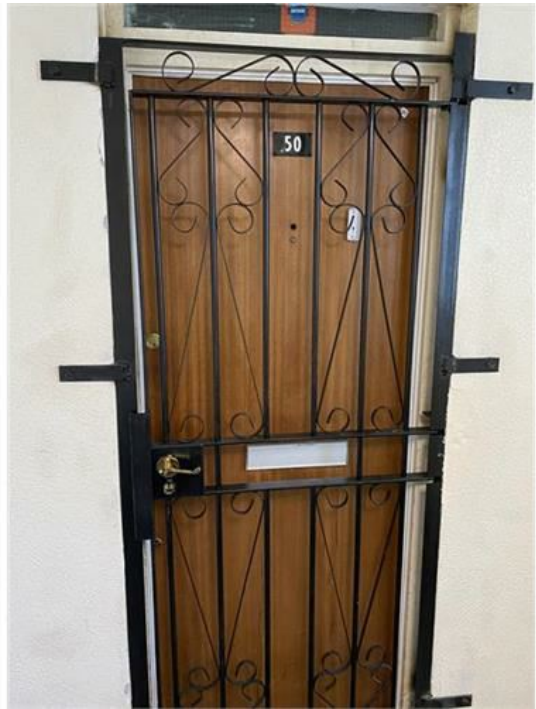
Ref	Sub Section	Question	Non-conformity	Recommendation	Location	Who is responsible	By When
13068351	5.0.F	Do the fire resisting door sets meet the appropriate standard?	The existing fire doors are likely to have conformed to BS 476, Part 22 upon original installation. However, due to their high usage and lack of maintenance over a number of years, they no longer appear to be of the appropriate fire resisting standard.	The existing doors are to be upgraded to include the provision of 3 x fire resistant hinges (BS EN 1935), door handles that comply with BS EN 1906 Annex C, dual intumescent heat strip/cold smoke seals along the door edges and suitable, positive action self-closing devices (BS EN 1154).	Front Door to Flats 49 & 50	Statutory requirement for the Client	02/04/2024

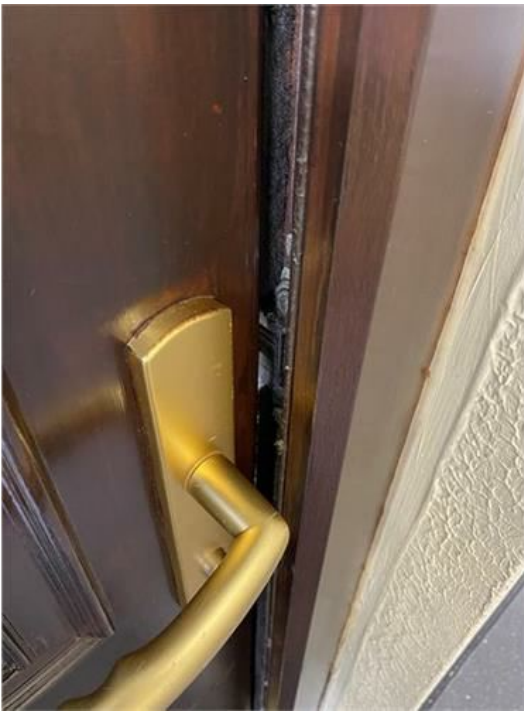
IMG_5855(1).jpg

Ref	Sub Section	Question	Non-conformity	Recommendation	Location	Who is responsible	By When
13068352	5.0.J	Do the fire resisting door sets meet the appropriate standard?	Ineffective self closing devices.	Repair or replace the self-closing device/s to ensure fire door/s close fully into their frame/s against the door stops.	Front door to Flat 47 and Flat 41	Statutory requirement for the Client	02/04/2024

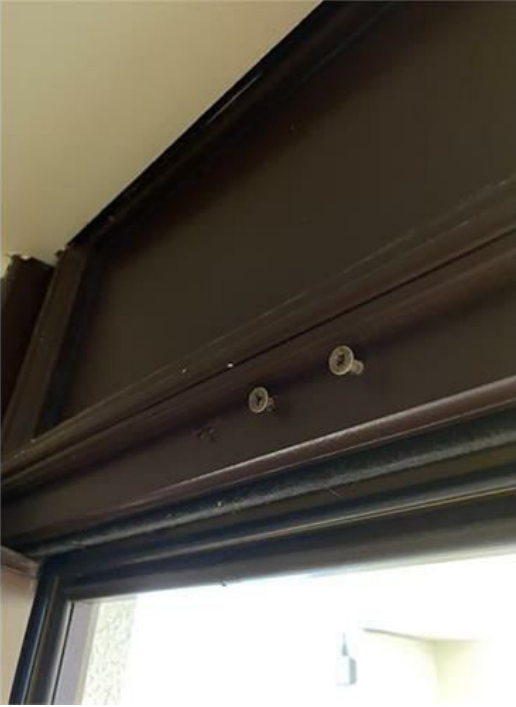
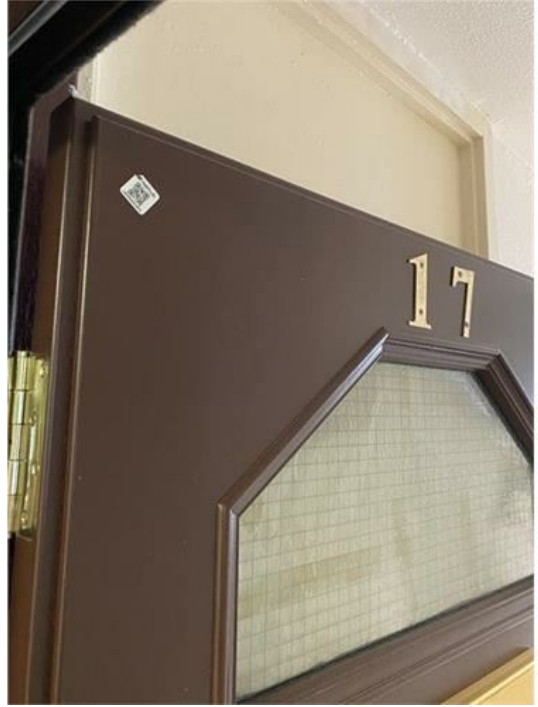
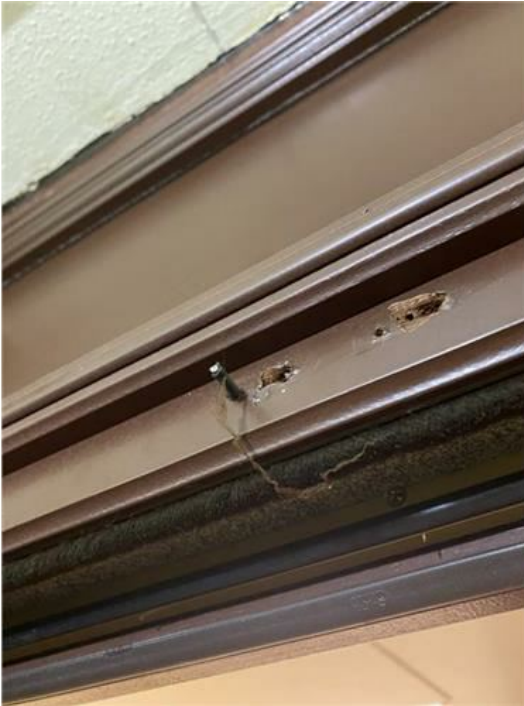
Ref	Sub Section	Question	Non-conformity	Recommendation	Location	Who is responsible	By When
13068353	5.0.K	Do the fire resisting door sets meet the appropriate standard?	The fire doors require a self-closing device.	The fire doors indicated must be fitted with a suitable positive action self-closing device (BS EN 1154).	Front doors to flats 42, 17 and 10	Statutory requirement for the Client	02/04/2024

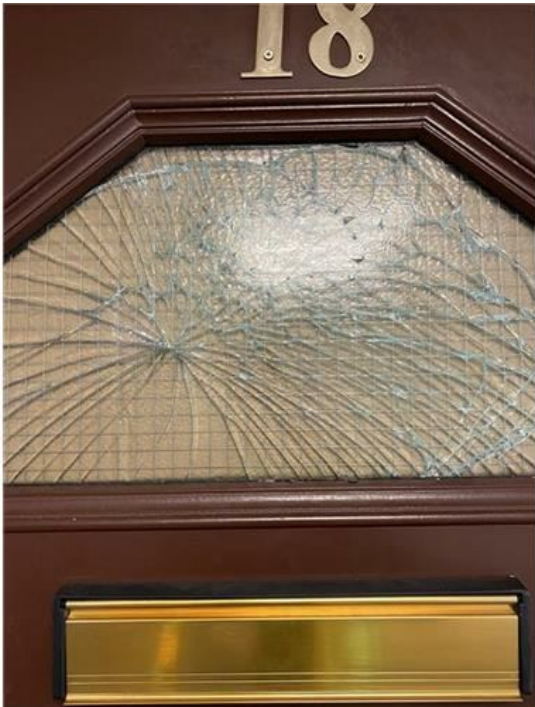
IMG_5863(1).jpg

Ref	Sub Section	Question	Non-conformity	Recommendation	Location	Who is responsible	By When
13068354	5.0.V	Do the fire resisting door sets meet the appropriate standard?	The existing fire doors are damaged compromising the fire resistance provided by the door sets.	The damaged fire doors must be repaired or replaced to ensure that the required level of fire resistance is maintained.	Front door to flat 18	Statutory requirement for the Client	02/04/2024

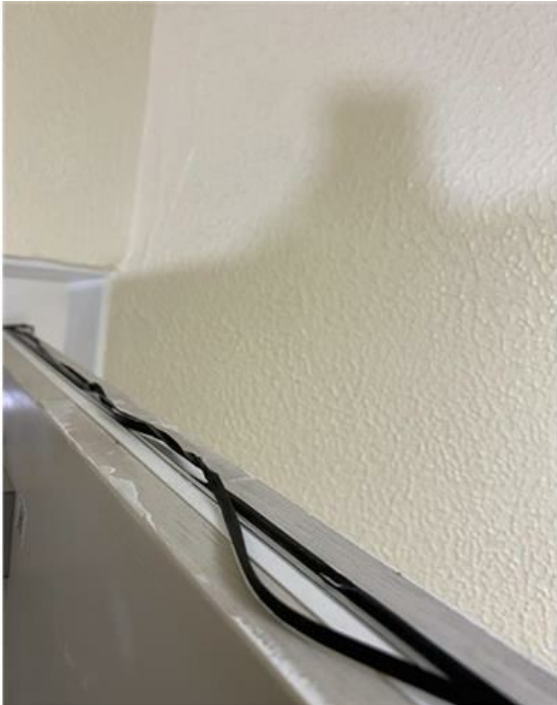
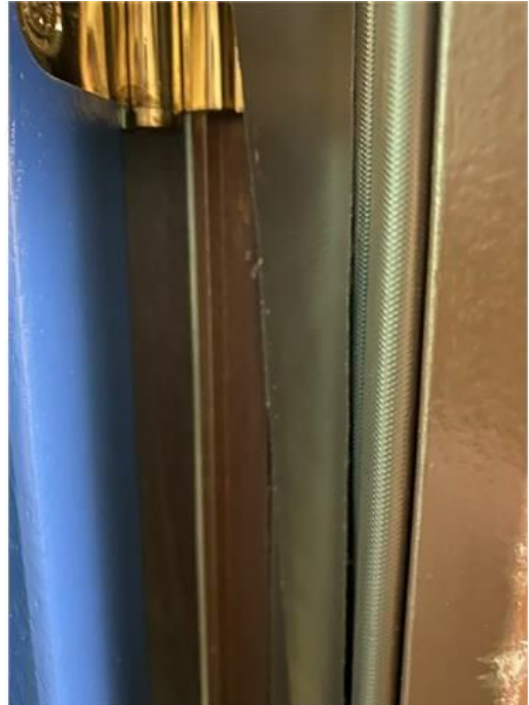
Ref	Sub Section	Question	Non-conformity	Recommendation	Location	Who is responsible	By When
13068350	B	Do the fire resisting door sets meet the appropriate standard?	The fire door has not been provided with a means to prevent the spread of smoke between compartments.	Cold smoke seals are to be installed by a competent person in accordance with the manufacturer's instructions.	8th Floor Stair Door and flat 10	Statutory requirement for the Client	02/04/2024

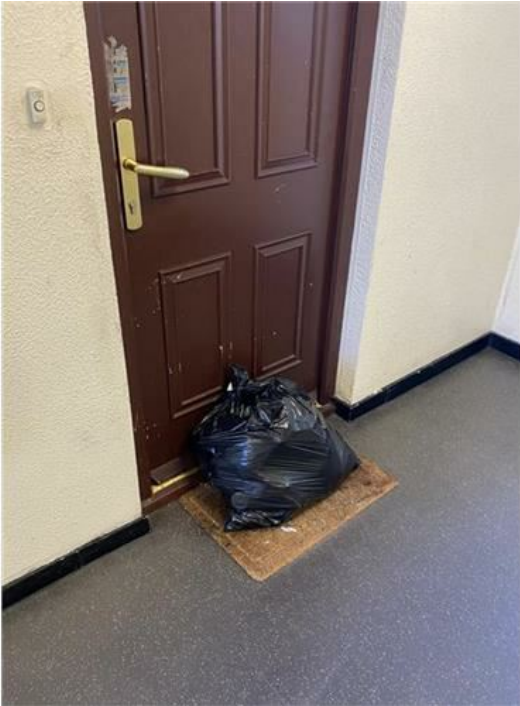
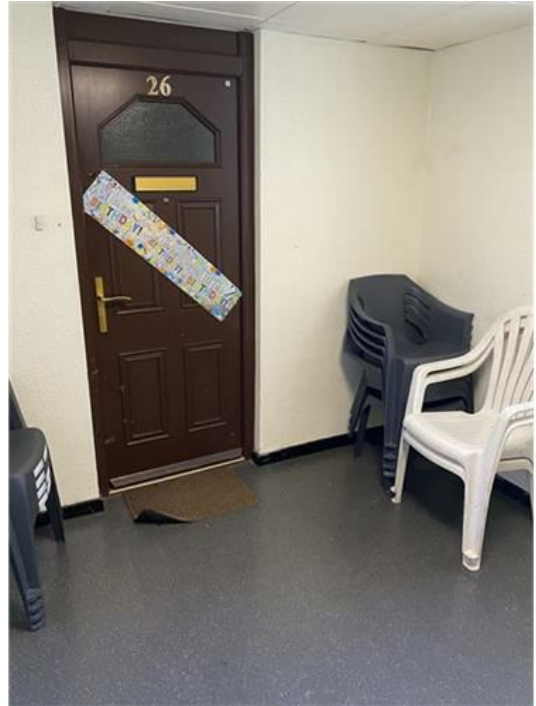
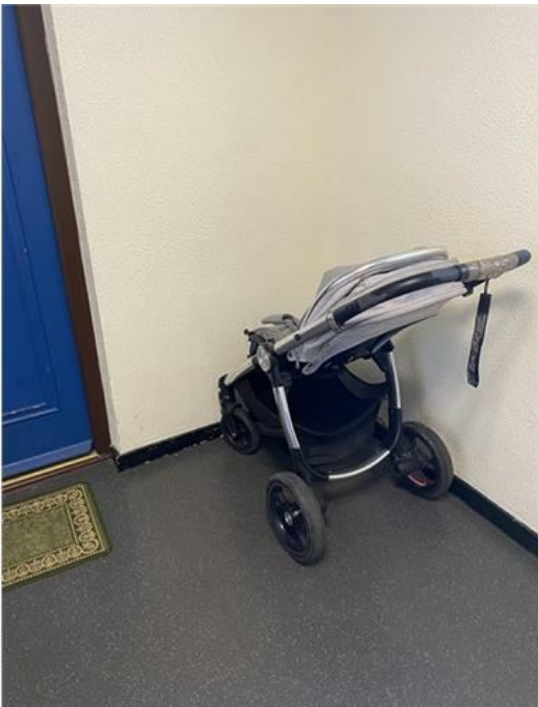
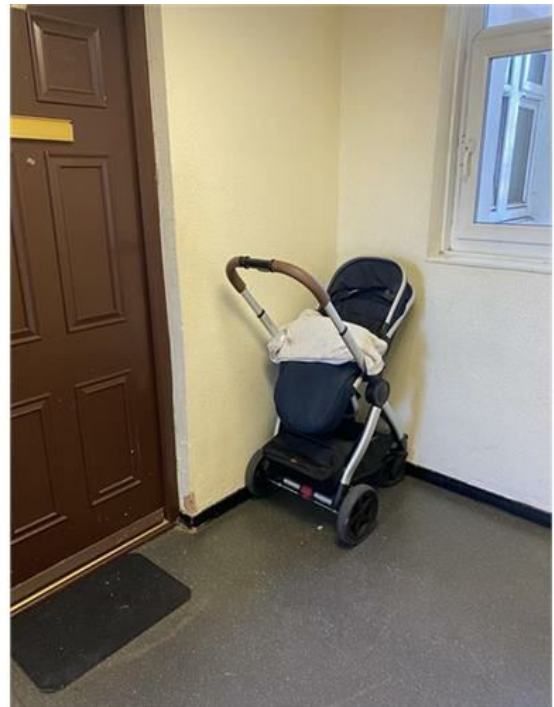
Ref	Sub Section	Question	Non-conformity	Recommendation	Location	Who is responsible	By When
13068355	A	Are house keeping arrangements satisfactory?	Combustible materials are located/stored in the escape routes.	Items that are a source of fuel or are combustible and likely to increase the fire loading or spread of fire, should not be located on any corridor, stairway or circulation space that will be used as an escape route. Therefore, the combustible materials stored in the escape routes must be removed.	O/S flats 30, 26, 14 and 12.	Statutory requirement for the Client	01/06/2024
