Fire Risk Assessment

13-38 John Burns Drive - Barking - 900009325

13 Mar 2024

Chris Daly BEng(Hons) MIFSM

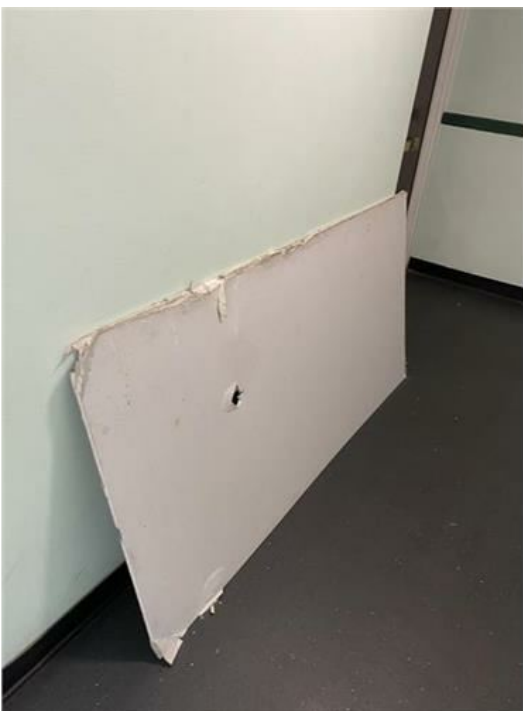
IMG_5982(1).jpg

Ref	Sub Section	Question	Non-conformity	Recommendation	Location	Who is responsible	By When
13095285	5.0.D	Are house keeping arrangements satisfactory?	The escape route is obstructed.	The items obstructing the escape route must be removed.	O/S flat 30	Statutory requirement for the Client	29/04/2024

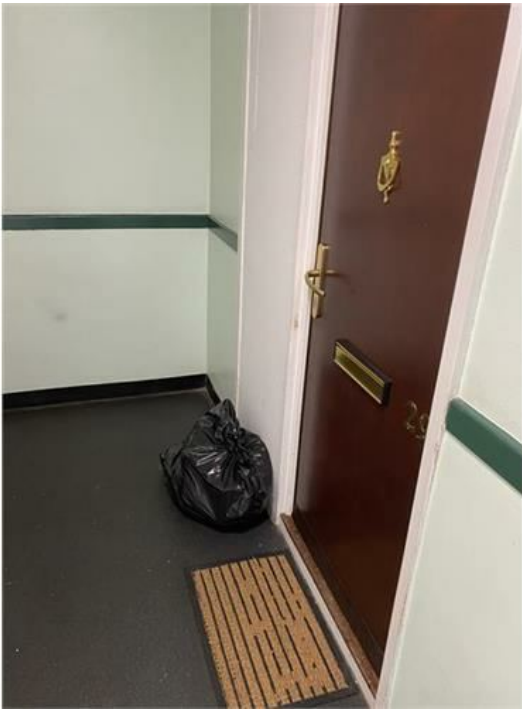
IMG_5981(1).jpg

Ref	Sub Section	Question	Non-conformity	Recommendation	Location	Who is responsible	By When
13095284	A	Are house keeping arrangements satisfactory?	Combustible materials are located/stored in the escape routes.	Items that are a source of fuel or are combustible and likely to increase the fire loading or spread of fire, should not be located on any corridor, stairway or circulation space that will be used as an escape route. Therefore, the combustible materials stored in the escape routes must be removed.	O/S flat 29	Statutory requirement for the Client	29/04/2024

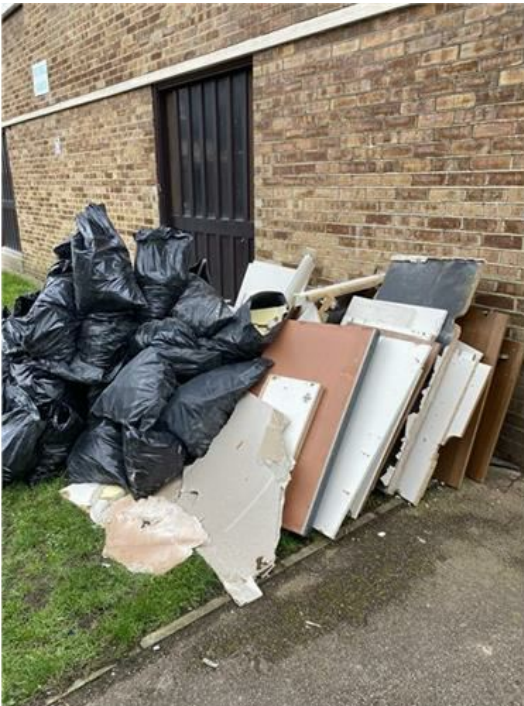
IMG_5988(1).jpg

Ref	Sub Section	Question	Non-conformity	Recommendation	Location	Who is responsible	By When
13095291	H	Are adequate measures in place to control risk of fire due to arson?	Waste and combustible items are located too close to the building.	A clear zone of approximately 3 -6 metres around the building should be kept clear. Items must be removed.	Ground floor externally.	Statutory requirement for the Client	29/04/2024

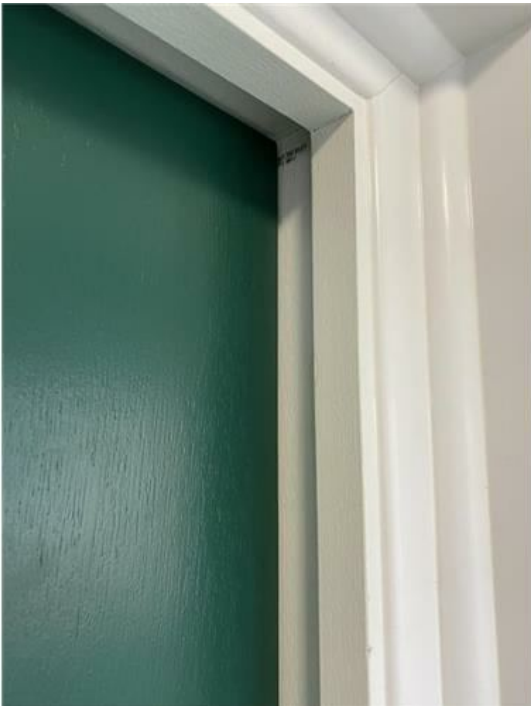
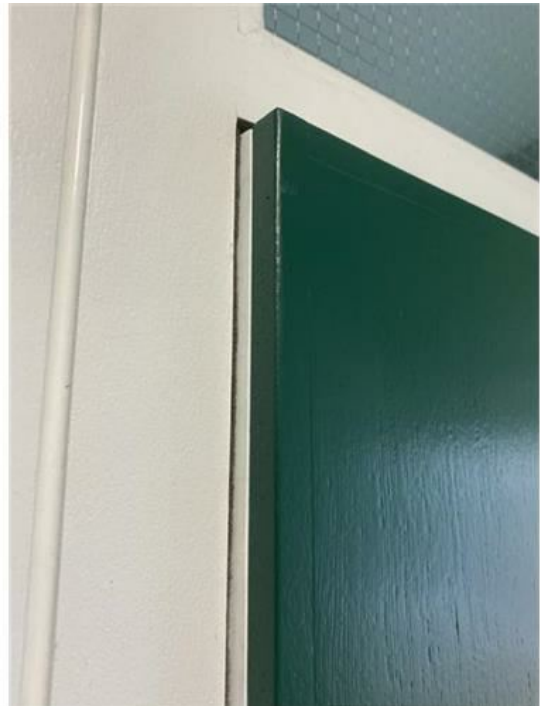
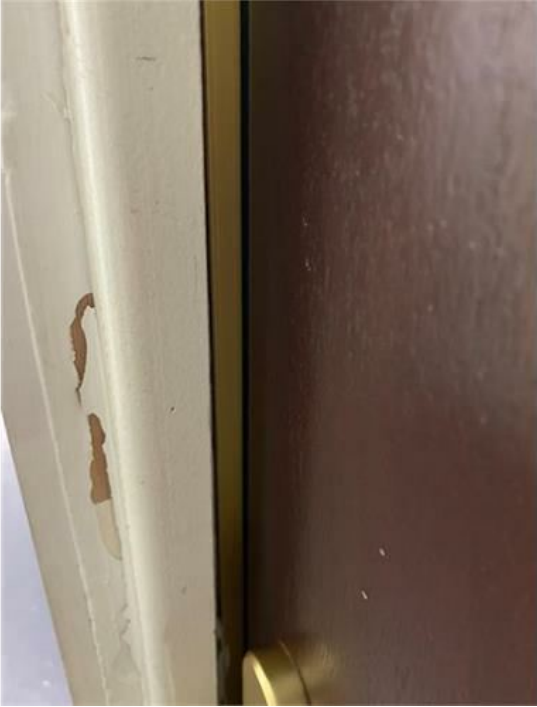
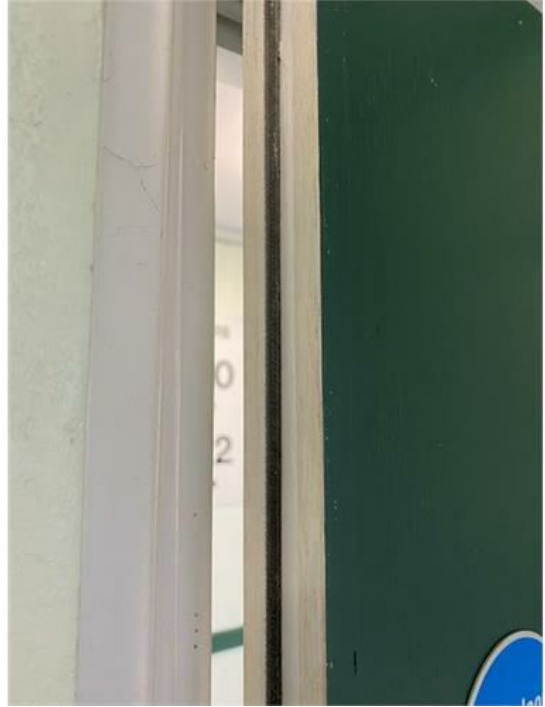
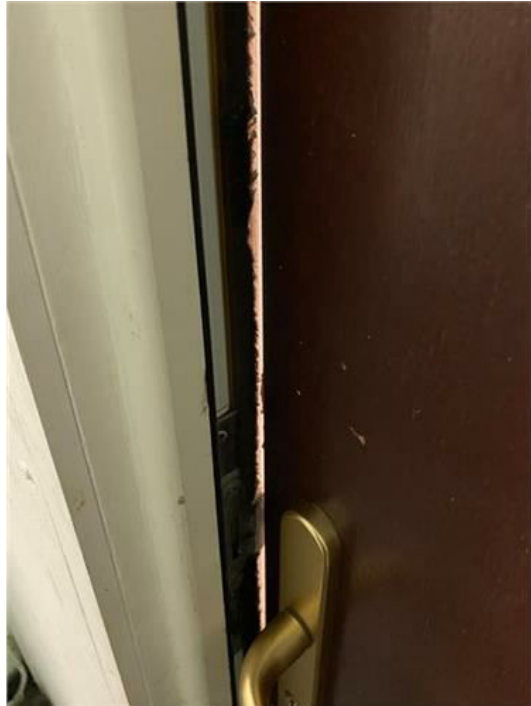
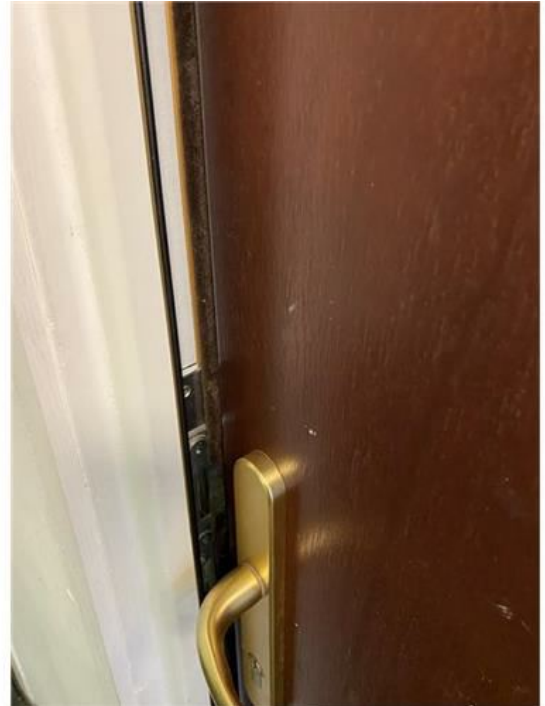
Ref	Sub Section	Question	Non-conformity	Recommendation	Location	Who is responsible	By When
13095283	J	Do the fire resisting door sets meet the appropriate standard?	Ineffective self closing devices.	Repair or replace the self-closing devices to ensure fire door/s close fully into their frames against the door stops.	Lobby doors on 6th & 2nd floors. Stair door on 5th floor. Flat doors for 23, 18 and 17.	Statutory requirement for the Client	29/04/2024

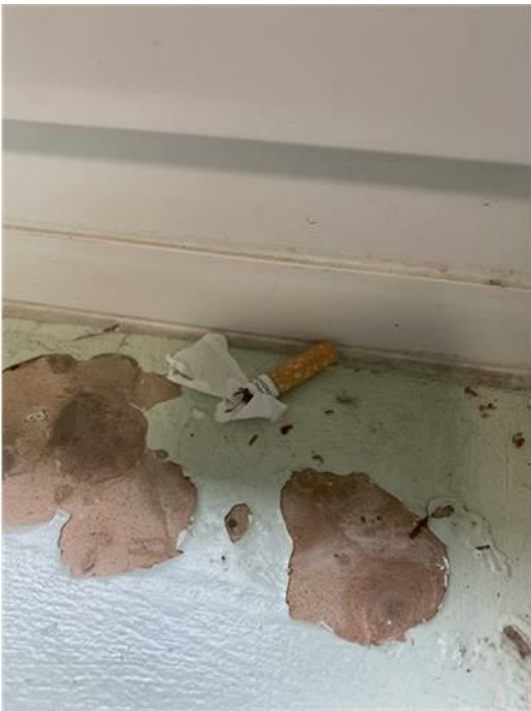
IMG_5980(1).jpg

Ref	Sub Section	Question	Non-conformity	Recommendation	Location	Who is responsible	By When
13095292	B	Is a suitable 'no smoking' policy in place?	Evidence of unauthorised smoking was found.	Management are to apprise all relevant persons on the company smoking policy.	Stairwell on 5th floor.	Statutory requirement for the Client	28/06/2024
