Fire Risk Assessment

1-96 Thaxted House - Dagenham - 900057818

19 Mar 2024

SECTION 1: MANAGEMENT OVERVIEW - RISK ASSESSMENT

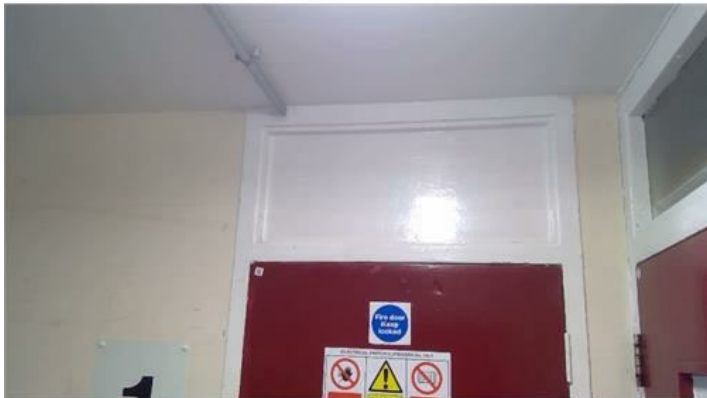
2024319102531.jpg

Ref	Sub Section	Question	Non-conformity	Recommendation	Location	Who is responsible	By When
13101001	4.0.A	Are the fire resisting and separating walls and floors in good condition?	The assessor was unable to ascertain that the materials used on the timber overpanel above the cupboards are to the required and approved levels of fire resistance.	A further investigation will be required by a competent person to ascertain the integrity of the materials used and that they will provide the correct level of fire resistance.	Cupboards on the protected stair. Timber panels above flat entrance doors.	Statutory requirement of the Client	06/05/2024

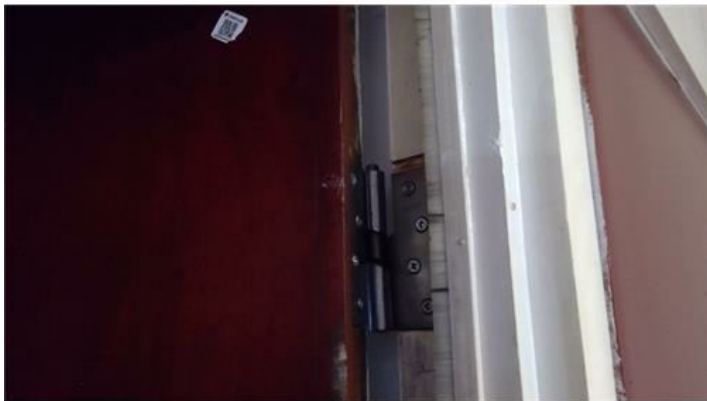
2024319104112.jpg

Ref	Sub Section	Question	Non-conformity	Recommendation	Location	Who is responsible	By When
13101016	5.0.A	Do the fire resisting door sets meet the appropriate standard?	The number/fire resisting standard of the installed hinges is insufficient.	Three fire resisting hinges that comply with BS EN 1935 are to be installed by a competent person.	Lift lobby and stair core. Refuge Shute doors. Electrical cupboard.	Statutory requirement of the Client	06/05/2024

Ref	Sub Section	Question	Non-conformity	Recommendation	Location	Who is responsible	By When
13101014	5.0.E	Do the fire resisting door sets meet the appropriate standard?	The existing doors are not deemed to be of the appropriate fire resisting standard. Doors accessed showed a combination of discrepancies including rising butt hinge provision, missing intumescent strips and cold smoke seals and a general doubt about the door construction.	The existing doors are to be visually examined and where necessary replaced to include the provision of 3 x fire resistant hinges (BS EN 1935), door handles that comply with BS EN 1906 Annex C, dual intumescent heat strip/cold smoke seals along the door edges and suitable, positive action self-closing devices (BS EN 1154).	All flat entrance doors.	Statutory requirement of the Client	06/05/2024

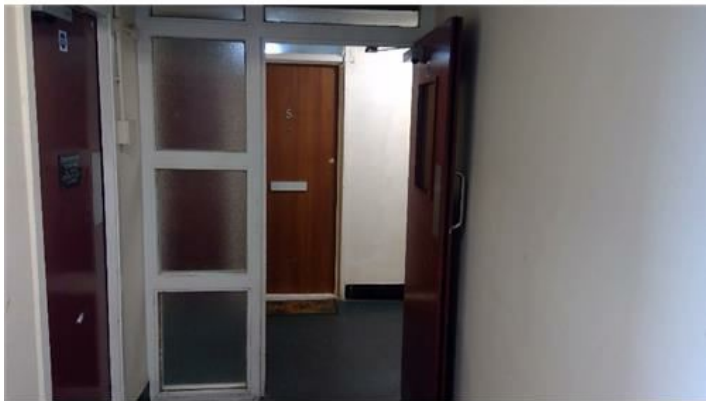
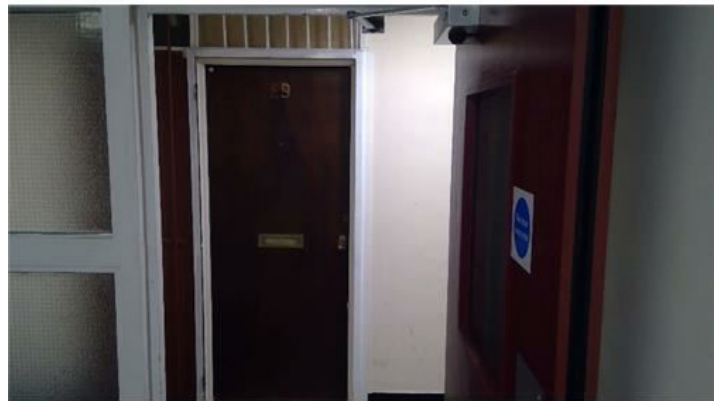
2024319103417.jpg

Ref	Sub Section	Question	Non-conformity	Recommendation	Location	Who is responsible	By When
13101013	5.0.G	Do the fire resisting door sets meet the appropriate standard?	Fire doors were found to be held open.	If this door requires to be held open, an approved automatic hold open/release device can be installed as an acceptable alternative. Installation must be completed by a competent person in accordance with BS EN 1155 or BS 5839-3.	Flat approach lobby doors.	Statutory requirement of the Client	06/05/2024

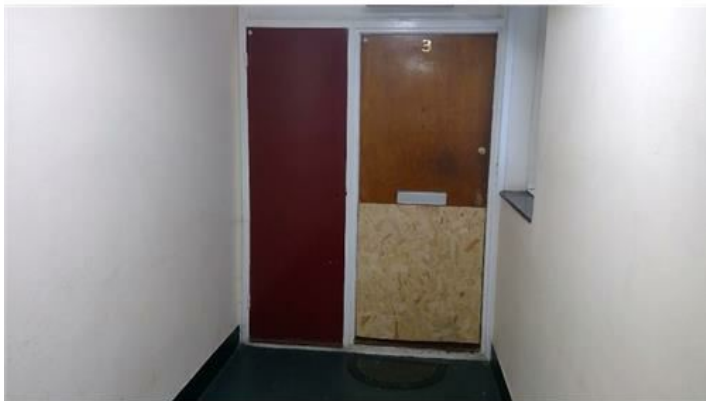
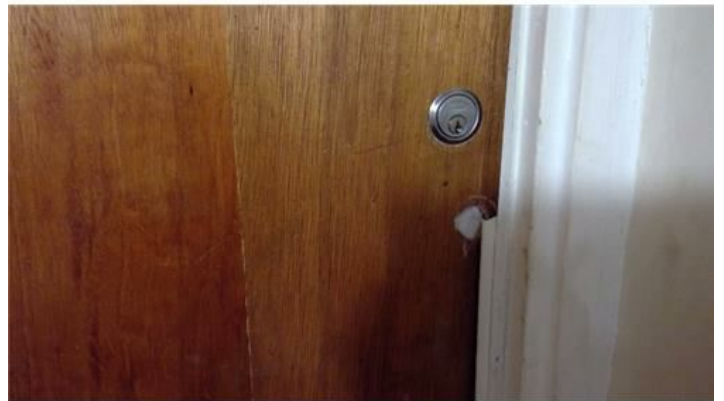
20243191139.jpg

Ref	Sub Section	Question	Non-conformity	Recommendation	Location	Who is responsible	By When
13101015	5.0.V	Do the fire resisting door sets meet the appropriate standard?	The existing fire doors are damaged compromising the fire resistance provided by the door sets.	The damaged fire doors must be repaired or replaced to ensure that the required level of fire resistance is maintained.	Flat 3 & 91.	Statutory requirement of the Client	06/05/2024

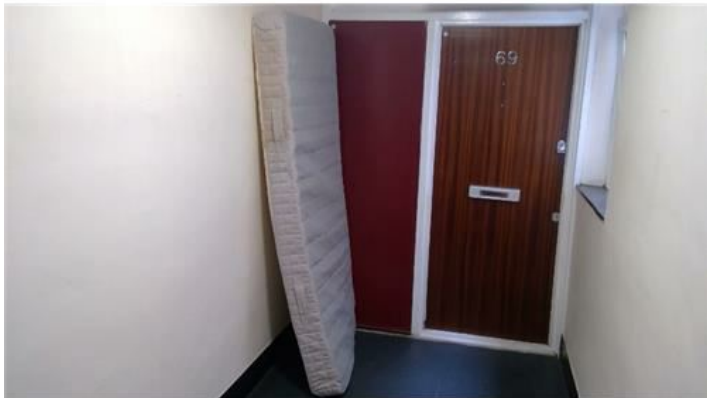
2024319124628.jpg

Ref	Sub Section	Question	Non-conformity	Recommendation	Location	Who is responsible	By When
13101018	A	Are house keeping arrangements satisfactory?	Combustible materials are located/stored in the escape routes.	Items that are a source of fuel or are combustible and likely to increase the fire loading or spread of fire, should not be located on any corridor, stairway or circulation space that will be used as an escape route. Therefore, the combustible materials stored in the escape routes must be removed.	Adjacent to flat 69.	Statutory requirement of the Client	06/05/2024

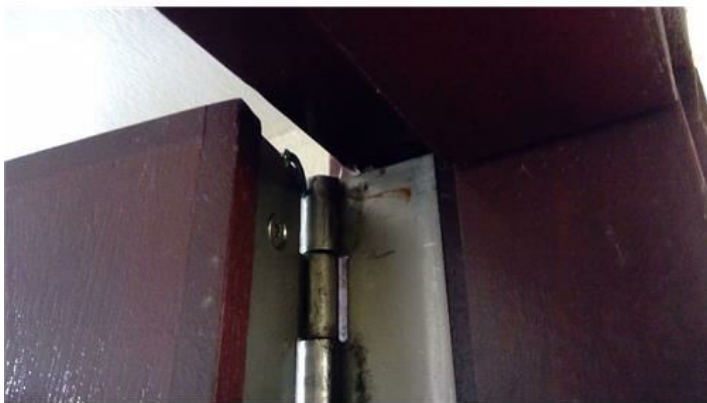
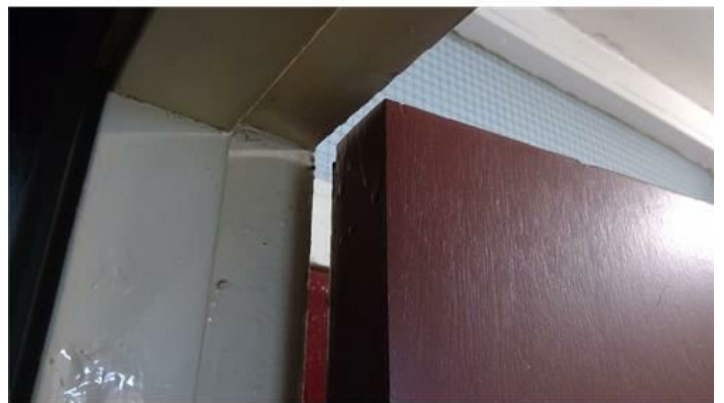
20243199437.jpg

Ref	Sub Section	Question	Non-conformity	Recommendation	Location	Who is responsible	By When
13101012	D	Do the fire resisting door sets meet the appropriate standard?	The fire door has not been provided with a means to prevent the spread of fire and smoke between compartments.	Dual intumescent heat strips/cold smoke seals are to be installed by a competent person in accordance with the manufacturer's instructions.	Staff office, ground floor stair lobby. Refuse Shute. Stair core Electric & dry riser cupboards	Statutory requirement of the Client	06/05/2024

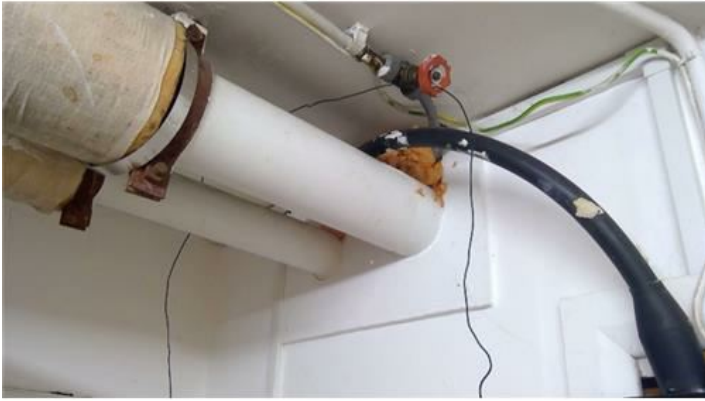
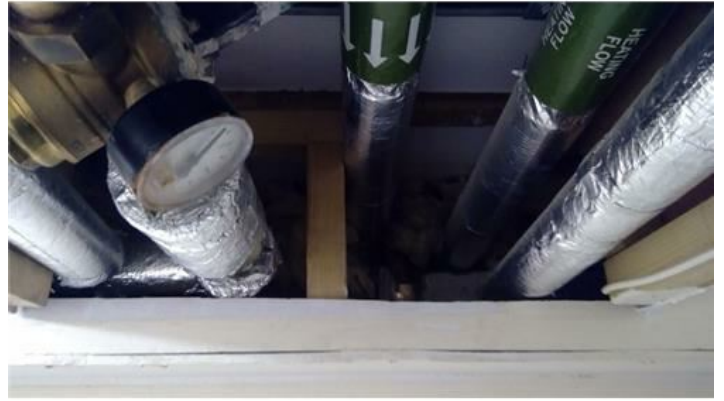
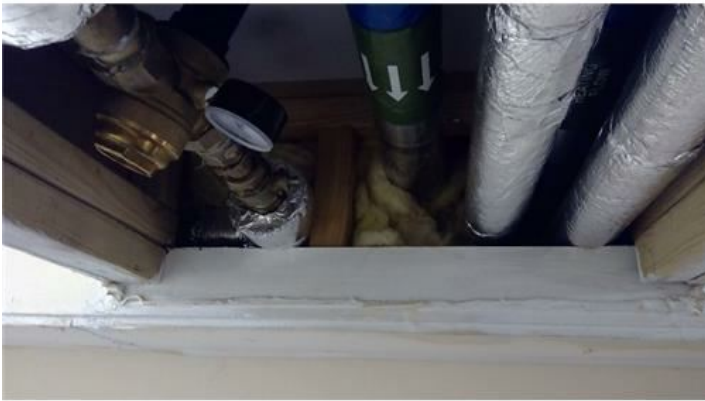
202431993928.jpg

Ref	Sub Section	Question	Non-conformity	Recommendation	Location	Who is responsible	By When
13101000	E	Are the fire resisting and separating walls and floors in good condition?	Fire stopping between compartments is missing and/or poorly installed. It was observed that a significant areas around service pipe penetrations has been infilled with expandable PU type foam and/or rockwool insulation.	In general PU fire stop foam is only intended for linear gaps up to approximately 30mm and small penetrations holes of up to approximately 30mm. Install fire stopping around services and pipe work which penetrate through the fire resisting and separating floors and walls. Ensure the correct approved proprietary materials are installed by a competent passive fire safety contractor.	Staff office. Lift lobby compartment wall. All floors	Statutory requirement of the Client	06/05/2024
