Fire Risk Assessment

101-710 Icehouse Court - Barking - IG11 7FR - 990017256

28 Aug 2024

SECTION 1: MANAGEMENT OVERVIEW - RISK ASSESSMENT

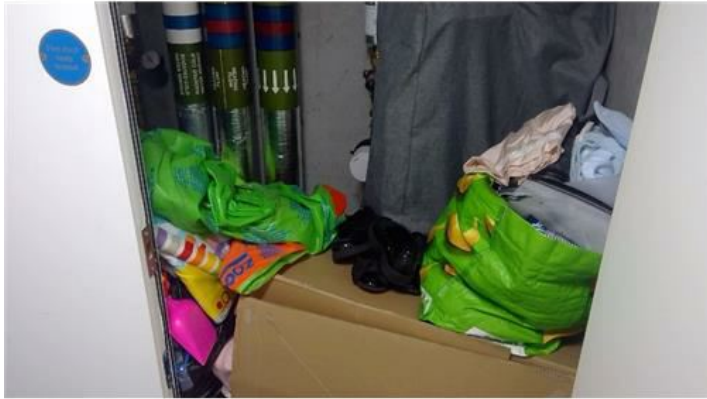
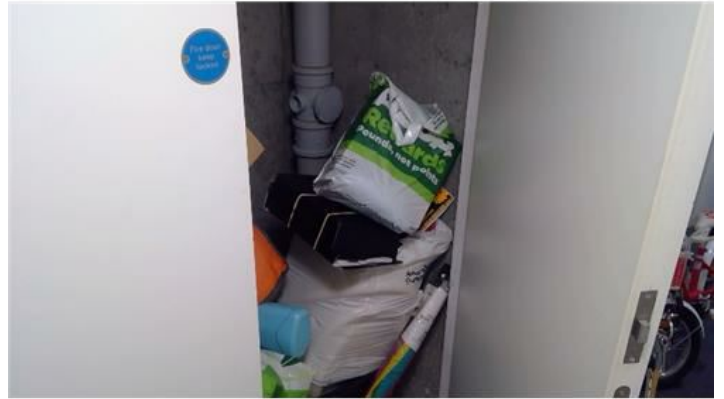
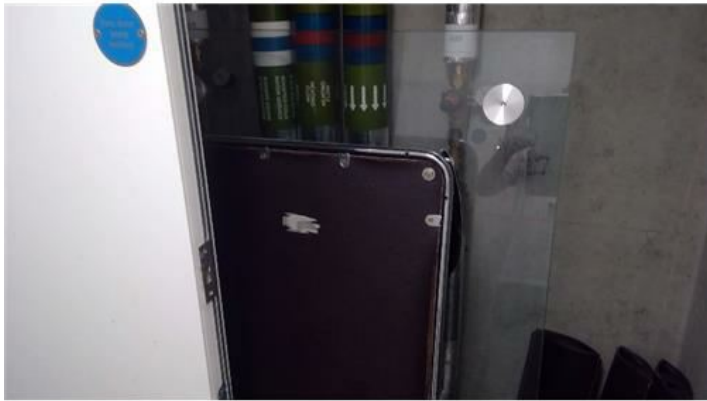
Ref	Sub Section	Question	Non-conformity	Recommendation	Location	Who is responsible	By When
13248398	A	Are house keeping arrangements satisfactory?	Inappropriate use of rooms/space.	The room/space should be utilised for the purpose for which it was designed.	Please See Plan	Statutory requirement of the Client	09/10/2024

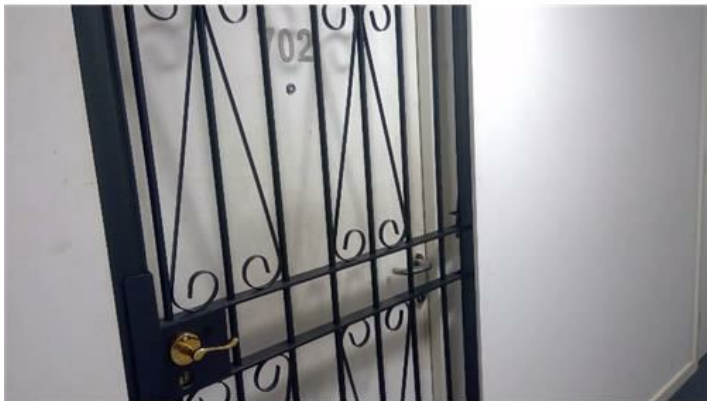
202482811421.jpg

Ref	Sub Section	Question	Non-conformity	Recommendation	Location	Who is responsible	By When
13248382	C	Are the doors required to form part of the escape route in an emergency?	A external security gate has been installed by the tenant the gate is secured with an inappropriate fastening device which requires the use of a key.	Replace the fastening device with a simple fastening that can be readily operated from the side approached by persons making an escape. The operation of such a fastening should be readily apparent; without the use of a key and without having to manipulate more than one mechanism. the new arrangement should ensure that the gate cannot be opened externally by unauthorised persons attempting to break in.	Please See Plan	Statutory requirement of the Client	09/10/2024

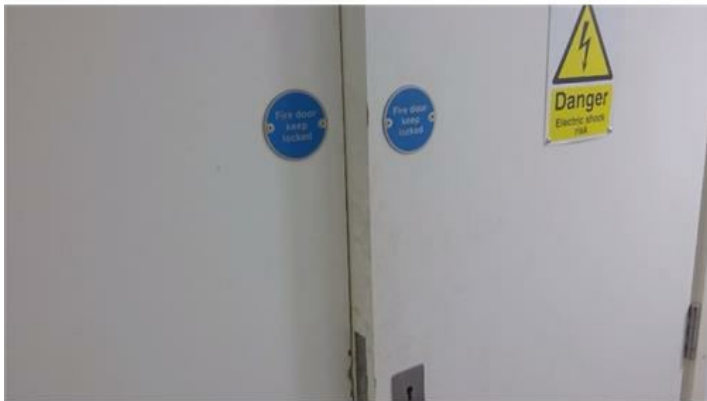
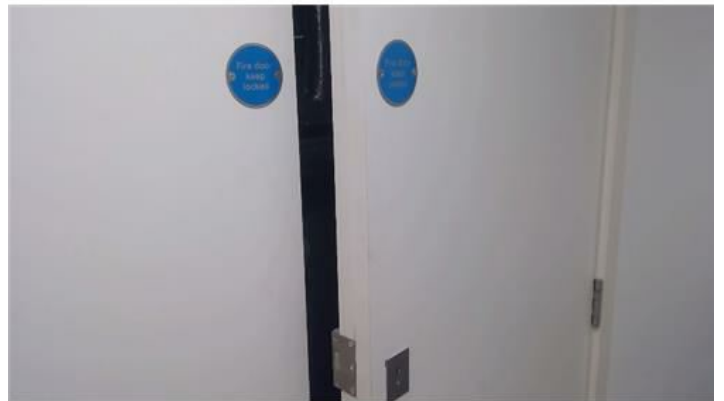
Ref	Sub Section	Question	Non-conformity	Recommendation	Location	Who is responsible	By When
13248379	I	Do the fire resisting door sets meet the appropriate standard?	The fire doors are not kept locked shut as required.	Fire doors are to be kept locked shut in accordance with the appropriate signage.	Please See Plan	Statutory requirement of the Client	09/10/2024

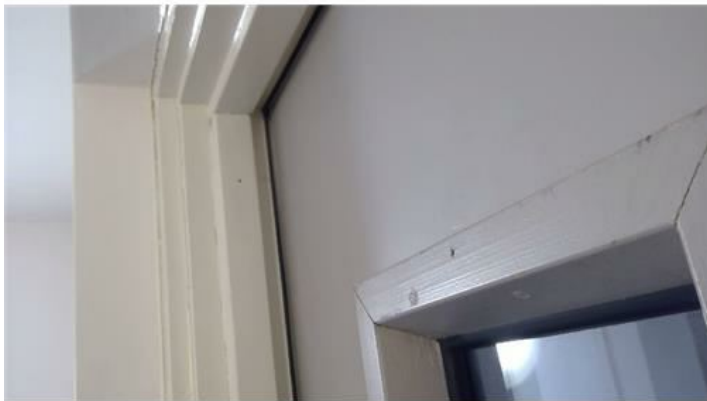
2024828105649.jpg

Ref	Sub Section	Question	Non-conformity	Recommendation	Location	Who is responsible	By When
13248378	J	Do the fire resisting door sets meet the appropriate standard?	Ineffective self closing devices.	Repair or replace the self-closing device/s to ensure fire door/s close fully into their frame/s against the door stops.	Please See Plan	Statutory requirement of the Client	09/10/2024

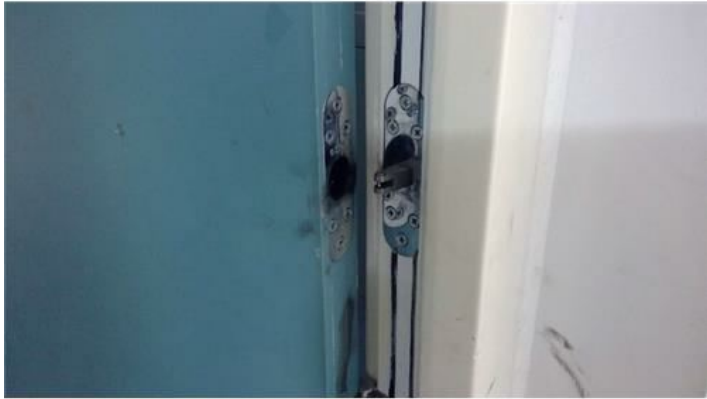
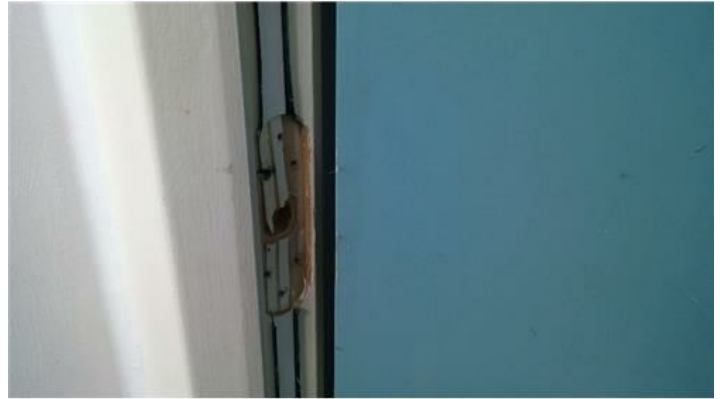
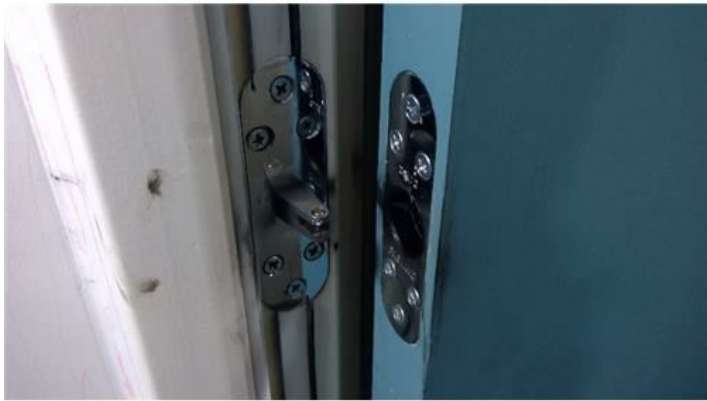
Ref	Sub Section	Question	Non-conformity	Recommendation	Location	Who is responsible	By When
13248377	K	Do the fire resisting door sets meet the appropriate standard?	The fire door/s require/s a self-closing device.	The fire doors indicated on the plan must be fitted with a suitable positive action self-closing device (BS EN 1154).	Please See Plan	Statutory requirement of the Client	09/10/2024

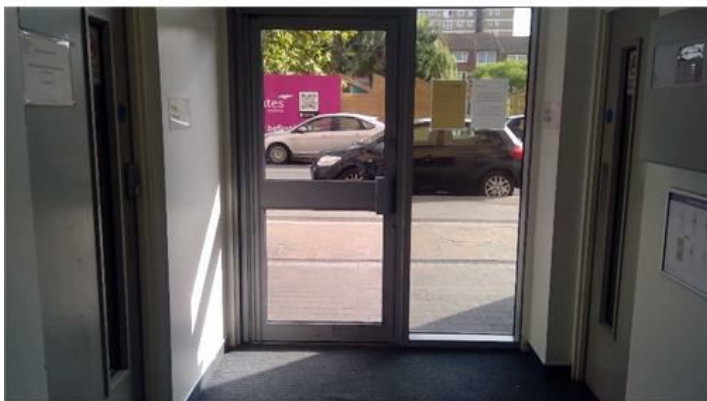
20248289268.jpg

Ref	Sub Section	Question	Non-conformity	Recommendation	Location	Who is responsible	By When
13248381	D	Are the doors required to form part of the escape route in an emergency?	At the time of the fire risk assessment it was not possible to ascertain whether the electronically locked doors release on the activation of the fire alarm and/or mains failure.	It must be ensured that all electronically powered locks return to the unlocked position upon activation of the fire alarm system, on loss of power or system error and upon activation of a manual release unit (Type A).	Please See Plan	Statutory requirement of the Client	08/12/2024
