Fire Risk Assessment

101/808 Jute Court - Barking - 990017175

21 Mar 2024

Chris Daly BEng(Hons) MIFSM

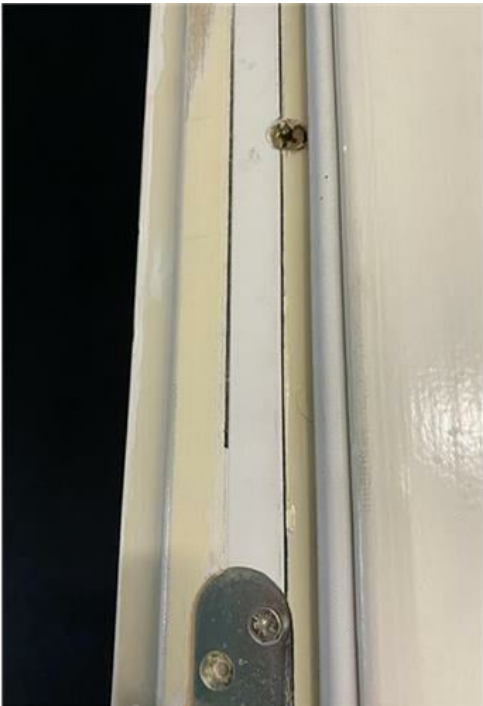
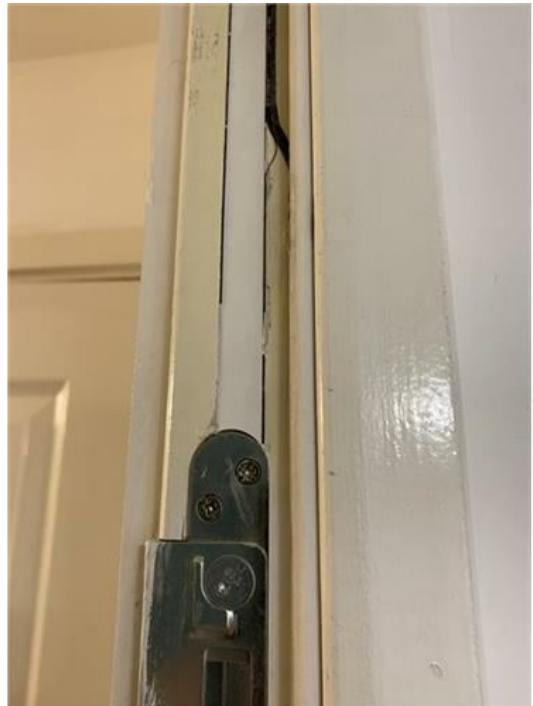
Ref	Sub Section	Question	Non-conformity	Recommendation	Location	Who is responsible	By When
13105269	5.0.B	Do the fire resisting door sets meet the appropriate standard?	The fire door has not been provided with a means to prevent the spread of smoke between compartments.	Cold smoke seals are to be installed by a competent person in accordance with the manufacturer's instructions.	Flats 502, 408, 306, 108 and 106.	Statutory requirement for the Client	14/05/2024

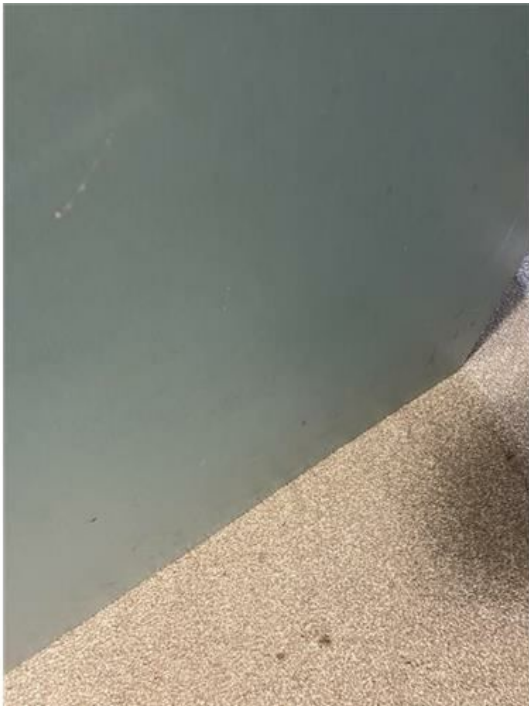
IMG_6032(1).jpg

Ref	Sub Section	Question	Non-conformity	Recommendation	Location	Who is responsible	By When
13105268	5.0.H	Do the fire resisting door sets meet the appropriate standard?	Fire door is dragging on the floor surface and are not closing completely against the door stops.	All fire doors and associated self-closing devices should be maintained to ensure they close fully into their frames.	Flat 108	Statutory requirement for the Client	14/05/2024

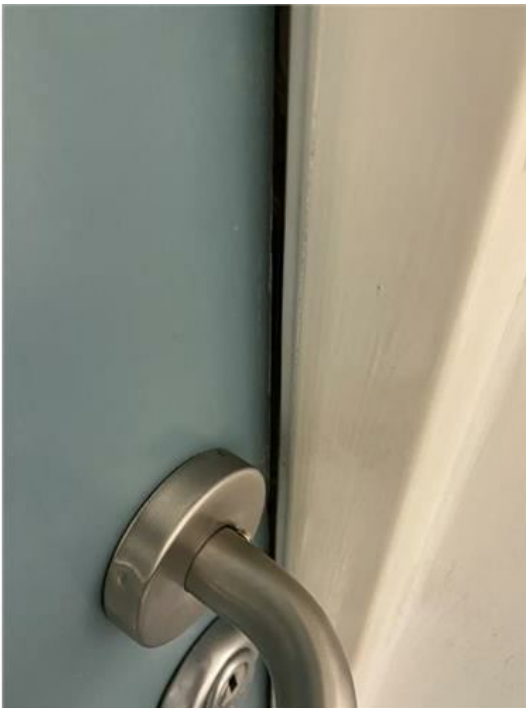
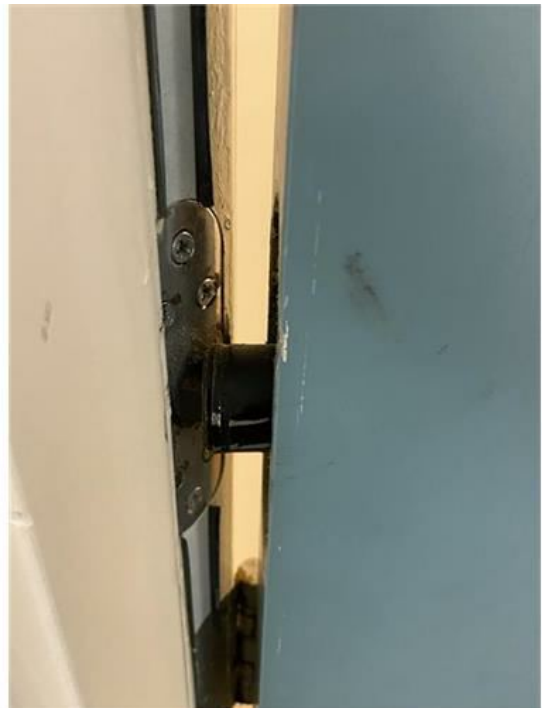
Ref	Sub Section	Question	Non-conformity	Recommendation	Location	Who is responsible	By When
13105265	5.0.J	Do the fire resisting door sets meet the appropriate standard?	Ineffective self closing devices.	Repair or replace the self-closing devices to ensure fire doors close fully into their frame/s against the door stops.	Front doors to flats 601, 408 and 108	Statutory requirement for the Client	14/05/2024

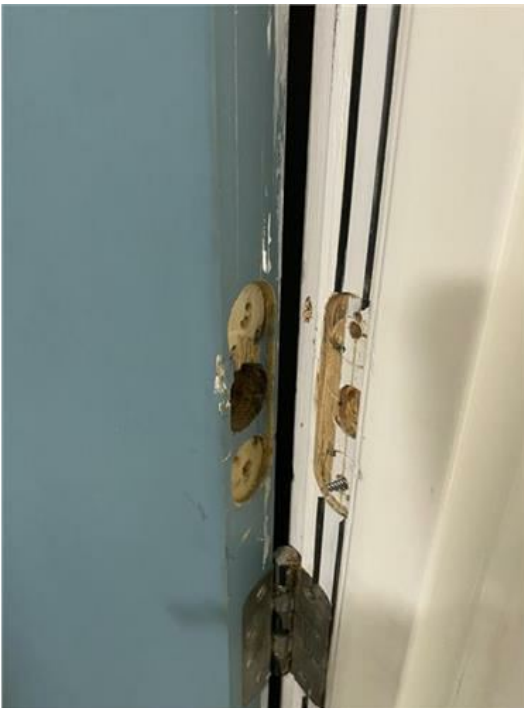
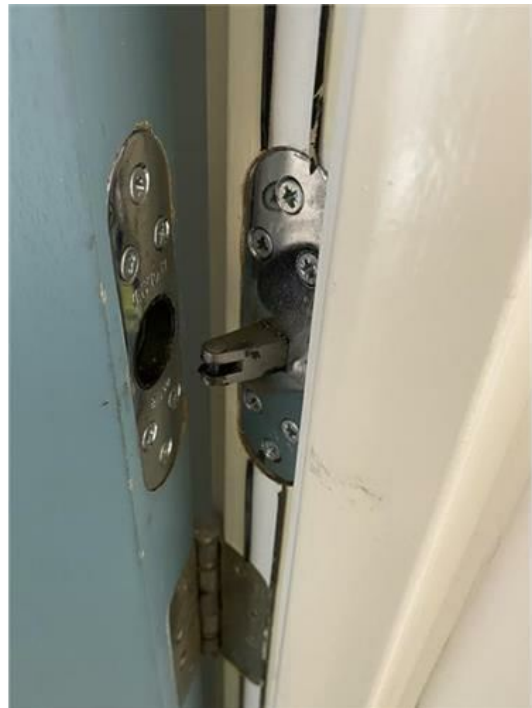
Ref	Sub Section	Question	Non-conformity	Recommendation	Location	Who is responsible	By When
13105266	5.0.K	Do the fire resisting door sets meet the appropriate standard?	The fire doors require a self-closing device.	The fire doors indicated must be fitted with a suitable positive action self-closing device (BS EN 1154).	Flat 404 and 403	Statutory requirement for the Client	14/05/2024

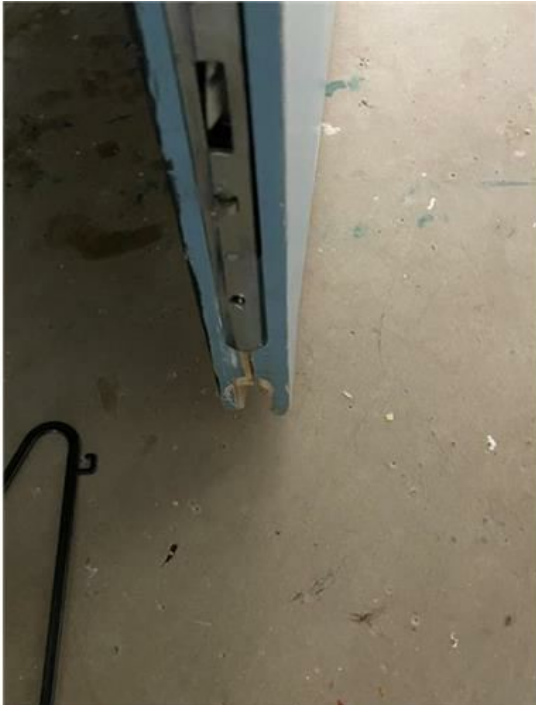
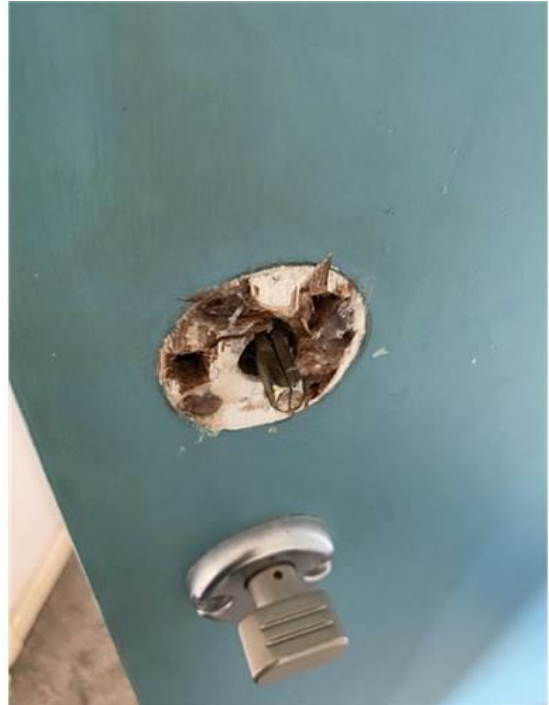
Ref	Sub Section	Question	Non-conformity	Recommendation	Location	Who is responsible	By When
13105267	5.0.V	Do the fire resisting door sets meet the appropriate standard?	The existing fire doors are damaged compromising the fire resistance provided by the door sets.	The damaged fire doors must be repaired or replaced to ensure that the required level of fire resistance is maintained.	Front door to flats 404 and 306	Statutory requirement for the Client	14/05/2024

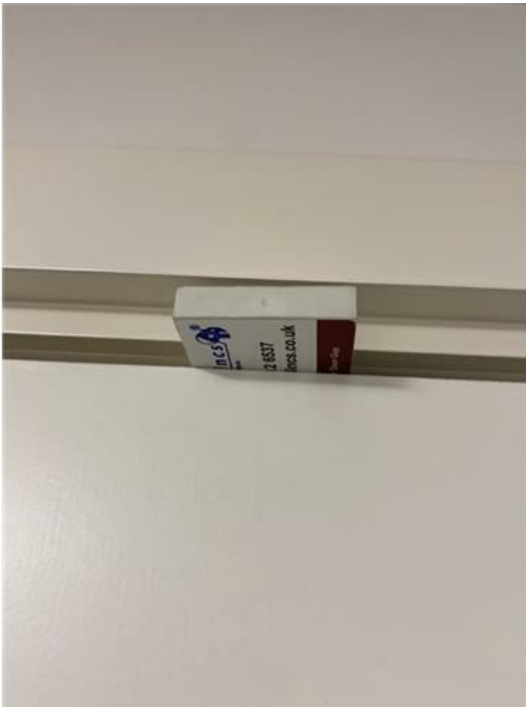
IMG_6022(1).jpg

Ref	Sub Section	Question	Non-conformity	Recommendation	Location	Who is responsible	By When
13105270	5.0.X	Do the fire resisting door sets meet the appropriate standard?	The fire doors have a large gap between the doors and the frame which may prevent the intumescent seals being effective.	The doors should be adjusted to ensure that there is between 2-4mm gap between the hinge edge, leading edge and the top of the door frame.	Riser cupboard doors on all floors.	Statutory requirement for the Client	14/05/2024

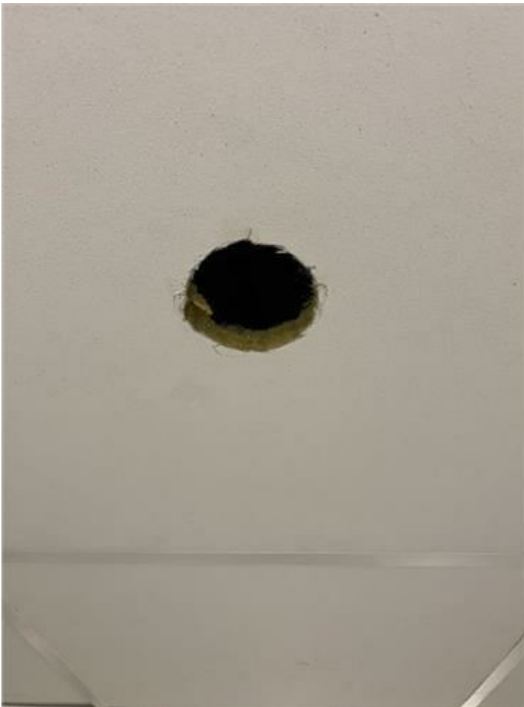
IMG_6023(1).jpg

Ref	Sub Section	Question	Non-conformity	Recommendation	Location	Who is responsible	By When
13105264	C	Are the fire resisting and separating walls and floors in good condition?	The holes/gaps in the ceiling negate the fire integrity of the separating floor.	These breaches are to be infilled with appropriate fire resisting materials by a competent person to provide the compartment with the required level of fire resistance.	Corridor on 7th floor by the lifts.	Statutory requirement for the Client	14/05/2024
