Fire Risk Assessment

1-34 West House - Barking - 900003043

05 Feb 2024

SECTION 1: MANAGEMENT OVERVIEW - RISK ASSESSMENT

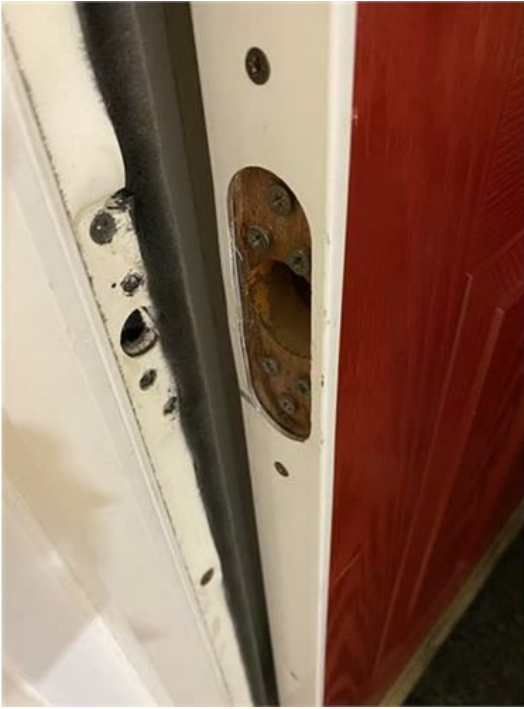
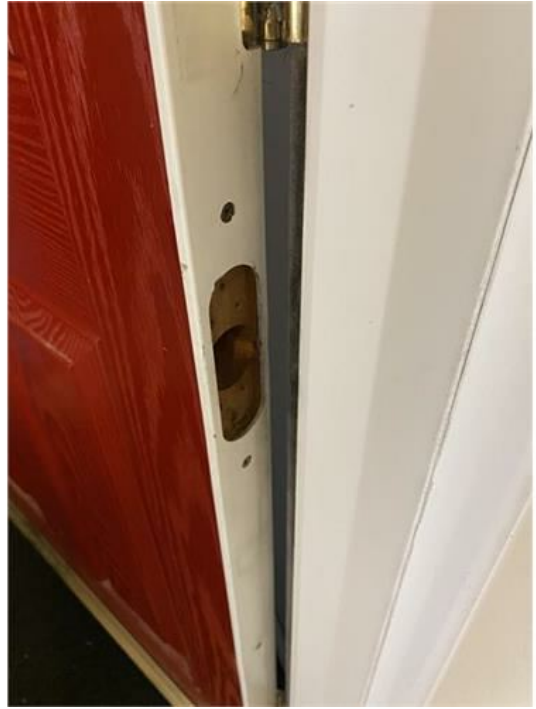
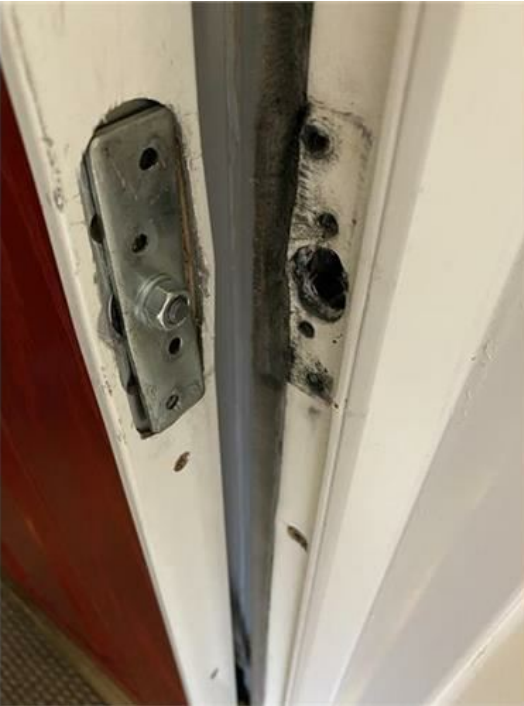
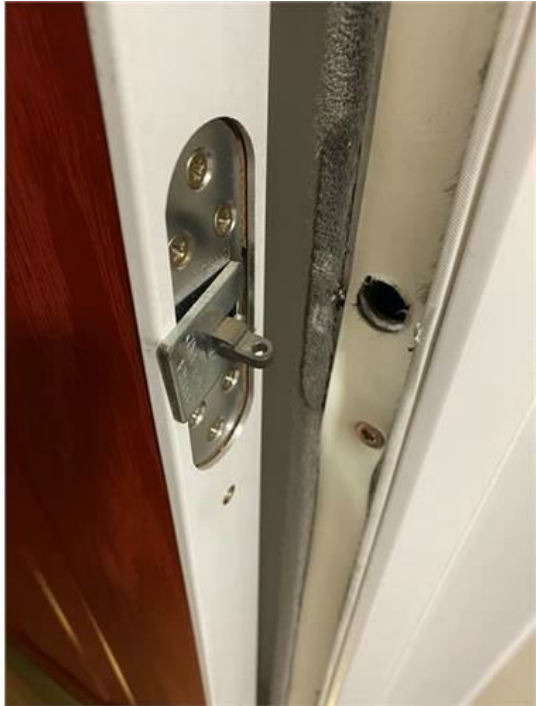
Ref	Sub Section	Question	Non-conformity	Recommendation	Location	Who is responsible	By When
13058244	5.0.K	Do the fire resisting door sets meet the appropriate standard?	The fire doors require a self-closing device.	The fire doors indicated must be fitted with a suitable positive action self-closing device (BS EN 1154).	Front Doors to Flats 32, 31, 14, 7 and 4	Statutory requirement for the Client	31/03/2024

10 - Escape Route across a flat roof	Is the escape route across a flat roof acceptable?	Flat roofs do not form part of the escape route.		N/A
11 - Fire-resisting doors	Do the fire resisting door sets meet the appropriate standard?	Ineffective self closing devices.	J	Non_Compliant
11 - Fire-resisting doors	Do the fire resisting door sets meet the appropriate standard?	The fire doors require a self-closing device.	5.0.K	Non_Compliant
11 - Fire-resisting doors	Do the fire resisting door sets meet the appropriate standard?	The existing fire door is damaged compromising the fire resistance provided by the door sets.	5.0.V	Non_Compliant
12 - Fire-resisting partitions	Are the fire resisting partitions present installed and maintained to the appropriate standards?	The fire resisting partitions within the building are constructed and maintained to an appropriate standard.		Compliant
13 - General Doors	Are the doors required to form part of the escape route in an emergency?	All the doors required to form part of the escape route are in good working order and are capable of being used effectively.		Compliant

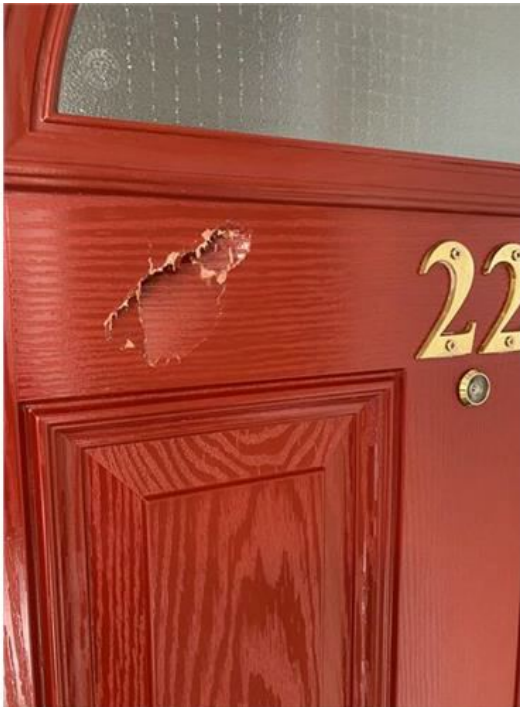
IMG_5809(1).jpg

Ref	Sub Section	Question	Non-conformity	Recommendation	Location	Who is responsible	By When
13058245	5.0.V	Do the fire resisting door sets meet the appropriate standard?	The existing fire door is damaged compromising the fire resistance provided by the door sets.	The damaged fire door must be repaired or replaced to ensure that the required level of fire resistance is maintained.	Flat 22	Statutory requirement for the Client	31/03/2024

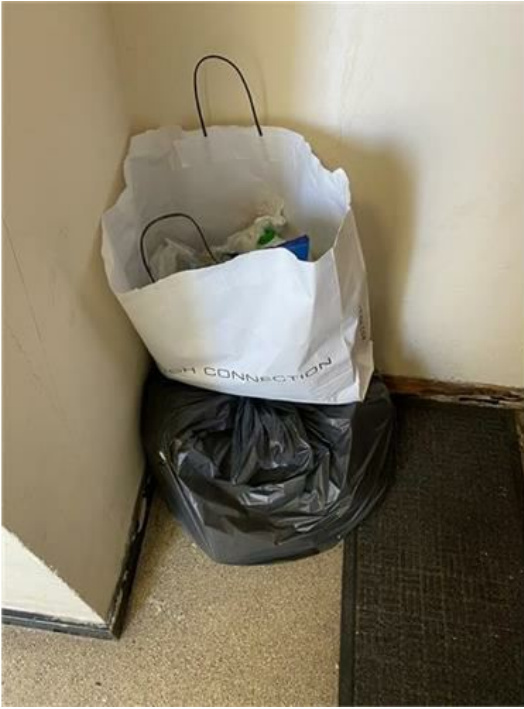
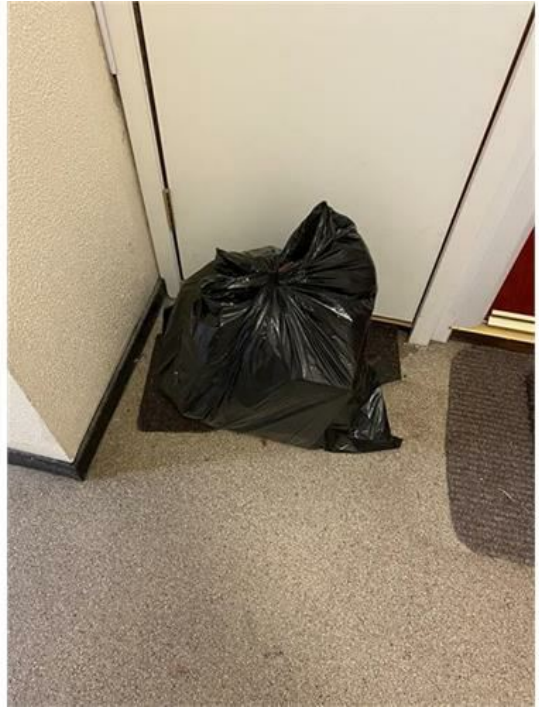
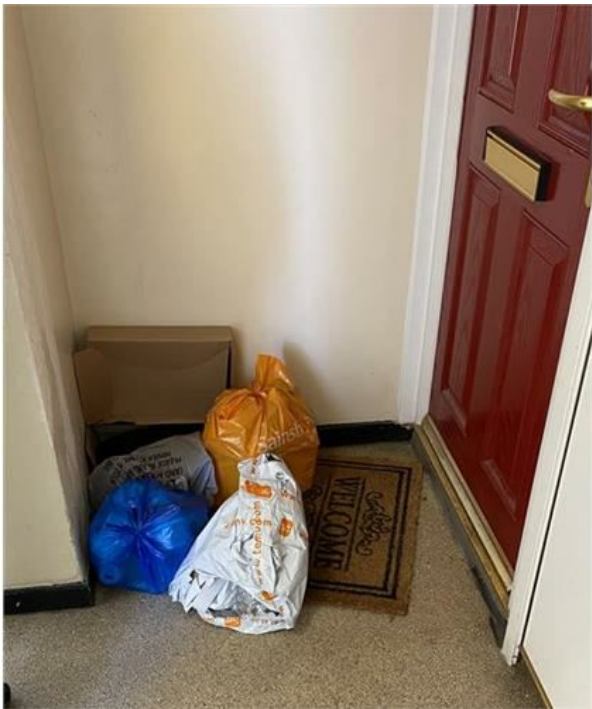
Ref	Sub Section	Question	Non-conformity	Recommendation	Location	Who is responsible	By When
13058246	A	Are house keeping arrangements satisfactory?	Combustible materials are located/stored in the escape routes.	Items that are a source of fuel or are combustible and likely to increase the fire loading or spread of fire, should not be located on any corridor, stairway or circulation space that will be used as an escape route. Therefore, the combustible materials stored in the escape routes must be removed.	O/S Flats 25, 23 and 4.	Statutory requirement for the Client	31/03/2024

14 - Housekeeping	Are house keeping arrangements satisfactory?	Combustible materials are located/stored in the escape routes.	A	Non_Compliant

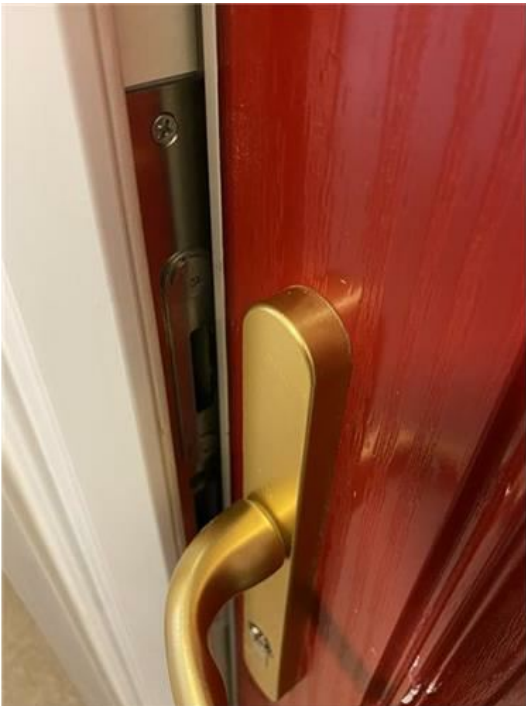
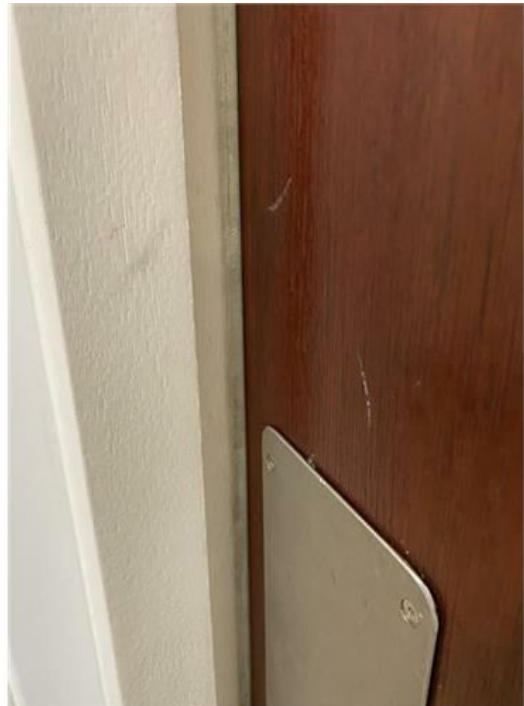
Ref	Sub Section	Question	Non-conformity	Recommendation	Location	Who is responsible	By When
13058243	J	Do the fire resisting door sets meet the appropriate standard?	Ineffective self closing devices.	Repair or replace the self-closing device/s to ensure fire door/s close fully into their frame/s against the door stops.	Flats 21, 15 and stair door 2nd Floor	Statutory requirement for the Client	31/03/2024
