Fire Risk Assessment

67-92 John Burns Drive - Barking - 900000723

13 Mar 2024

Chris Daly BEng(Hons) MIFSM

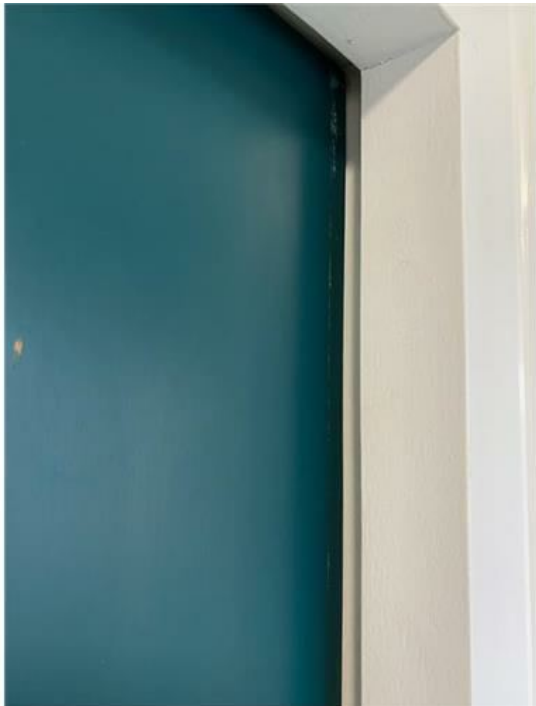
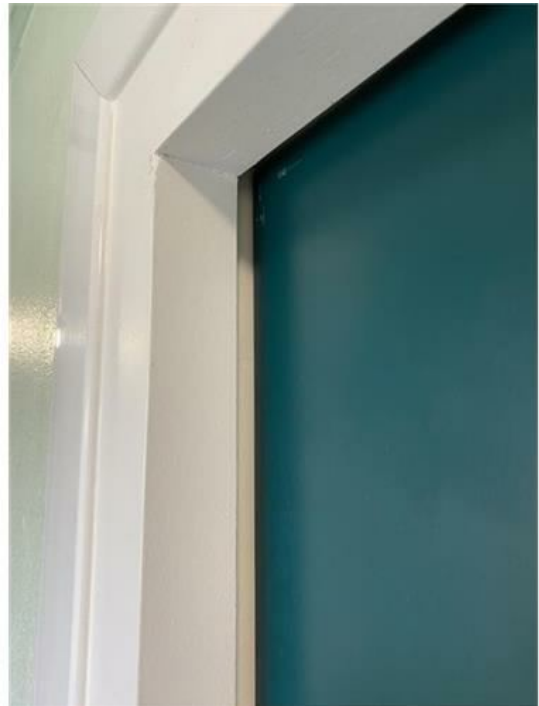
Ref	Sub Section	Question	Non-conformity	Recommendation	Location	Who is responsible	By When
13095272	5.0.J	Do the fire resisting door sets meet the appropriate standard?	Ineffective self closing devices.	Repair or replace the self-closing device/s to ensure fire doors close fully into their frames against the door stops.	Lobby door on 6th floor and chute room door on 4th floor.		29/04/2024

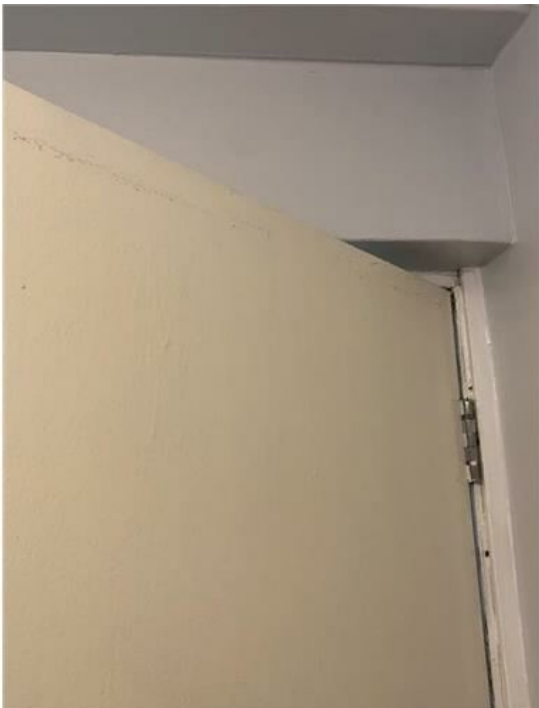
IMG_5973(1).jpg

Ref	Sub Section	Question	Non-conformity	Recommendation	Location	Who is responsible	By When
13095273	5.0.K	Do the fire resisting door sets meet the appropriate standard?	The fire door requires a self-closing device.	The fire doors indicated must be fitted with a suitable positive action self-closing device (BS EN 1154).	Front door to flat 86	Statutory requirement for the Client	29/04/2024

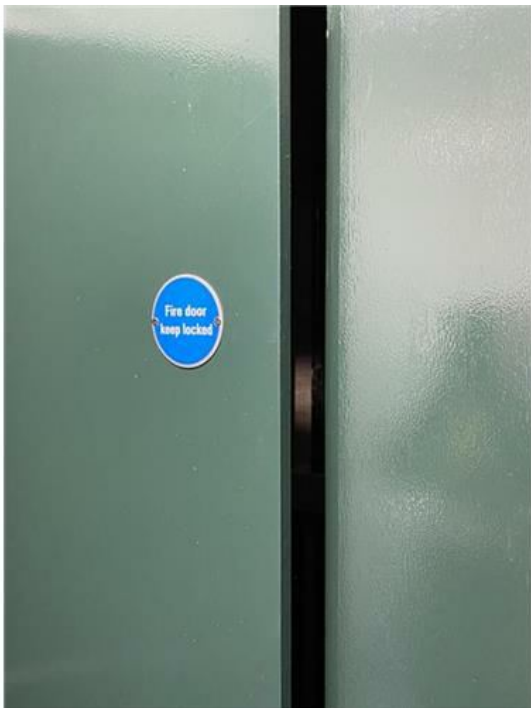
IMG_5971(1).jpg

Ref	Sub Section	Question	Non-conformity	Recommendation	Location	Who is responsible	By When
13095271	I	Do the fire resisting door sets meet the appropriate standard?	The fire doors are not kept locked shut as required.	Fire doors are to be kept locked shut in accordance with the appropriate signage.	Electrical Cupboard in chute room on 6th Floor	Statutory requirement for the Client	29/04/2024

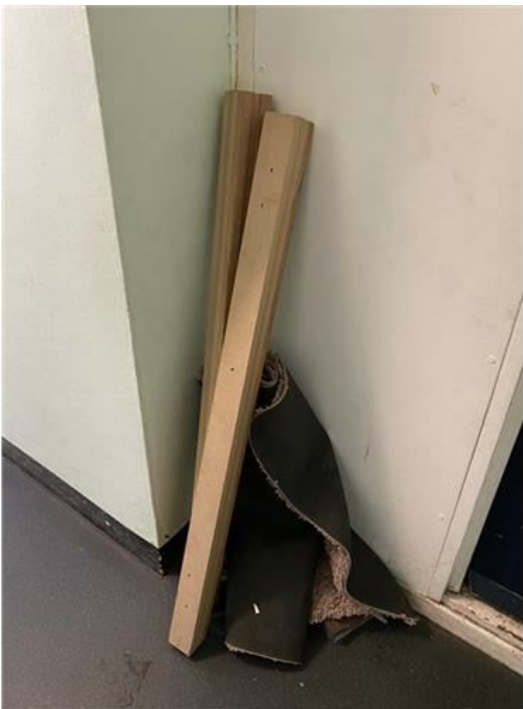
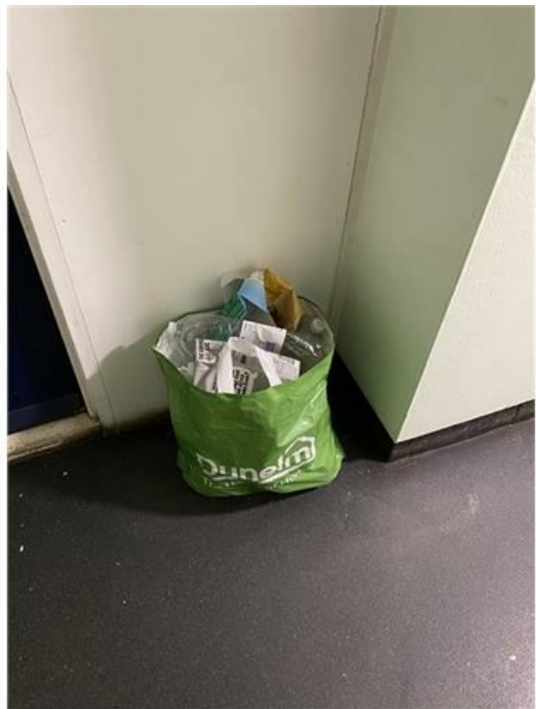
Ref	Sub Section	Question	Non-conformity	Recommendation	Location	Who is responsible	By When
13095274	A	Are house keeping arrangements satisfactory?	Combustible materials are located/stored in the escape routes.	Items that are a source of fuel or are combustible and likely to increase the fire loading or spread of fire, should not be located on any corridor, stairway or circulation space that will be used as an escape route. Therefore, the combustible materials stored in the escape routes must be removed.	O/S flats 84 and 68.	Statutory requirement for the Client	28/06/2024
