Fire Risk Assessment

1-18 Longreach Court - Barking - 970000544

13 Jun 2024

SECTION 1: MANAGEMENT OVERVIEW - RISK ASSESSMENT

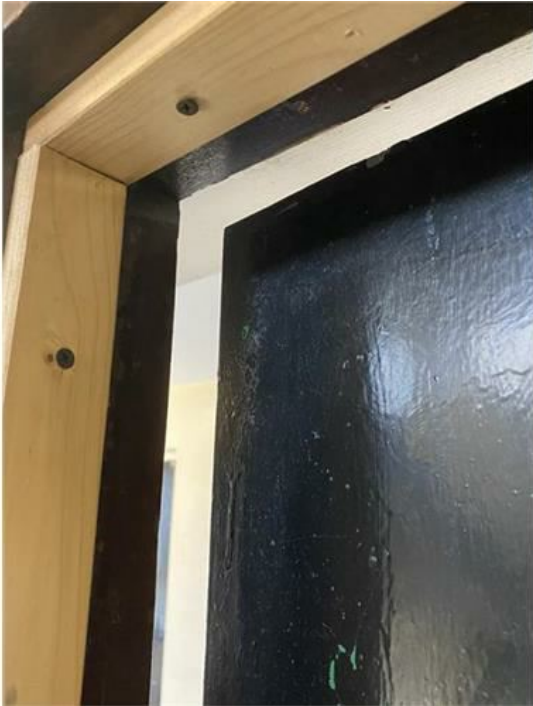
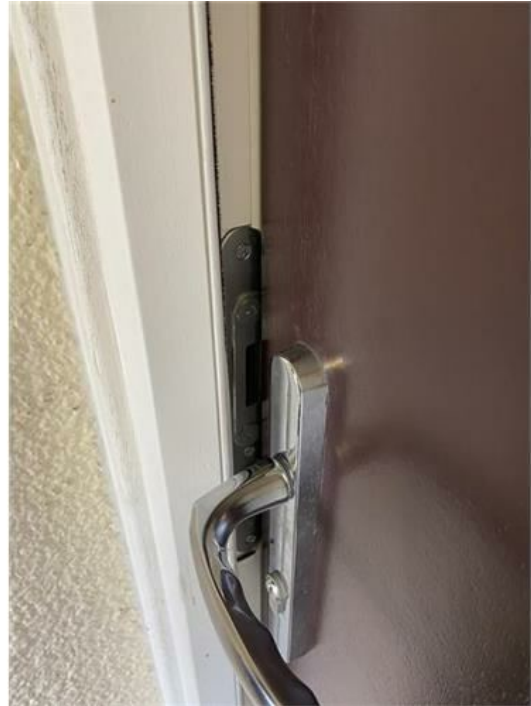
Ref	Sub Section	Question	Non-conformity	Recommendation	Location	Who is responsible	By When
13178392	5.0.J	Do the fire resisting door sets meet the appropriate standard?	Ineffective self closing devices.	Repair or replace the self-closing devices to ensure fire doors close fully into their frames against the door stops.	1st floor lobby door and Flat 2 front door.	Statutory requirement of the Client	23/07/2024

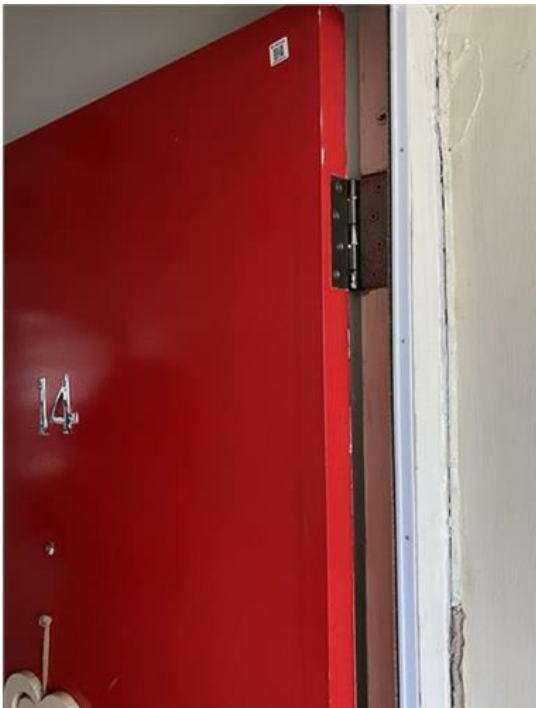
IMG_6306(1).jpg

Ref	Sub Section	Question	Non-conformity	Recommendation	Location	Who is responsible	By When
13178393	5.0.K	Do the fire resisting door sets meet the appropriate standard?	The fire door requires a self-closing device.	The fire doors indicated must be fitted with a suitable positive action self-closing device (BS EN 1154).	Flat 14 front door	Statutory requirement for the Client	23/07/2024

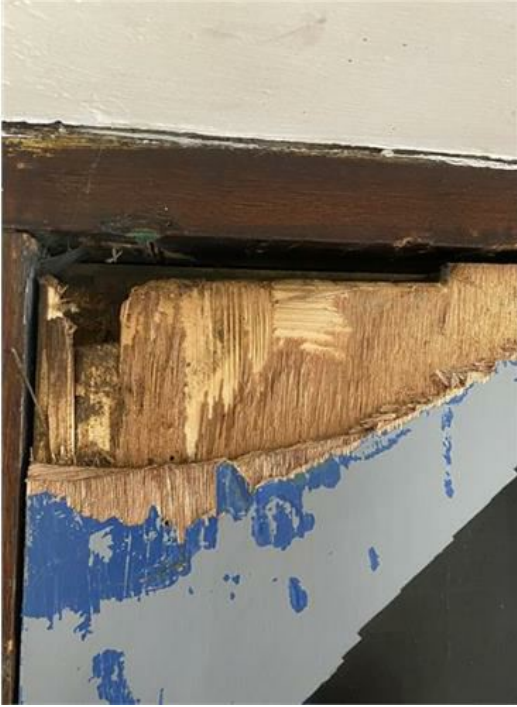
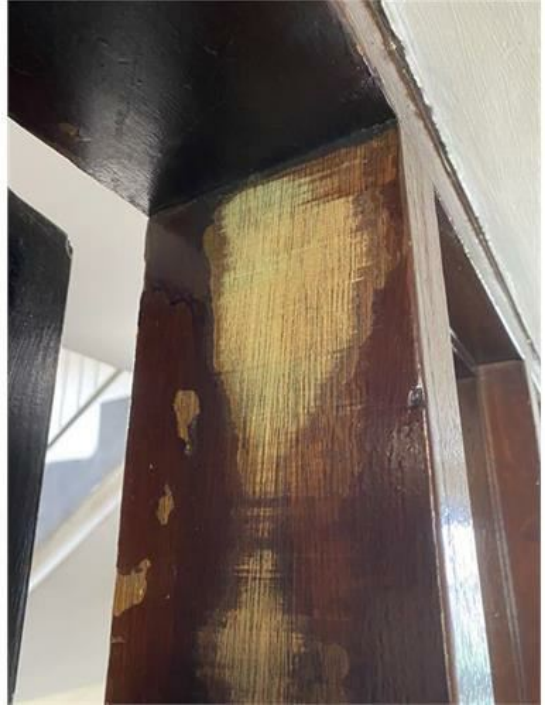
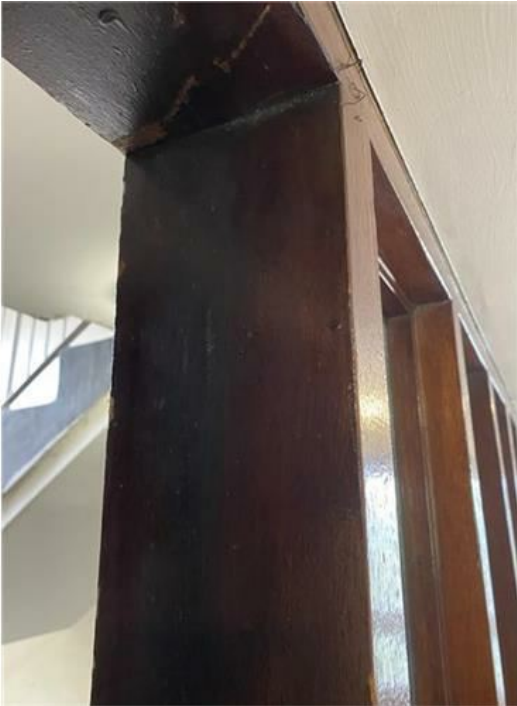
Ref	Sub Section	Question	Non-conformity	Recommendation	Location	Who is responsible	By When
13178391	5.0.V	Do the fire resisting door sets meet the appropriate standard?	The existing fire doors are damaged compromising the fire resistance provided by the door sets. Door stops are missing from a couple of stairwell doors too.	The damaged fire doors must be repaired or replaced to ensure that the required level of fire resistance is maintained.	4th, 3rd 1st floor lobby doors.	Statutory requirement for the Client	23/07/2024

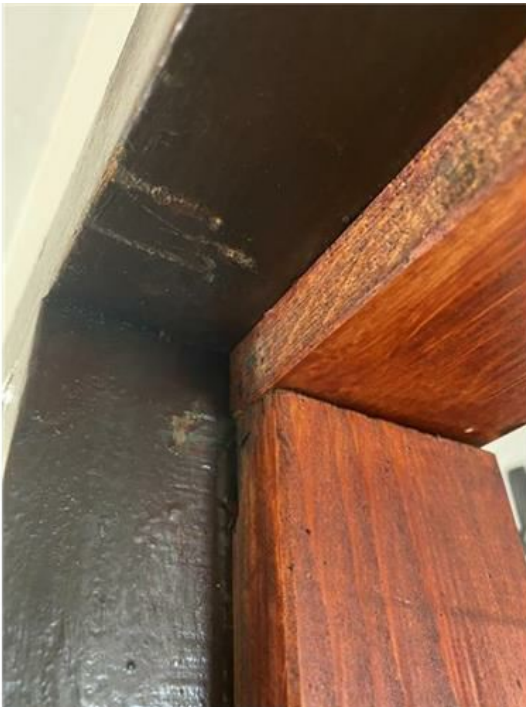
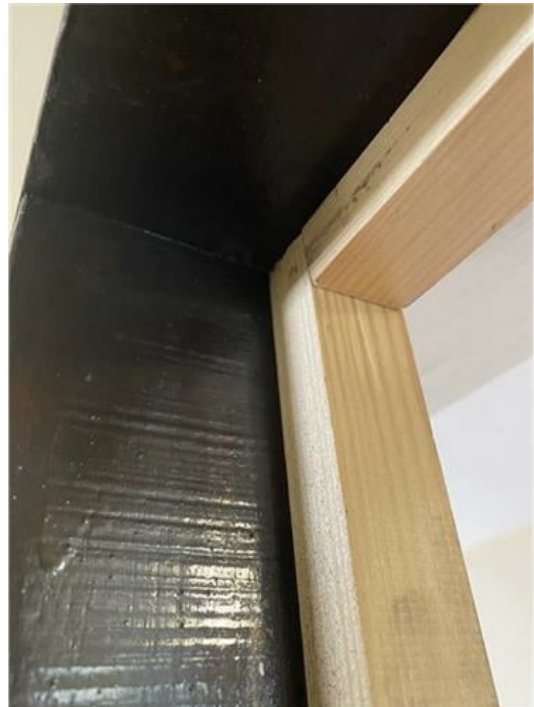
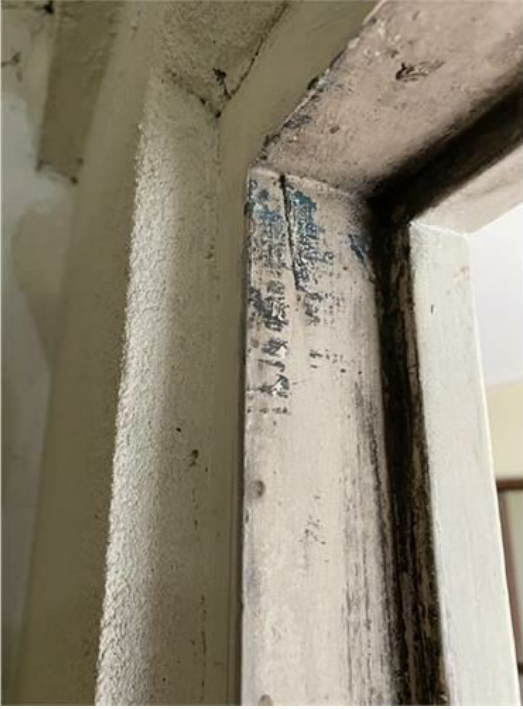
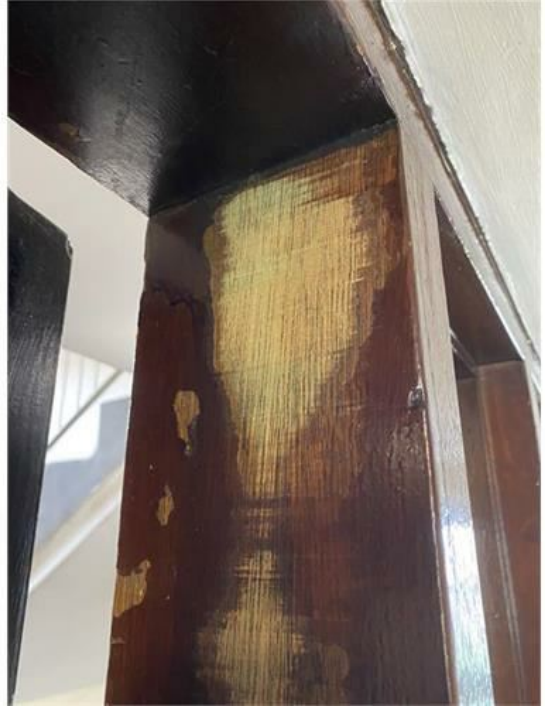
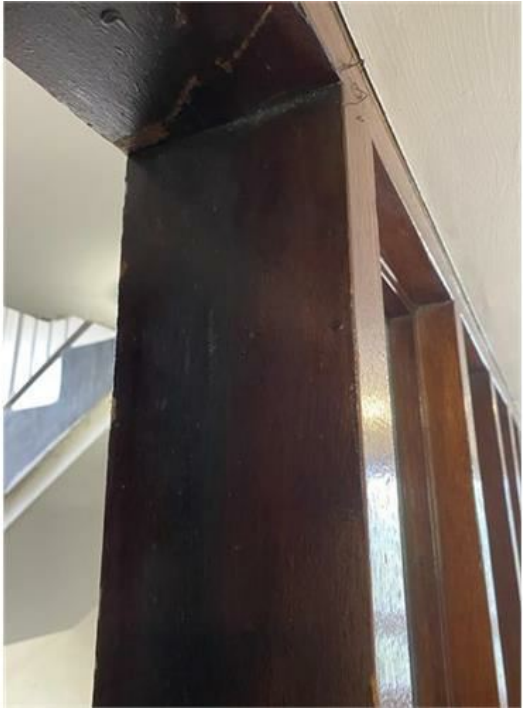
Ref	Sub Section	Question	Non-conformity	Recommendation	Location	Who is responsible	By When
13178390	D	Do the fire resisting door sets meet the appropriate standard?	The stairwell and refuse chute fire doors have not been provided with a means to prevent the spread of fire and smoke between compartments.	Dual intumescent heat strips/cold smoke seals are to be installed by a competent person in accordance with the manufacturer's instructions.	All floors.	Statutory requirement of the Client	23/07/2024

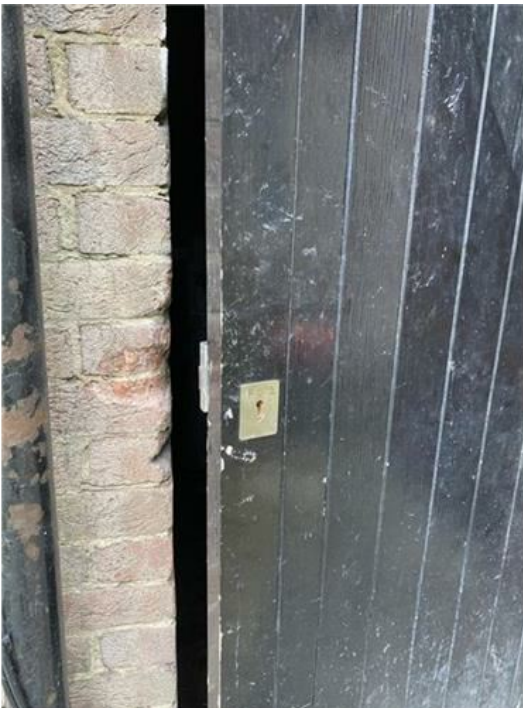
IMG_6315.jpg

Ref	Sub Section	Question	Non-conformity	Recommendation	Location	Who is responsible	By When
13178397	NR-54-215-1	Are adequate measures in place to control risk of fire due to arson?	Refuse store on ground floor not kept secure. Considered a potential arson risk.	Ensure that the door is kept locked and secured.	Refuse Store	Statutory requirement for the Client	21/09/2024
