# Fire Risk Assessment

Carried out on behalf of  
1-24 Law House - Barking - 900028178  
On the  
28 Mar 2024  
By  
Chris Daly BEng(Hons) MIFSM

**Address**  
 1-24 Law House - Barking - 900028178  
 1-24 Law House  
 Barking  
 IG11 0PQ

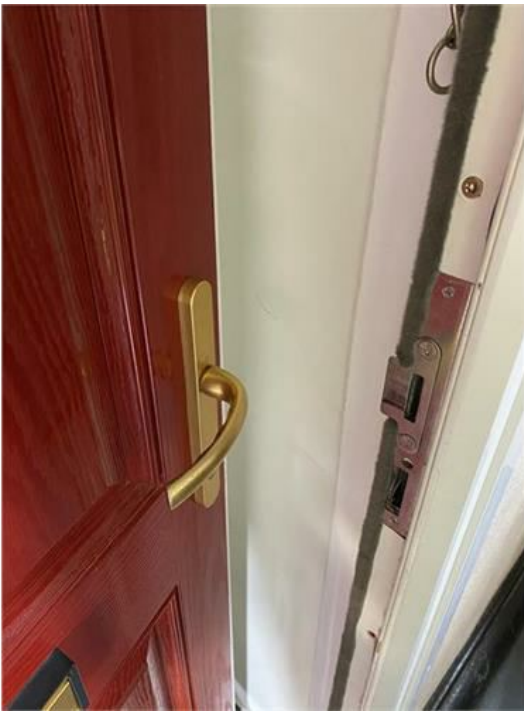
IMG\_6048(1).jpg

Ref	Sub Section	Question	Non-conformity	Recommendation	Location	Who is responsible	By When
13109738	5.0.J	Do the fire resisting door sets meet the appropriate standard?	Ineffective self closing devices.	Repair or replace the self-closing device/s to ensure fire door close fully into their frame/s against the door stops.	Front door to flat 19	Statutory requirement for the Client	14/05/2024

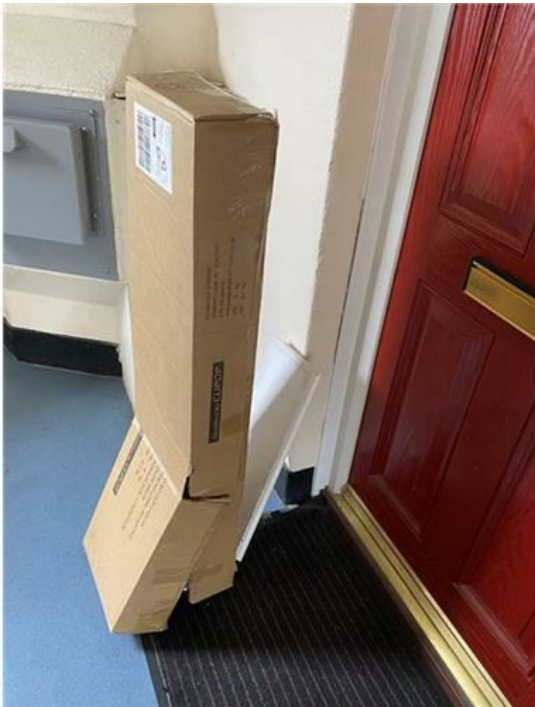
IMG\_6053[3630](1).jpg

Ref	Sub Section	Question	Non-conformity	Recommendation	Location	Who is responsible	By When
13109739	A	Are house keeping arrangements satisfactory?	Combustible materials are located/stored in the escape routes.	Items that are a source of fuel or are combustible and likely to increase the fire loading or spread of fire, should not be located on any corridor, stairway or circulation space that will be used as an escape route. Therefore, the combustible materials stored in the escape routes must be removed.	O/S flat 24	Statutory requirement for the Client	14/05/2024

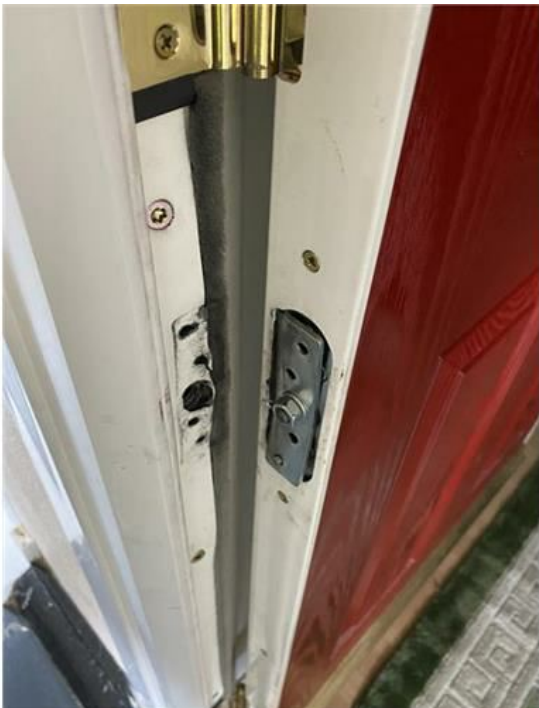
IMG\_6049(1).jpg

Ref	Sub Section	Question	Non-conformity	Recommendation	Location	Who is responsible	By When
13109737	K	Do the fire resisting door sets meet the appropriate standard?	The fire door requires a self-closing device.	The fire doors indicated must be fitted with a suitable positive action self-closing device (BS EN 1154).	Front door to flat 23	Statutory requirement for the Client	14/05/2024
