Fire Risk Assessment

1-24 Triumph House - Barking - 900026655

27 Mar 2024

SECTION 1: MANAGEMENT OVERVIEW - RISK ASSESSMENT

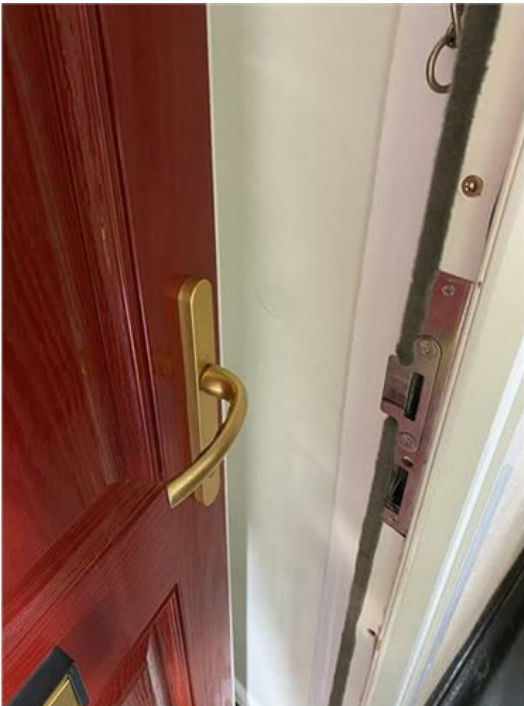
IMG_6048(1).jpg

Ref	Sub Section	Question	Non-conformity	Recommendation	Location	Who is responsible	By When
13109706	J	Do the fire resisting door sets meet the appropriate standard?	Ineffective self closing devices.	Repair or replace the self-closing device/s to ensure fire door/s close fully into their frame/s against the door stops.	Flat 8	Statutory requirement for the Client	12/05/2024
