Fire Risk Assessment

25-48 Law House - Barking - 900028178

28 Mar 2024

SECTION 1: MANAGEMENT OVERVIEW - RISK ASSESSMENT

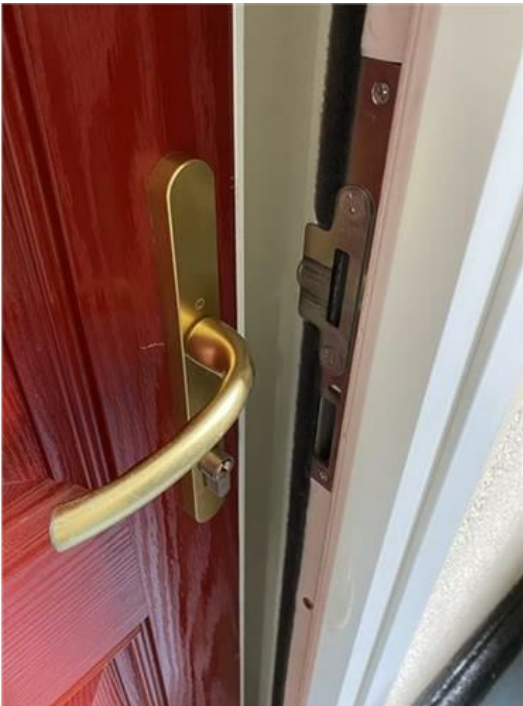
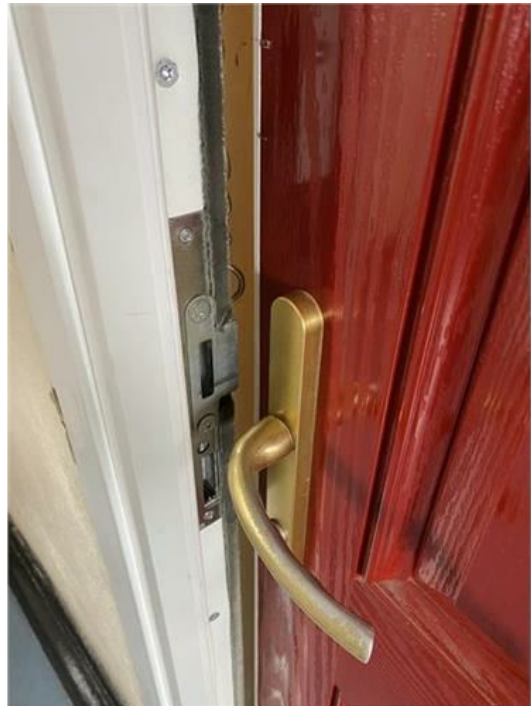
IMG_6058(1).jpg

Ref	Sub Section	Question	Non-conformity	Recommendation	Location	Who is responsible	By When
13109774	J	Do the fire resisting door sets meet the appropriate standard?	Ineffective self closing devices.	Repair or replace the self-closing devices to ensure fire doors close fully into their frames against the door stops.	Front doors to flats 41 and 34	Statutory requirement for the Client	14/05/2024

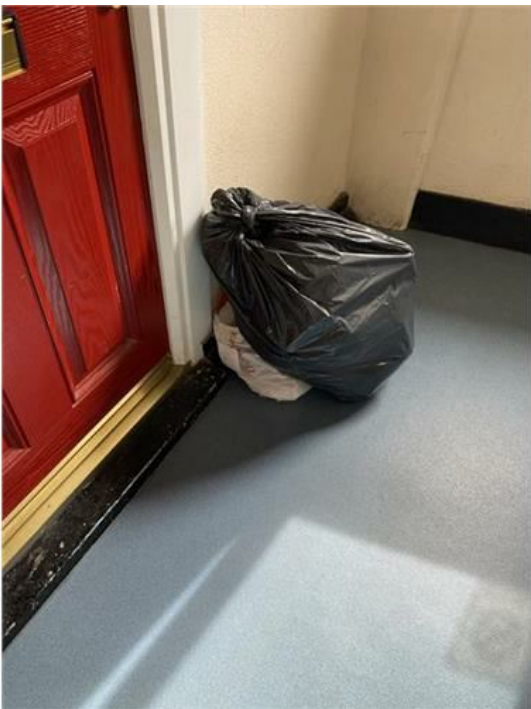
IMG_6056(1).jpg

Ref	Sub Section	Question	Non-conformity	Recommendation	Location	Who is responsible	By When
13109775	A	Are house keeping arrangements satisfactory?	Combustible materials are located/stored in the escape routes.	Items that are a source of fuel or are combustible and likely to increase the fire loading or spread of fire, should not be located on any corridor, stairway or circulation space that will be used as an escape route. Therefore, the combustible materials stored in the escape routes must be removed.	O/S flat 47	Statutory requirement for the Client	13/07/2024

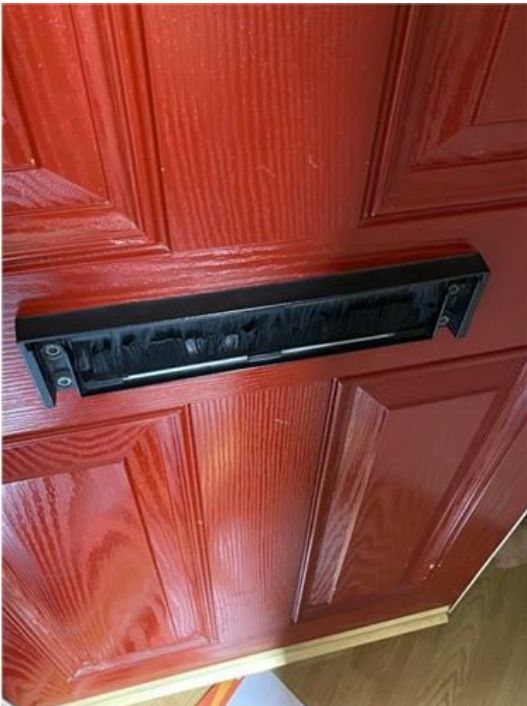
IMG_6057(1).jpg

Ref	Sub Section	Question	Non-conformity	Recommendation	Location	Who is responsible	By When
13109781	C	Are adequate measures in place to control risk of fire due to arson?	The letterbox has not been enclosed within fire resisting construction. Missing front plate to letterbox.	The letterbox should be enclosed with materials which provide a degree of fire resistance.	Front door to flat 41	Statutory requirement for the Client	13/07/2024
