Fire Risk Assessment

Carried out on behalf of
25-48 Triumph House - Barking - 900026655

On the
27 Mar 2024

SECTION 1: MANAGEMENT OVERVIEW - RISK ASSESSMENT

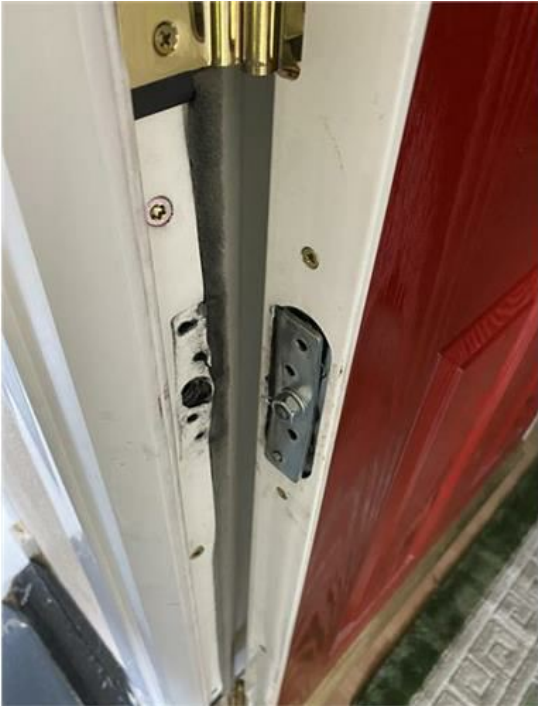
IMG_6049(1).jpg

Ref	Sub Section	Question	Non-conformity	Recommendation	Location	Who is responsible	By When
13109723	K	Do the fire resisting door sets meet the appropriate standard?	The fire doors require a self-closing device.	The fire doors indicated must be fitted with a suitable positive action self-closing device (BS EN 1154).	Front doors to flats 47, 46 and 37	Statutory requirement for the Client	12/05/2024
