Fire Risk Assessment

4-82 Gosfield Road - Dagenham - RM8 1LB - 900042718

05 Aug 2024

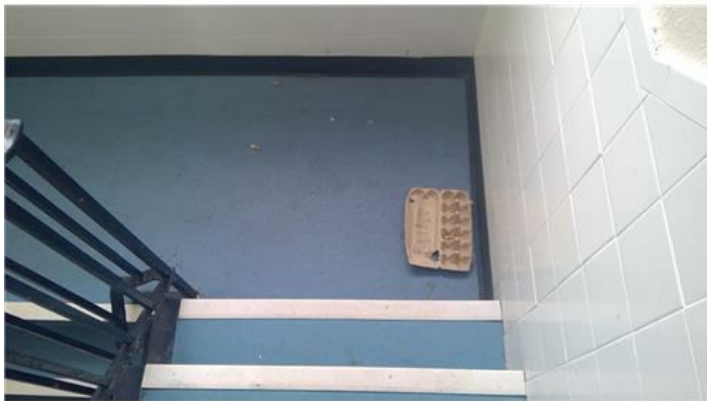
WIN_20240805_10_56_12_Pro.jpg

Ref	Sub Section	Question	Non-conformity	Recommendation	Location	Who is responsible	By When
13229905	B	Is a suitable 'no smoking' policy in place?	Evidence of unauthorised smoking was found.	Management are to apprise all relevant persons on the company smoking policy.		Statutory requirement for the Client	15/09/2024
