Fire Risk Assessment

1-100 Mersea House - Barking - IG11 8LN - 900005452

06 Nov 2024

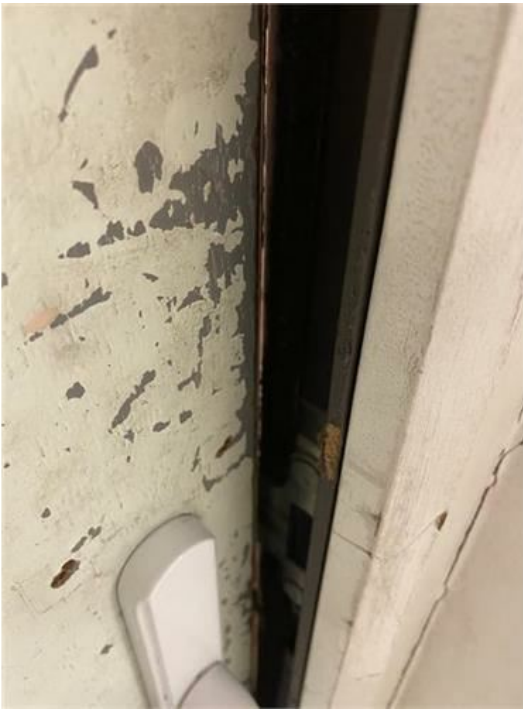
IMG_6724(1).jpg

Ref	Sub Section	Question	Non-conformity	Recommendation	Location	Who is responsible	By When
13327585	5.0.J	Do the fire resisting door sets meet the appropriate standard?	Ineffective self closing devices.	Repair or replace the self-closing devices to ensure fire doors close fully into their frames against the door stops.	Flat doors 42 and 20	Statutory requirement for the Client	20/12/2024

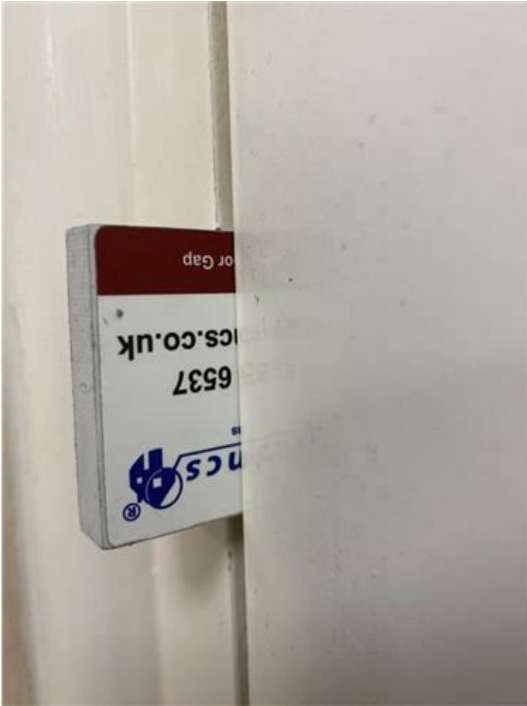
IMG_6726(1).jpg

Ref	Sub Section	Question	Non-conformity	Recommendation	Location	Who is responsible	By When
13327584	X	Do the fire resisting door sets meet the appropriate standard?	The fire doors have a large gap between the doors and the frame which may prevent the intumescent seals being effective.	The doors should be adjusted to ensure that there is no more than a 4mm gap (min 2mm) between the hinge edge, leading edge and the top of the door.	Lobby and stair doors on 1st and Ground floor.	Statutory requirement for the Client	20/12/2024
