Fire Risk Assessment

25-48 Enterprise House - Barking - 900027825

25 Mar 2024

The premises is a purpose built 9 storey general needs block of flats.

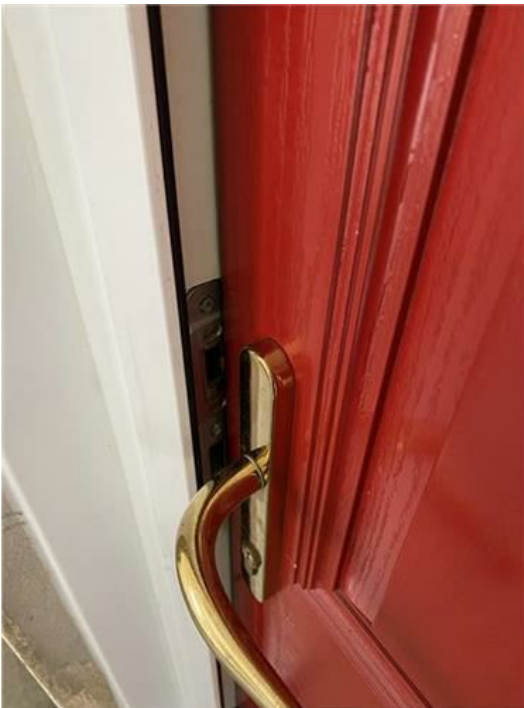
IMG_6046.jpg

Ref	Sub Section	Question	Non-conformity	Recommendation	Location	Who is responsible	By When
13107932	J	Do the fire resisting door sets meet the appropriate standard?	Ineffective self closing devices.	Repair or replace the self-closing device to ensure fire door/s close fully into their frame/s against the door stops.	Front door to flat 39	Statutory requirement for the Client	12/05/2024
