Fire Risk Assessment

Carried out on behalf of
1-32 Hepworth Court - Barking - 900019947

On the
18 Mar 2024

Address
 1-32 Hepworth Court - Barking - 900019947
 1-32 Hepworth Court
 Barking
 IG11 9AZ

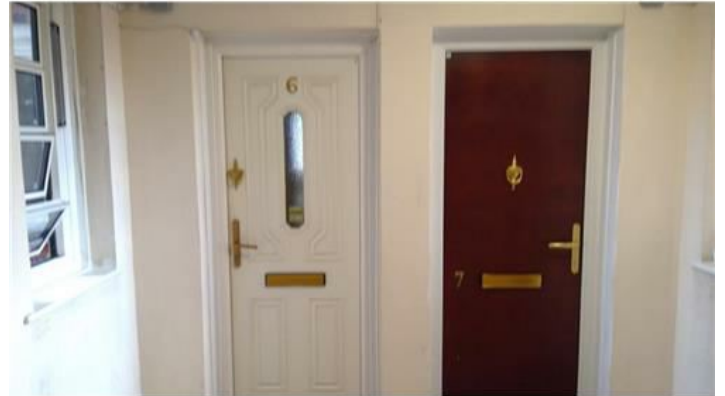
Ref	Sub Section	Question	Non-conformity	Recommendation	Location	Who is responsible	By When
13097601	E	Do the fire resisting door sets meet the appropriate standard?	The existing doors are not deemed to be of the appropriate fire resisting standard.	Install door sets which provide the required standard of fire resistance. The door must be fitted with a positive self closing device or in the case of a cupboard kept locked shut and be provided with the appropriate signage to indicate that the door should be kept locked.	Flat 21 & 6	Statutory requirement for the Client	04/05/2024
