Fire Risk Assessment

1-70 Perryman House - Barking - 900011558

07 Mar 2024

SECTION 1: MANAGEMENT OVERVIEW - RISK ASSESSMENT

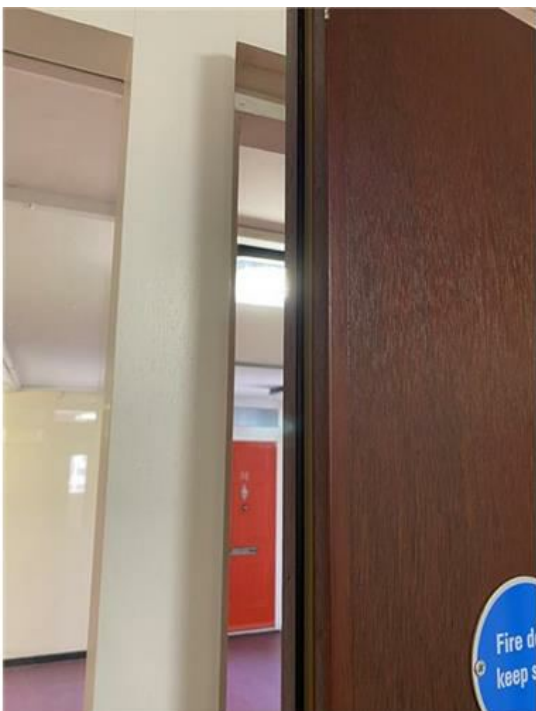
IMG_5953(1).jpg

Ref	Sub Section	Question	Non-conformity	Recommendation	Location	Who is responsible	By When
13093863	5.0.J	Do the fire resisting door sets meet the appropriate standard?	Ineffective self closing devices.	Repair or replace the self-closing device to ensure fire door/s close fully into their frame against the door stops.	Lobby door on 5th floor	Statutory requirement for the Client	23/04/2024

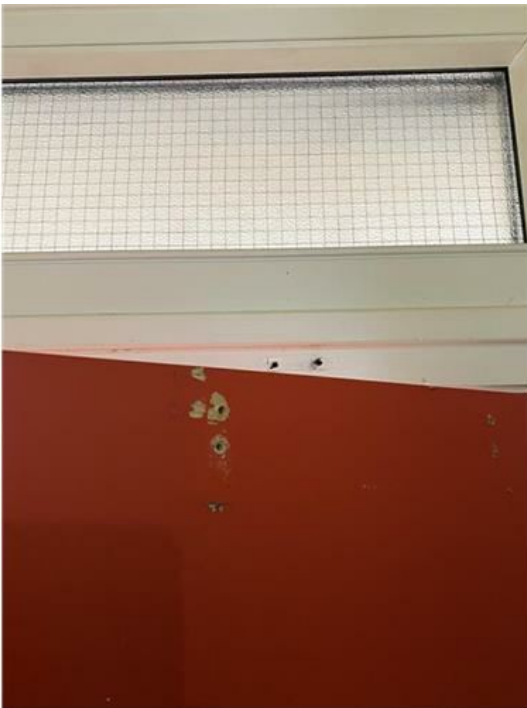
IMG_5949(1).jpg

Ref	Sub Section	Question	Non-conformity	Recommendation	Location	Who is responsible	By When
13093862	K	Do the fire resisting door sets meet the appropriate standard?	The fire door requires a self-closing device.	The fire doors indicated must be fitted with a suitable positive action self-closing device (BS EN 1154).	Flats 70, 66,. 57 and 42.	Statutory requirement for the Client	23/04/2024

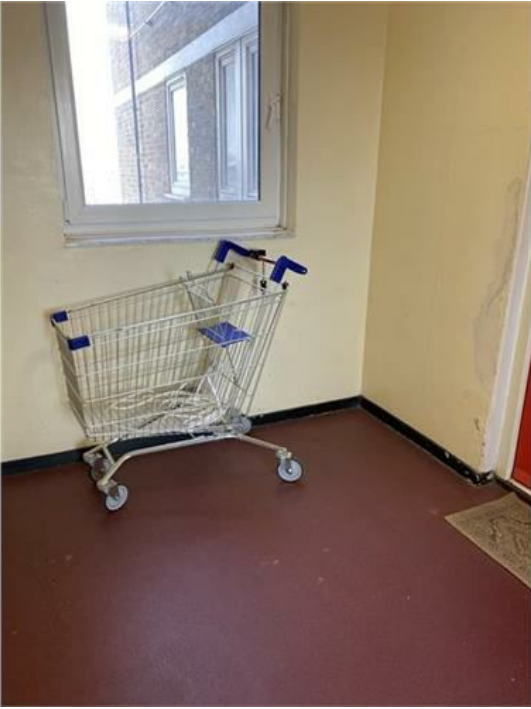
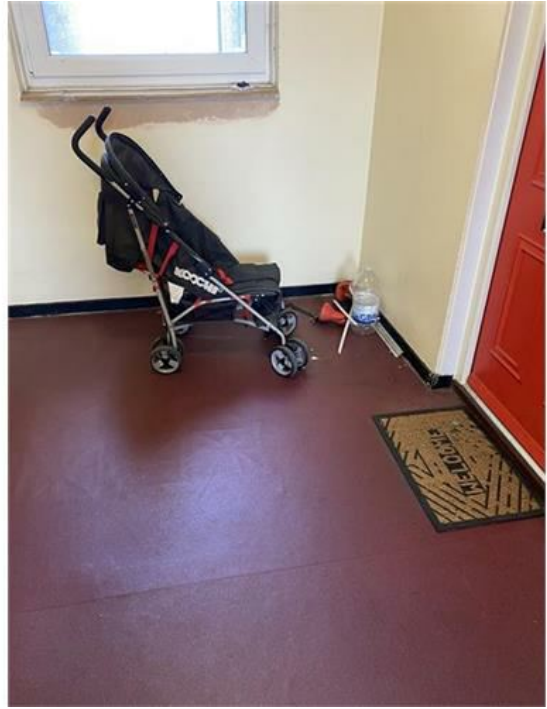
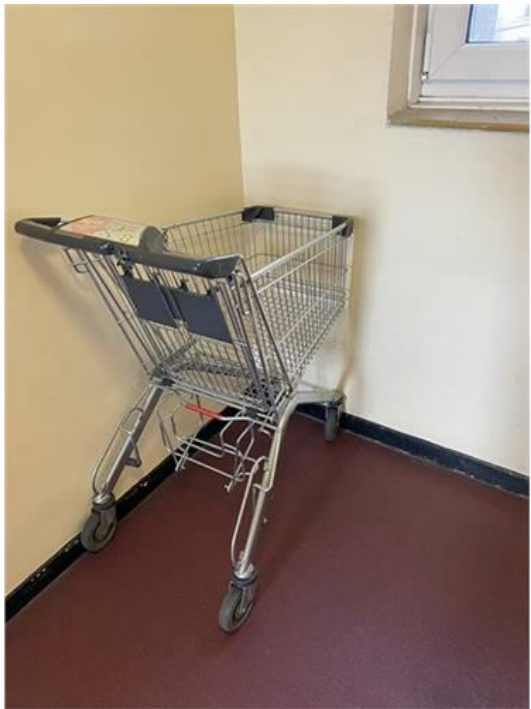
Ref	Sub Section	Question	Non-conformity	Recommendation	Location	Who is responsible	By When
13093865	5.0.D	Are house keeping arrangements satisfactory?	The escape route is obstructed.	The items obstructing the escape route must be removed..	O/S Flats 36 and 30.	Statutory requirement for the Client	22/06/2024

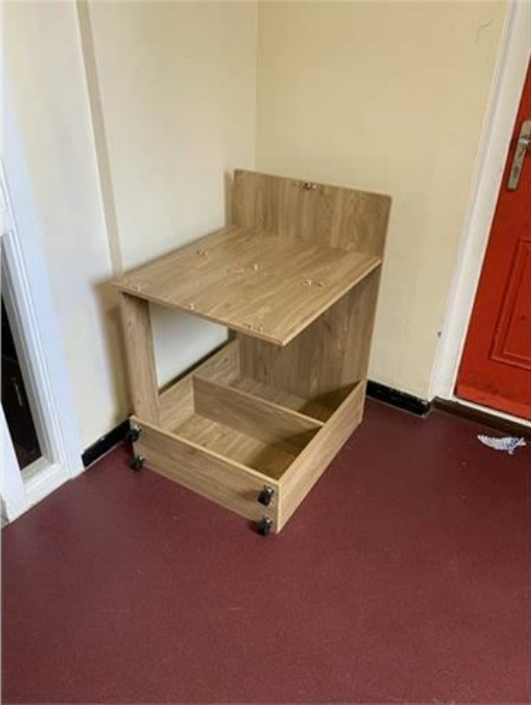
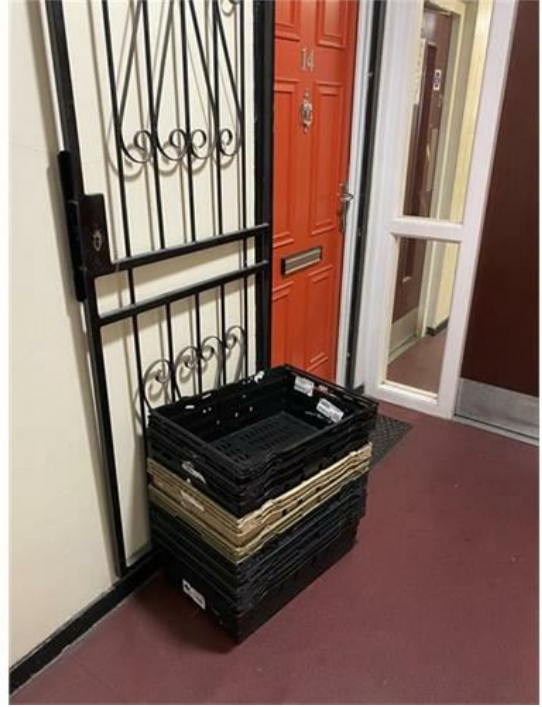
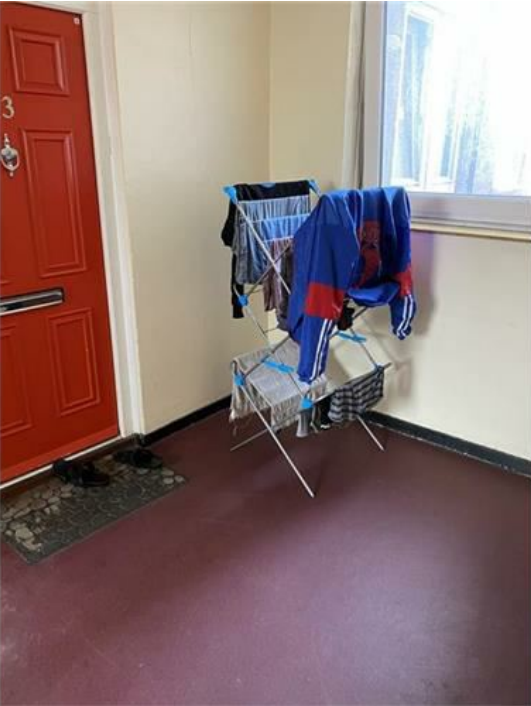
Ref	Sub Section	Question	Non-conformity	Recommendation	Location	Who is responsible	By When
13093864	A	Are house keeping arrangements satisfactory?	Combustible materials are located/stored in the escape routes.	Items that are a source of fuel or are combustible and likely to increase the fire loading or spread of fire, should not be located on any corridor, stairway or circulation space that will be used as an escape route. Therefore, the combustible materials stored in the escape routes must be removed.	O/S Flat 69, 14 and 13.	Statutory requirement for the Client	22/06/2024

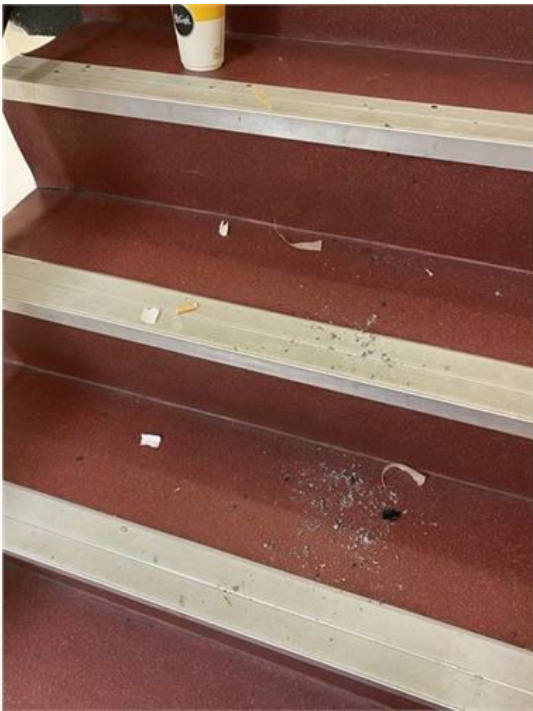
IMG_5947(1).jpg

Ref	Sub Section	Question	Non-conformity	Recommendation	Location	Who is responsible	By When
13093871	B	Is a suitable 'no smoking' policy in place?	Evidence of unauthorised smoking was found.	Management are to apprise all relevant persons on the company smoking policy.	11th floor stairwell	Statutory requirement for the Client	22/06/2024
